**Re: Chiquita Canyon, LLC's Weekly Report on the Documentation and Tracking of Cover Issues**

In accordance with the Local Enforcement Agency's ("LEA") May 2, 2024 letter approving Chiquita's April 16, 2024 Second Revised Written Plan for Documenting and Tracking Cover Issues ("Second Revised Written Plan"), the LEA's May 29, 2024 letter, and the LEA's June 6, 2024 Compliance Order, Chiquita presents the enclosed report for documenting and tracking cover issues for the week of April 27, 2026 to May 2, 2026.

# 4050 - Chiquita Reaction Area Tracking of Fissures and Tension Cracks

# 4050 - Geosynthetic Cover Inspection

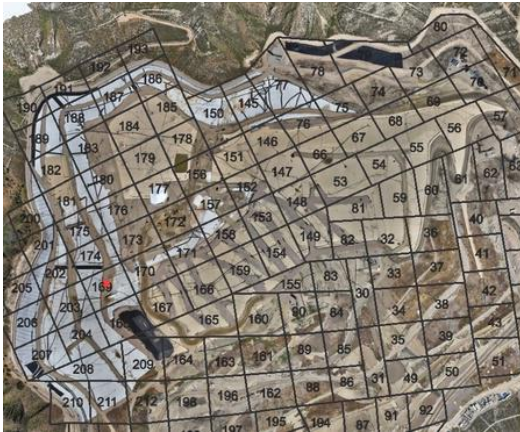
169

Yes

20 ft X 40 ft

Small 0.5-2" in width

Extra small <0.5" in height

E to W

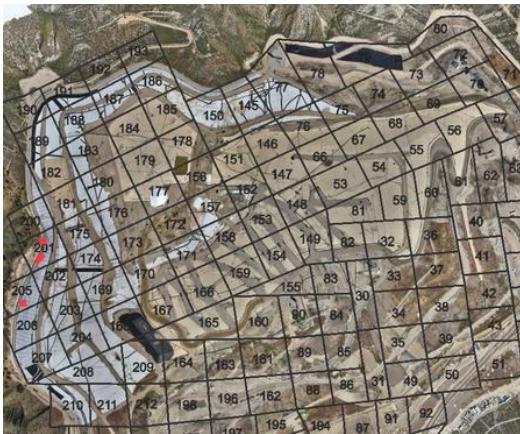
201/205

Yes

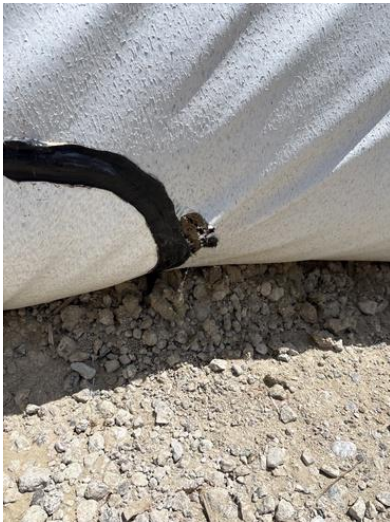
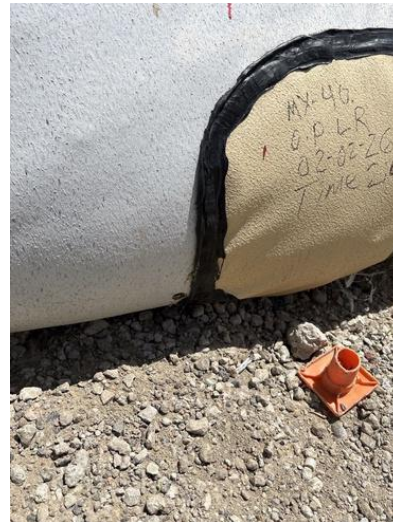
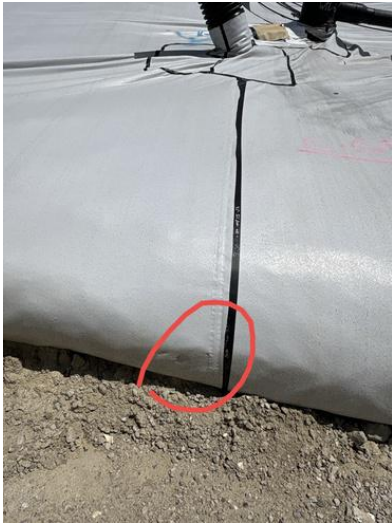
Liner needs to be patched

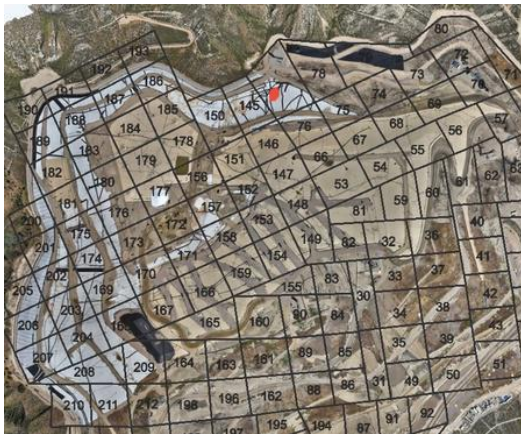
77

Yes

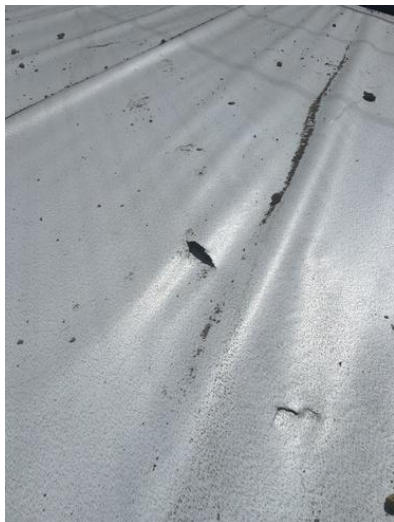
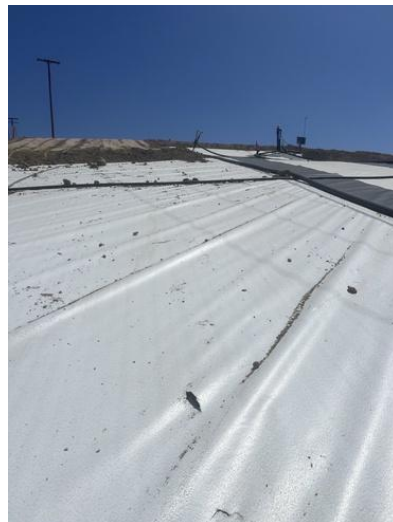
Liner torn, needs to be patched and extrusion welded
