Re: Chiquita Canyon, LLC's Weekly Report on the Documentation and Tracking of Cover Issues, Monthly Summary and Monthly Isopach Map

4050 - Chiquita Reaction Area Tracking of Fissures and Tension Cracks

**APRIL 2026 FISSURE AND TENSION CRACK MONITORING SUMMARY
CHIQUITA CANYON LANDFILL
CASTAIC, CALIFORNIA**

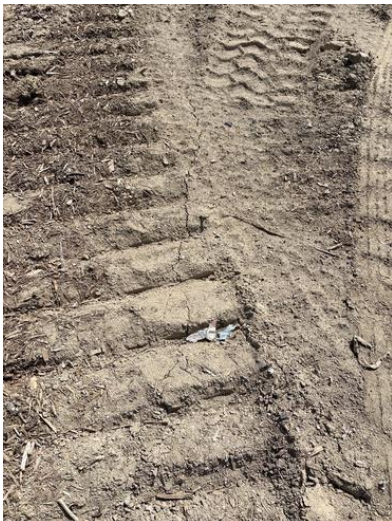
Photo 1

Length of crack (ft) or area containing multiple cracks (ft x ft) 35ft x 15ft

Horizontal Offset (width) Small 0.5-2" in width

Vertical Offset (height) Extra small <0.5" in height

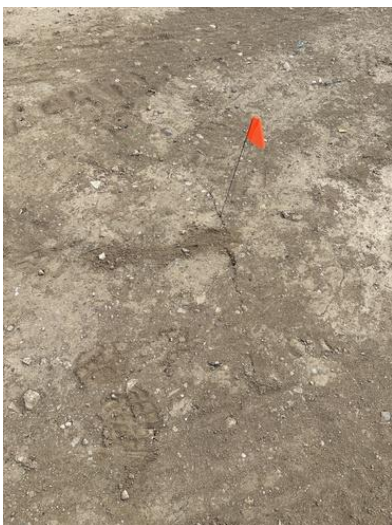
Photo 5

No individual crack 50ft or longer.

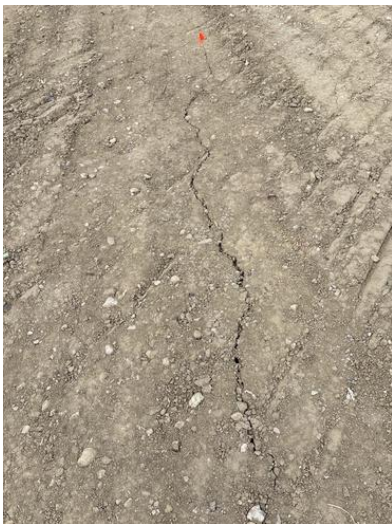
Photo 11

No individual crack 50ft or longer.

Horizontal Offset (width)	Small 0.5-2" in width
Vertical Offset (height)	Extra small <0.5" in height
Orientation (direction)	NE to SW
Location	Castaic CA 91384 United States (34.43232910860781, -118.64881009154321)
Was Fissure or Crack fixed? If yes, add photo and description of repairs performed	Yes

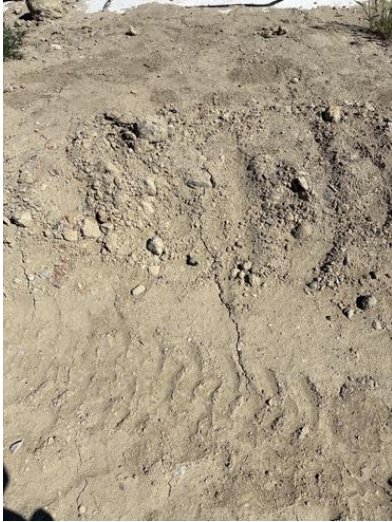
Photo 3

Length of crack (ft) or area containing multiple cracks (ft x ft) 20ft x 15ft

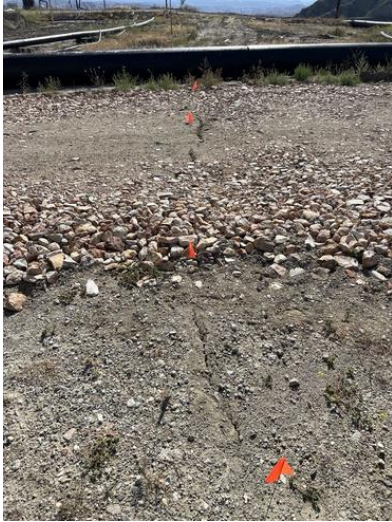
Photo 3

Length of crack (ft) or area containing multiple cracks (ft x ft) 17ft

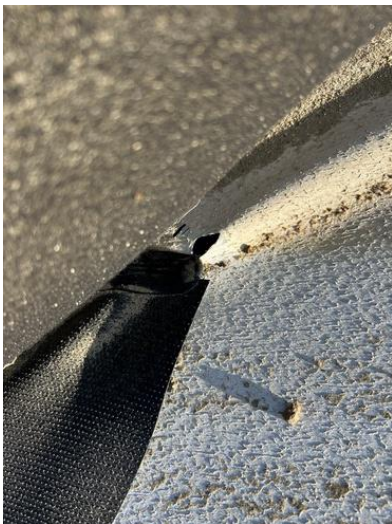
Photo 1

Small tear in liner, needs to be patched and extrusion welded

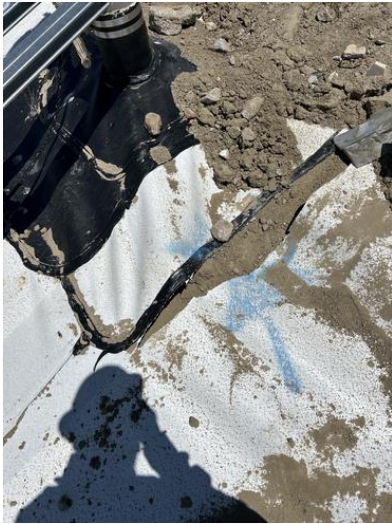
Photo 3

Liner torn, needs to be patched and extrusion welded

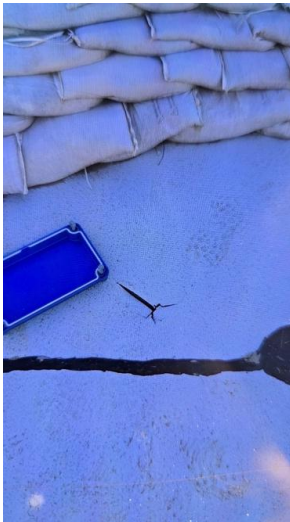
Photo 1

Liner torn, needs to be patched and extrusion welded

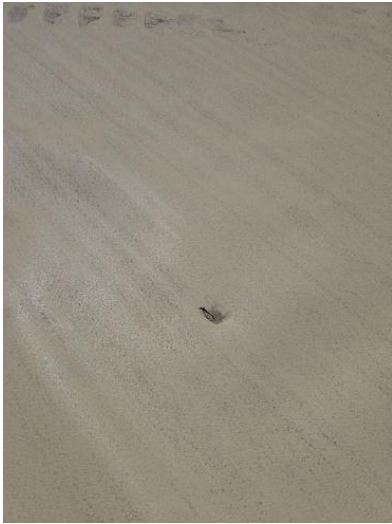
Photo 4

Liner torn, needs to be patched and extrusion welded

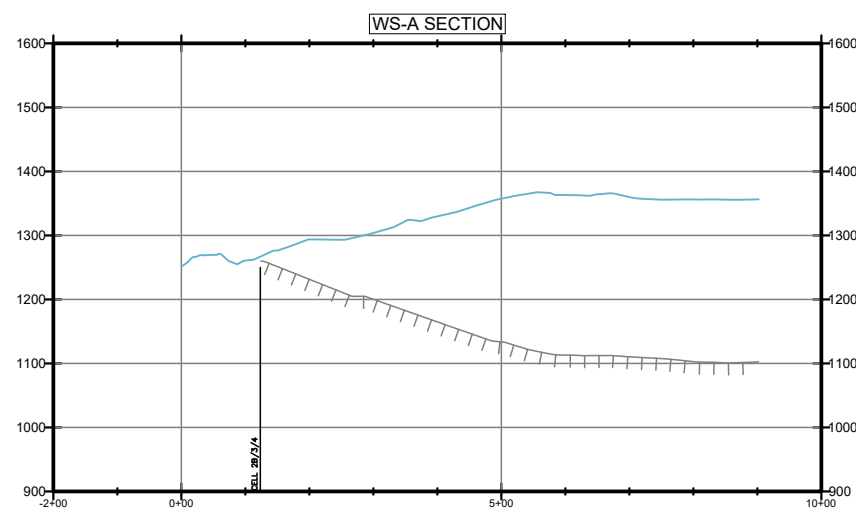
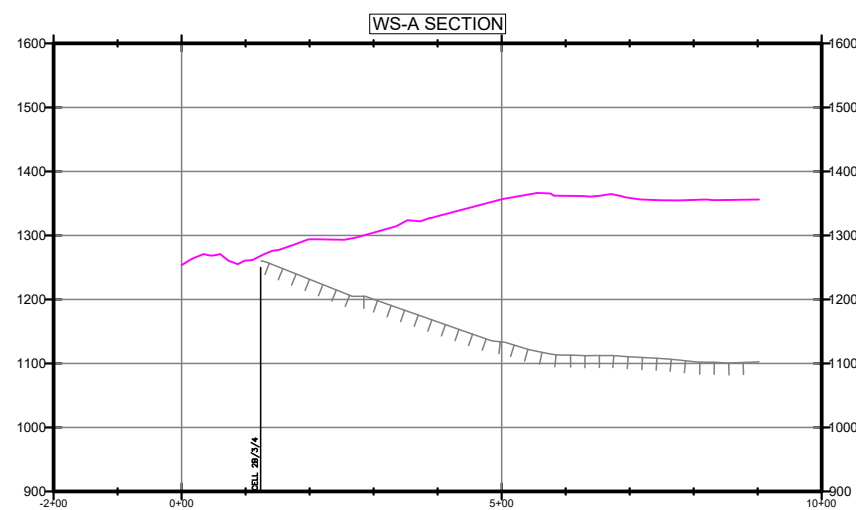
FIGURE 2A

All the cracks identified in Table 1 were repaired. Cross sections that compare March 25, 2026 and April 30, 2026 topography are shown in Figures 2A through 2E. The locations of these cross sections are shown in Figure 1. The sections show no significant differences in slope or evidence of instability between the March 2026 and April 2026 profiles, which is consistent with the observational records summarized in Tables 1 and 2.

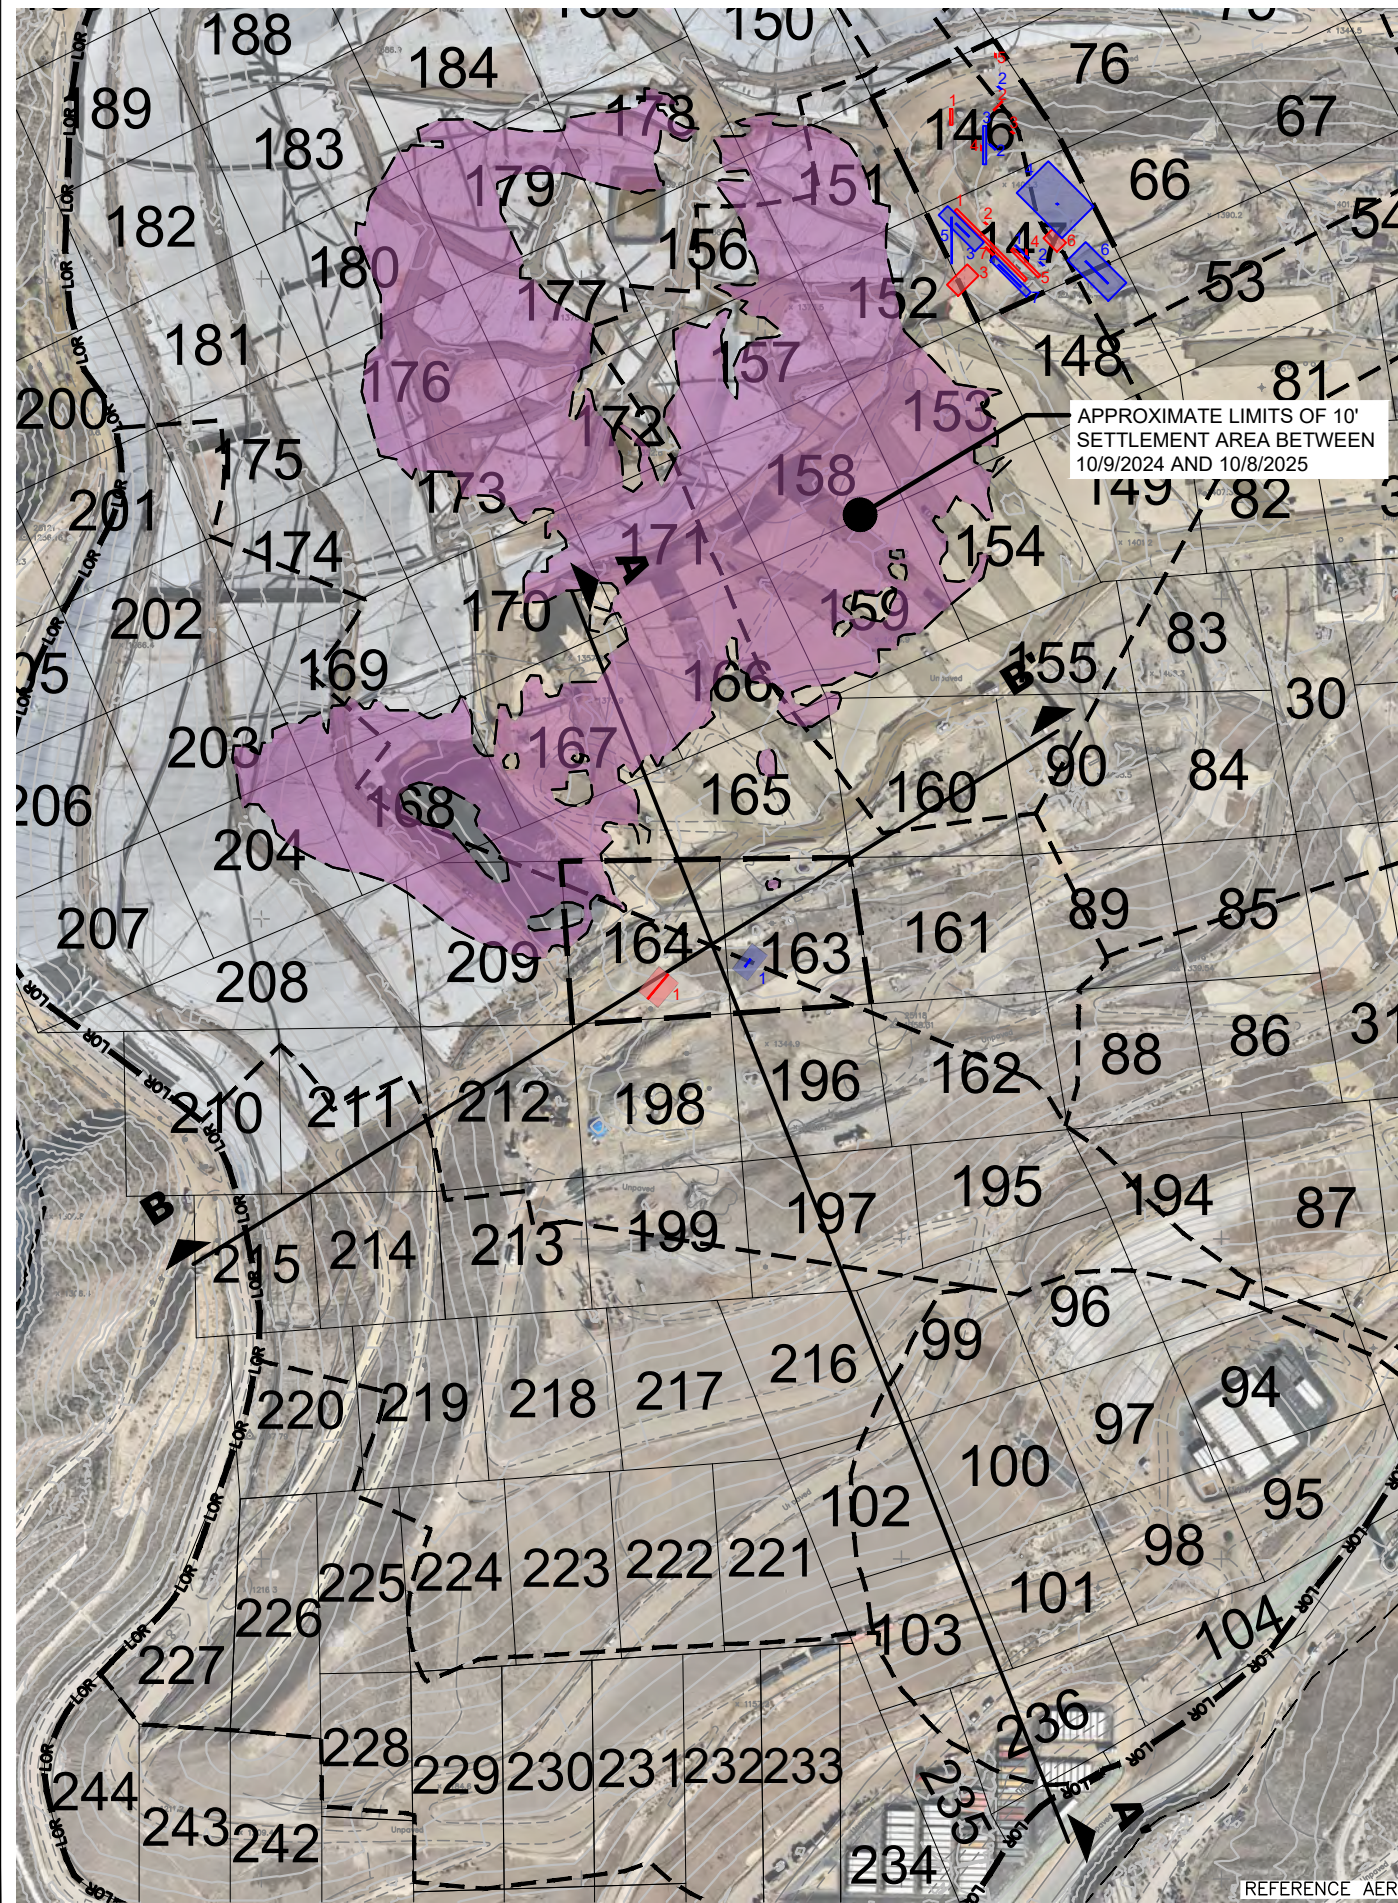
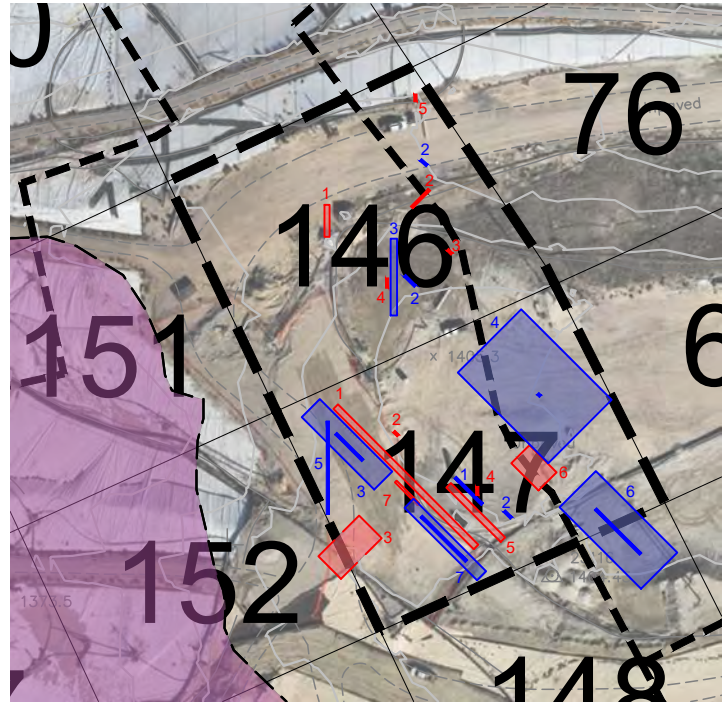
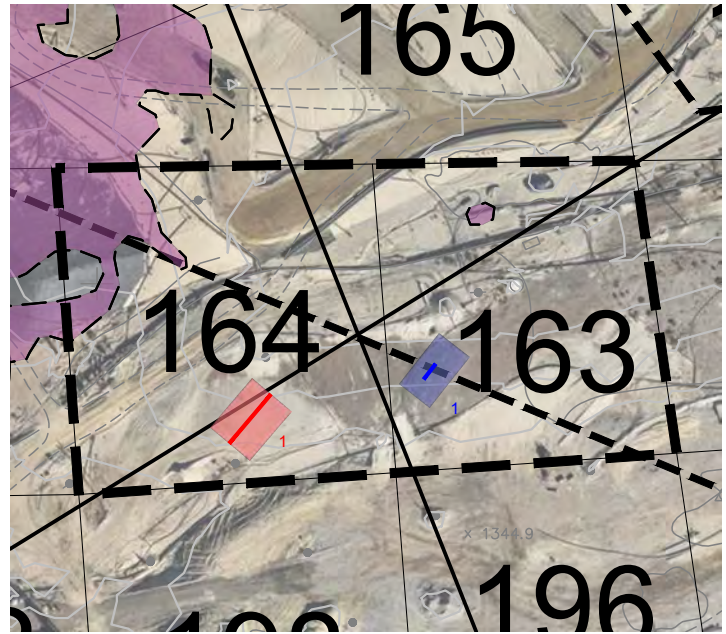
GRIDS 146, 147, 148, 163, AND 164
TENSION CRACKS OBSERVED IN
SEPTEMBER AND OCTOBER 2025

Observations on the western slope included bulging at the toe of the slope, vertical risers tilted in a downslope direction, "trampolining" of the geomembrane near the top of slope, and evidence of variable, multi-directional geomembrane stress between the crest and toe. The observed deformation is spatially coincident with, and likely associated with, the reaction area and corresponding zone of maximum settlement originally described and shown in Figure 3 of the GLA November 11, 2025 monthly summary report and reattached herein as Figure 3.
