Re: Chiquita Canyon, LLC's Weekly Leachate Inspection Report for Stipulated Order for Abatement (Case No. 6177-4), Condition 27(c)

4050 - Chiquita Leachate Seep/Pooling Inspection

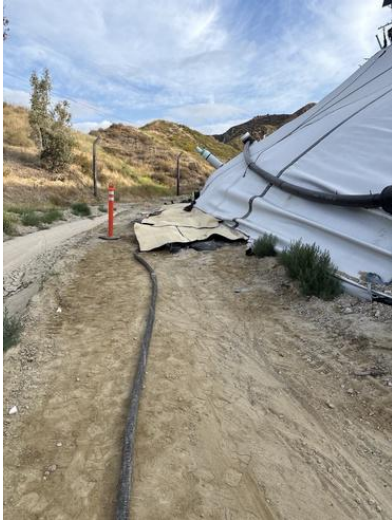
Photo 1

Westside perimeter road. None of the seeps that occurred in this area were observed at the time of this inspection. Area continues to be monitored and vacuumed out as needed to prevent pooling.

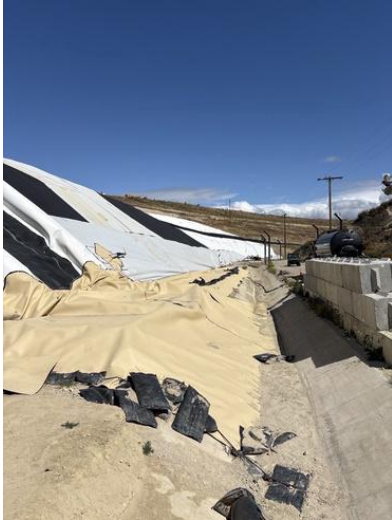
Photo 1

Westside perimeter road. None of the seeps that occurred in this area were observed at the time of this inspection. Area continues to be monitored and vacuumed out as needed to prevent pooling.

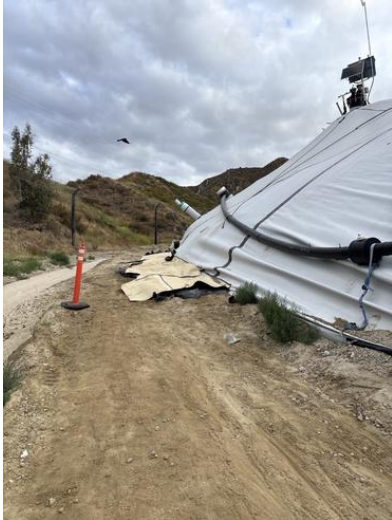
Photo 1

Westside perimeter road. None of the seeps that occurred in this area were observed at the time of this inspection. Area continues to be monitored and vacuumed out as needed to prevent pooling.

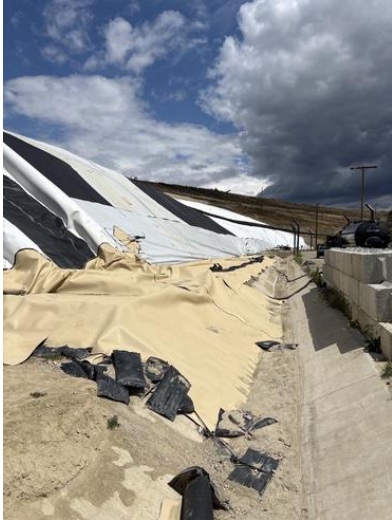
Photo 1

Westside perimeter road. None of the seeps that occurred in this area were observed at the time of this inspection. Area continues to be monitored and vacuumed out as needed to prevent pooling.

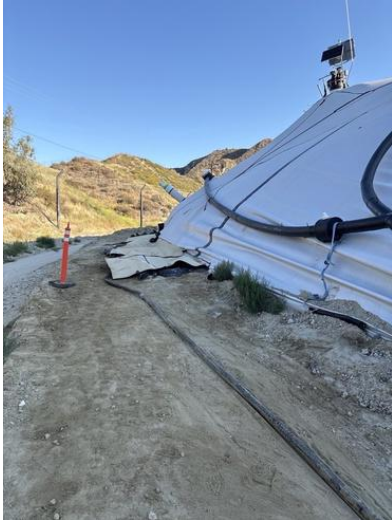
Photo 1

Westside perimeter road. None of the seeps that occurred in this area were observed at the time of this inspection. Area continues to be monitored and vacuumed out as needed to prevent pooling.

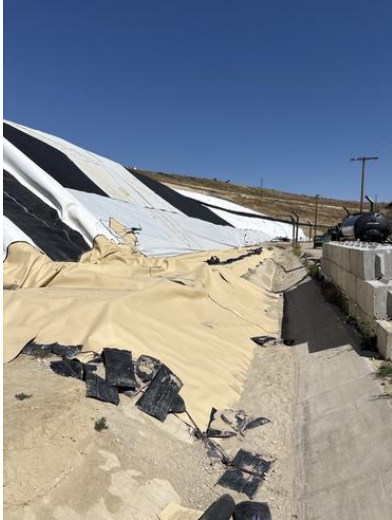
Photo 1

Westside perimeter road. None of the seeps that occurred in this area were observed at the time of this inspection. Area continues to be monitored and vacuumed out as needed to prevent pooling.

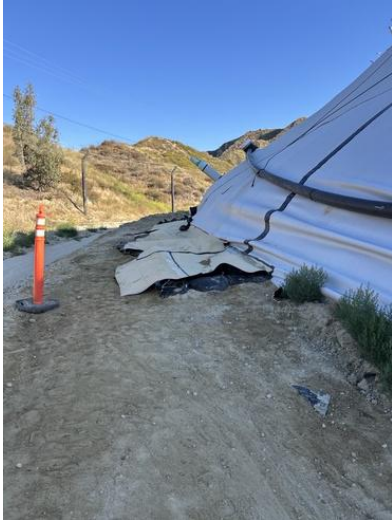
Photo 1

Westside perimeter road. None of the seeps that occurred in this area were observed at the time of this inspection. Area continues to be monitored and vacuumed out as needed to prevent pooling.

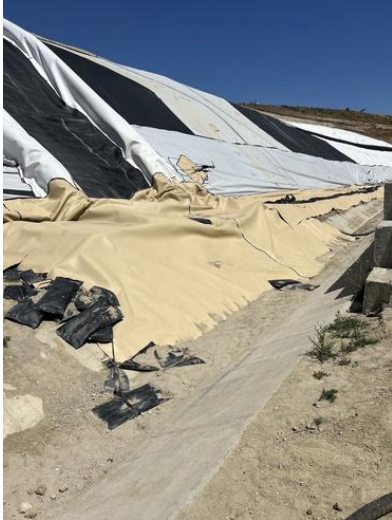
Photo 1

Westside perimeter road. None of the seeps that occurred in this area were observed at the time of this inspection. Area continues to be monitored and vacuumed out as needed to prevent pooling.

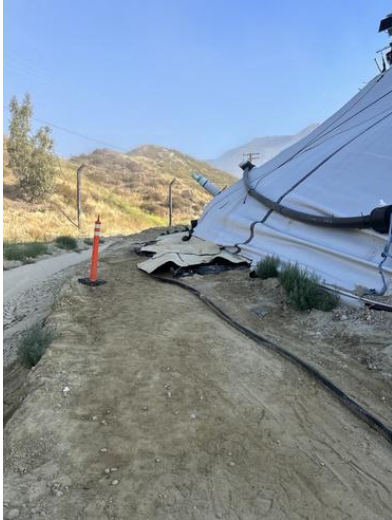
Photo 1

Westside perimeter road. None of the seeps that occurred in this area were observed at the time of this inspection. Area continues to be monitored and vacuumed out as needed to prevent pooling.

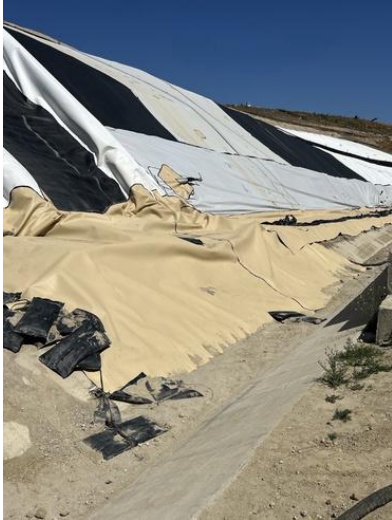
Photo 1

Westside perimeter road. None of the seeps that occurred in this area were observed at the time of this inspection. Area continues to be monitored and vacuumed out as needed to prevent pooling.

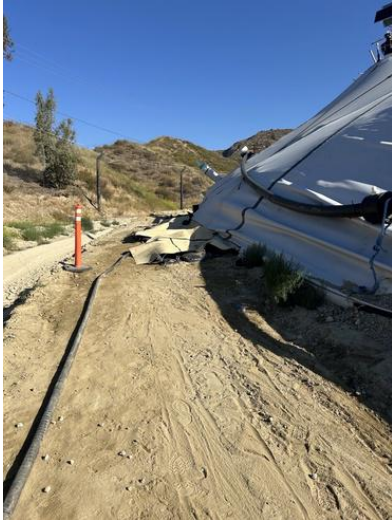
Photo 1

Westside perimeter road. None of the seeps that occurred in this area were observed at the time of this inspection. Area continues to be monitored and vacuumed out as needed to prevent pooling.

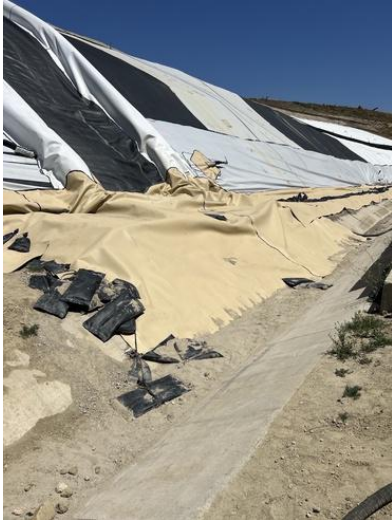
Photo 1

Westside perimeter road. None of the seeps that occurred in this area were observed at the time of this inspection. Area continues to be monitored and vacuumed out as needed to prevent pooling.

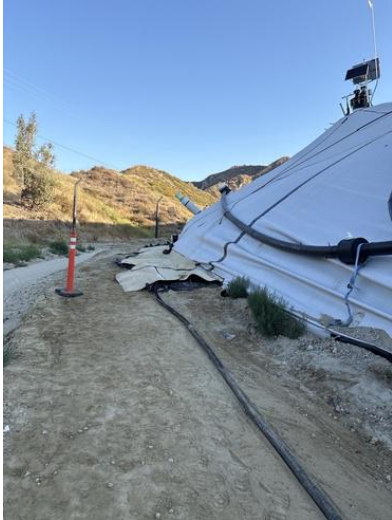
Photo 1

Westside perimeter road. None of the seeps that occurred in this area were observed at the time of this inspection. Area continues to be monitored and vacuumed out as needed to prevent pooling.
