Re: Chiquita Canyon, LLC's Weekly Leachate Inspection Report for Stipulated Order for Abatement (Case No. 6177-4), Condition 27(c)

4050 - Chiquita Leachate Seep/Pooling Inspection

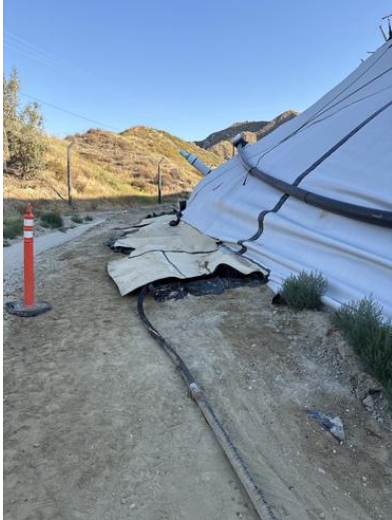
Photo 1

Westside perimeter road. None of the seeps that occurred in this area were observed at the time of this inspection. Area continues to be monitored and vacuumed out as needed to prevent pooling.

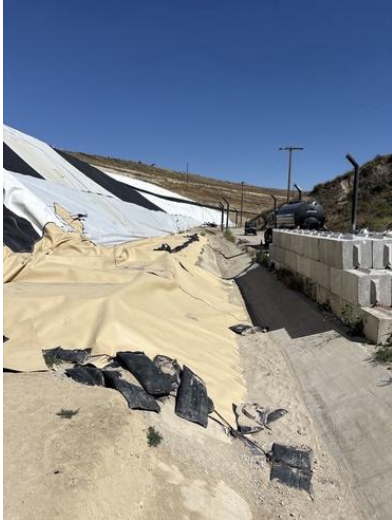
Photo 1

Westside perimeter road. None of the seeps that occurred in this area were observed at the time of this inspection. Area continues to be monitored and vacuumed out as needed to prevent pooling.

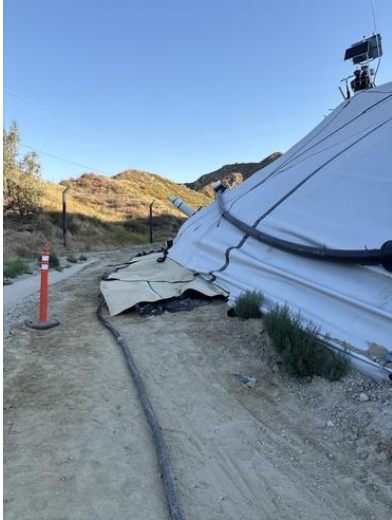
Photo 1

Westside perimeter road. None of the seeps that occurred in this area were observed at the time of this inspection. Area continues to be monitored and vacuumed out as needed to prevent pooling.

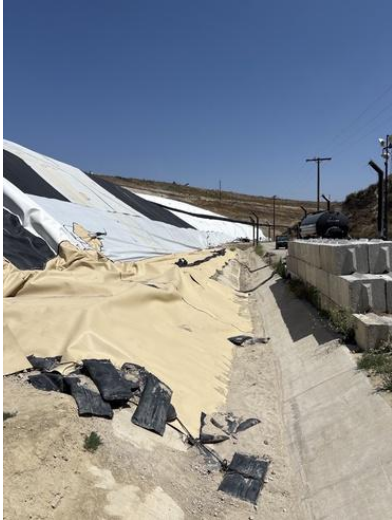
Photo 1

Westside perimeter road. None of the seeps that occurred in this area were observed at the time of this inspection. Area continues to be monitored and vacuumed out as needed to prevent pooling.

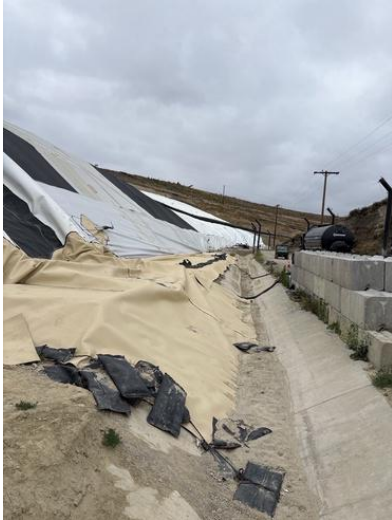
Photo 1

Westside perimeter road. None of the seeps that occurred in this area were observed at the time of this inspection. Area continues to be monitored and vacuumed out as needed to prevent pooling.

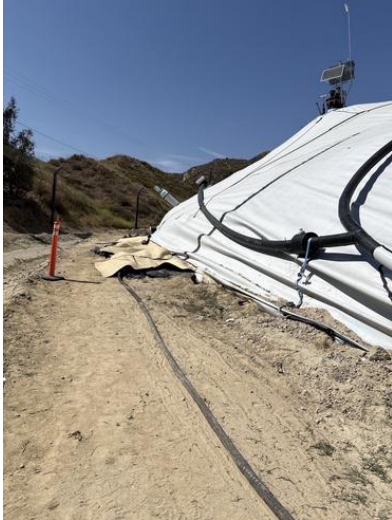
Photo 1

Westside perimeter road. None of the seeps that occurred in this area were observed at the time of this inspection. Area continues to be monitored and vacuumed out as needed to prevent pooling.

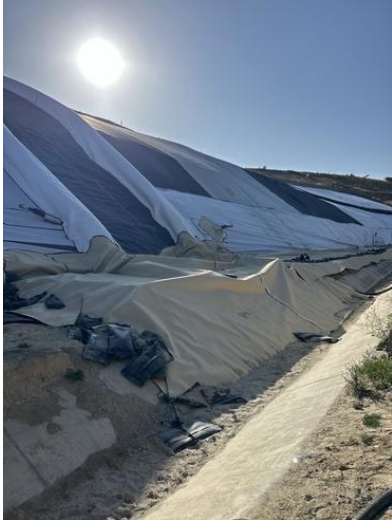
Photo 1

Westside perimeter road. None of the seeps that occurred in this area were observed at the time of this inspection. Area continues to be monitored and vacuumed out as needed to prevent pooling.

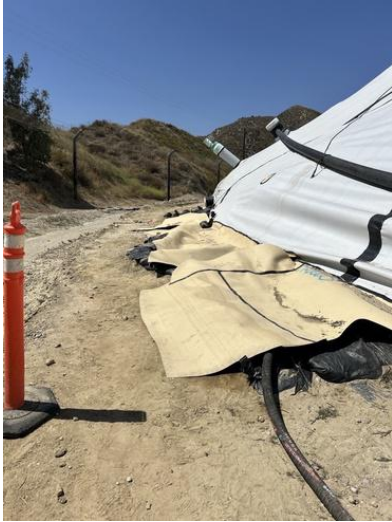
Photo 1

Westside perimeter road. None of the seeps that occurred in this area were observed at the time of this inspection. Area continues to be monitored and vacuumed out as needed to prevent pooling.

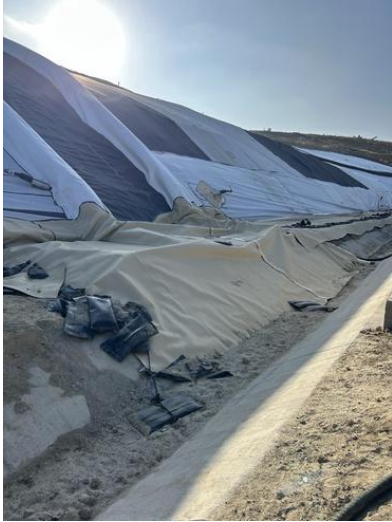
Photo 1

Westside perimeter road. None of the seeps that occurred in this area were observed at the time of this inspection. Area continues to be monitored and vacuumed out as needed to prevent pooling.

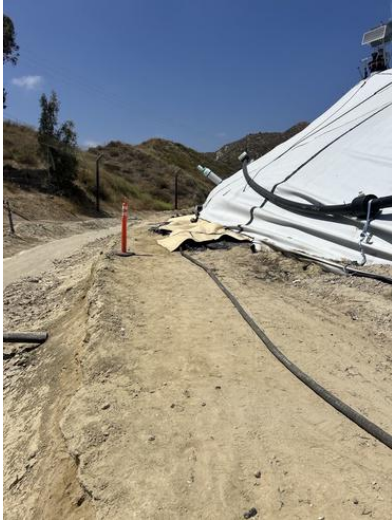
Photo 1

Westside perimeter road. None of the seeps that occurred in this area were observed at the time of this inspection. Area continues to be monitored and vacuumed out as needed to prevent pooling.

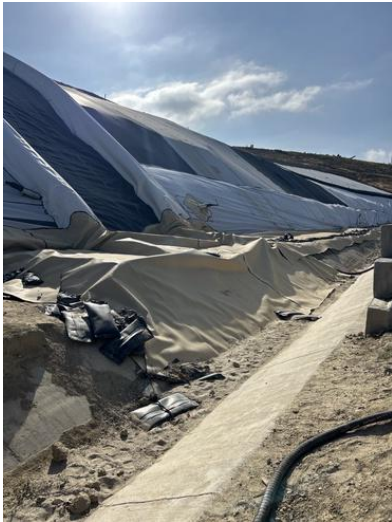
Photo 1

Westside perimeter road. None of the seeps that occurred in this area were observed at the time of this inspection. Area continues to be monitored and vacuumed out as needed to prevent pooling.

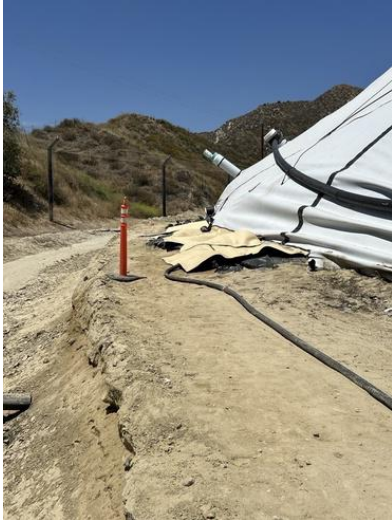
Photo 1

Westside perimeter road. None of the seeps that occurred in this area were observed at the time of this inspection. Area continues to be monitored and vacuumed out as needed to prevent pooling.

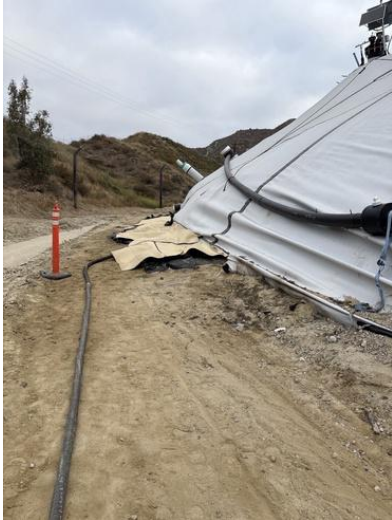
Photo 1

Westside perimeter road. None of the seeps that occurred in this area were observed at the time of this inspection. Area continues to be monitored and vacuumed out as needed to prevent pooling

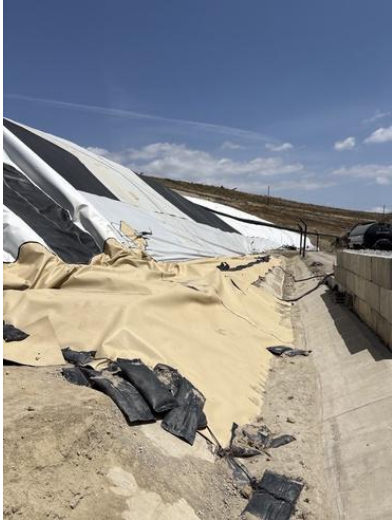
Photo 1

Westside perimeter road. None of the seeps that occurred in this area were observed at the time of this inspection. Area continues to be monitored and vacuumed out as needed to prevent pooling
