Re: Chiquita Canyon, LLC's Weekly Report on the Documentation and Tracking of Cover Issues

4050 - Chiquita Reaction Area Tracking of Fissures and Tension Cracks

4050 - Geosynthetic Cover Inspection

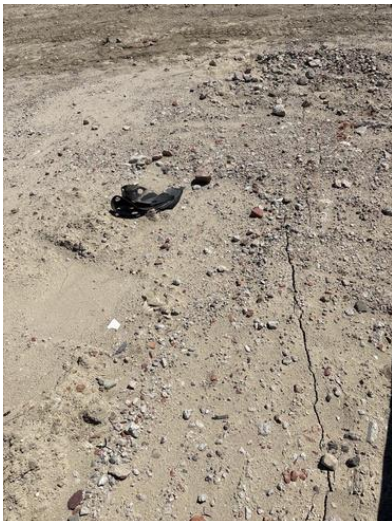
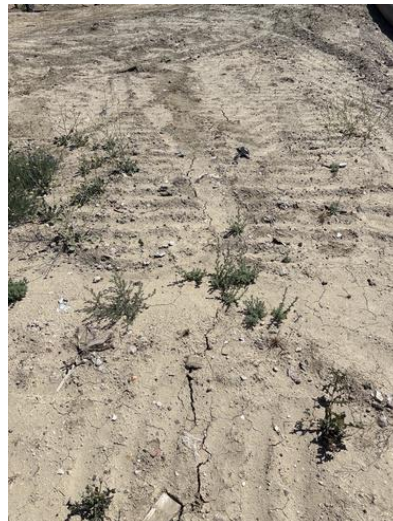
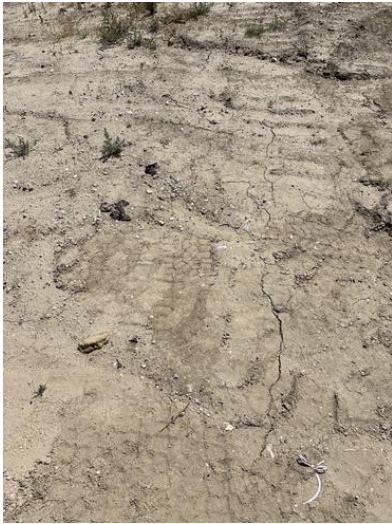
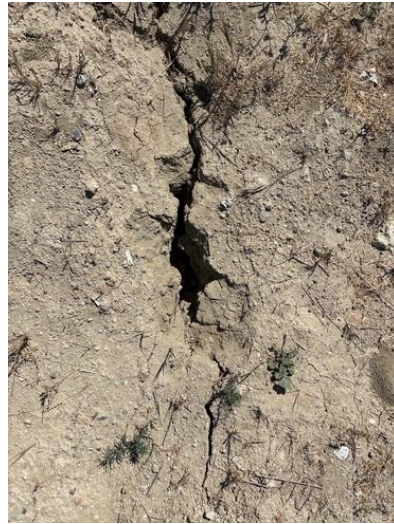
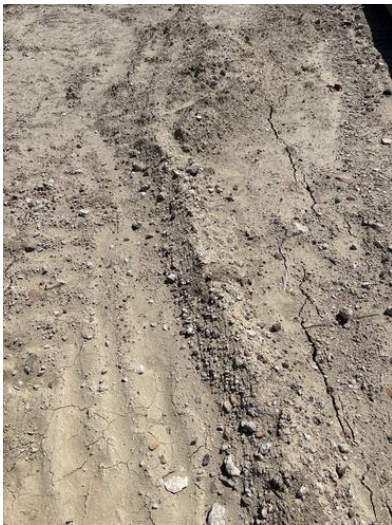
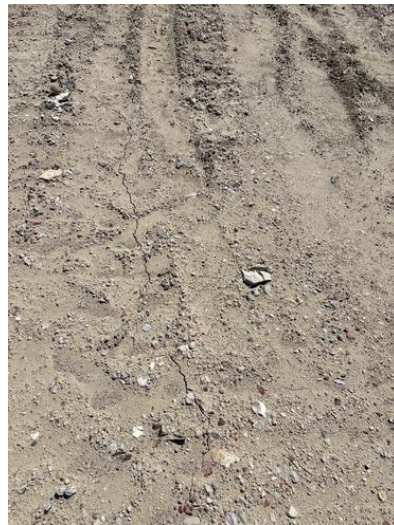
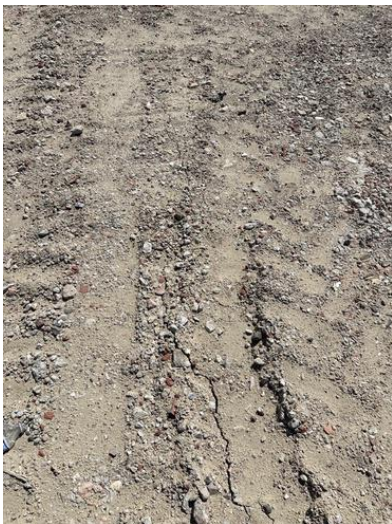
83

Length of crack (ft) or area containing multiple cracks (ft x ft)

140ft x 45ft

No individual crack 50ft or more

Horizontal Offset (width)	Medium 2-4" in width
Vertical Offset (height)	Extra small <0.5" in height
Orientation (direction)	NE to SW
Location	Castaic CA 91384 United States (34.43399783227074, -118.64607165578626)
Was Fissure or Crack fixed? If yes, add photo and description of repairs performed	Yes

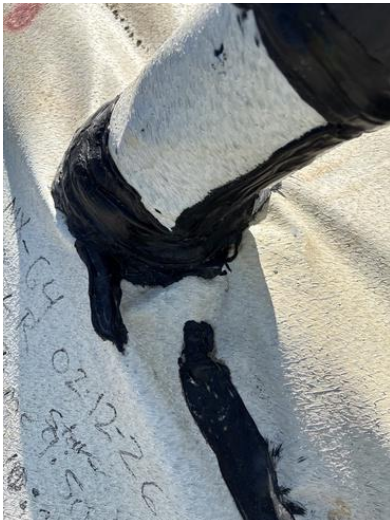
Photo 1

Small hole in liner near boot needs to be patched/extrusion welded.

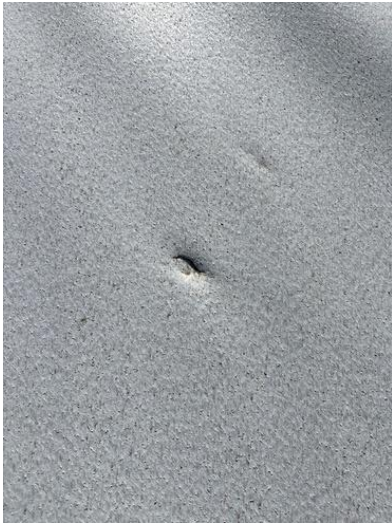
Photo 4

Small tear in liner needs to be patched/extrusion welded.

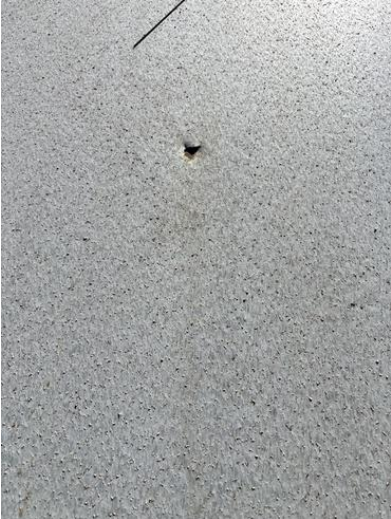
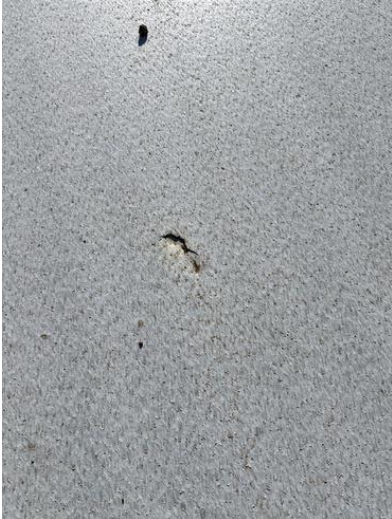
Two small tears in liner need to be patched/extrusion welded.

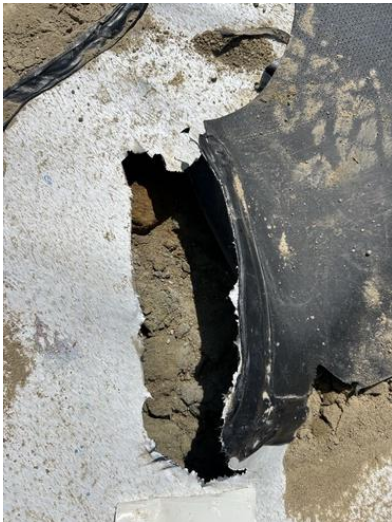
Photo 1

Liner torn, needs to be patched and extrusion welded
