Re: Chiquita Canyon, LLC's Weekly Report on the Documentation and Tracking of Cover Issues

4050 - Chiquita Reaction Area Tracking of Fissures and Tension Cracks

4050 - Geosynthetic Cover Inspection

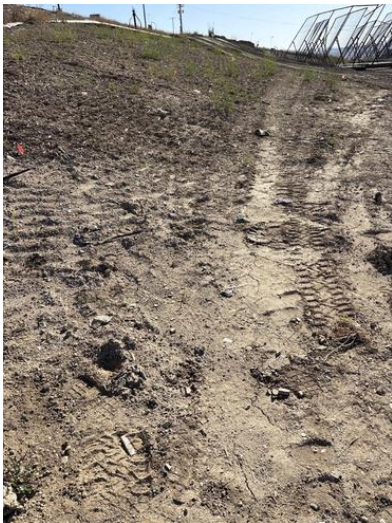
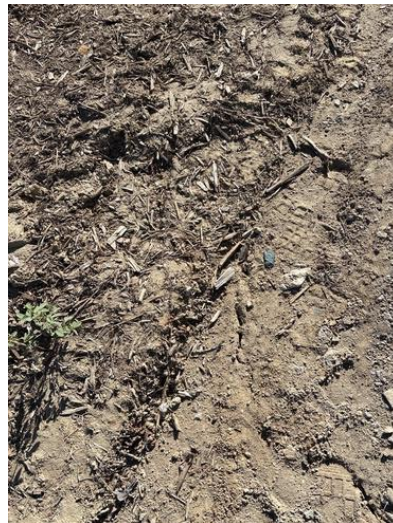
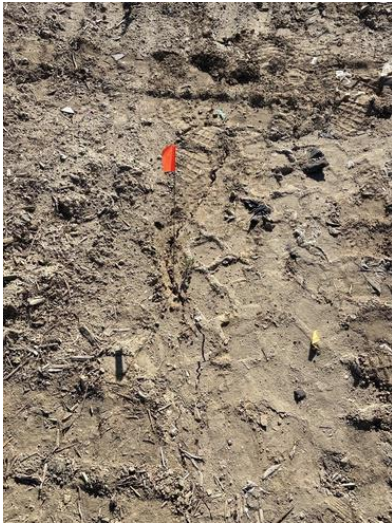
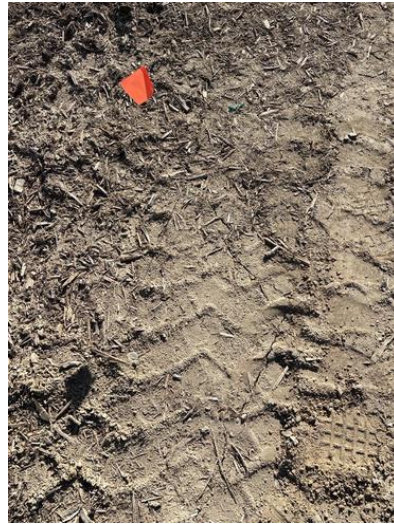
45ft x 10ft

Extra Small <0.5 in width

Extra small <0.5" in height

E to W

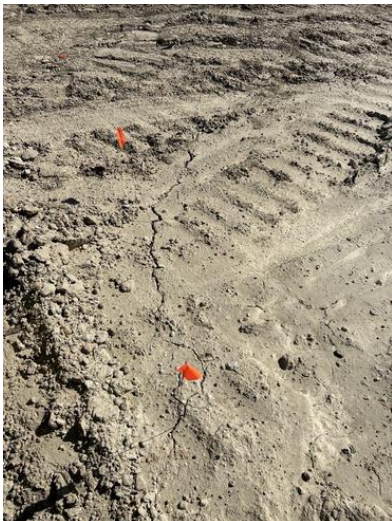
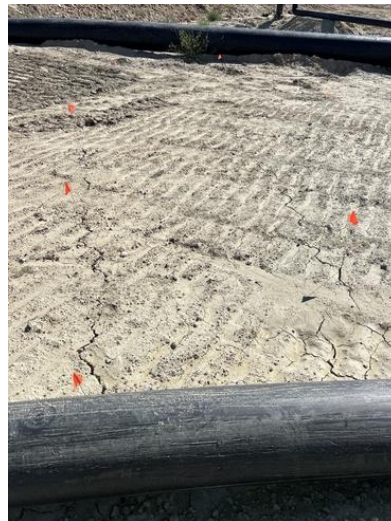
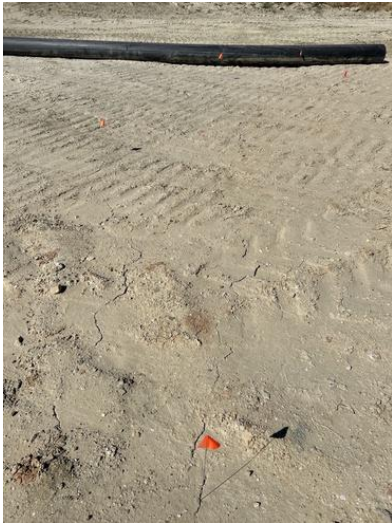
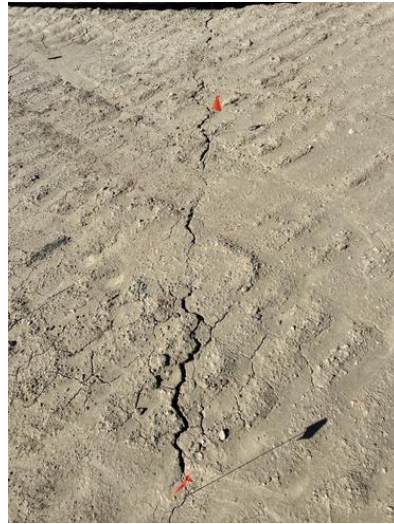
25ft x 25ft area

Small 0.5-2" in width

Extra small <0.5" in height

NE to SW

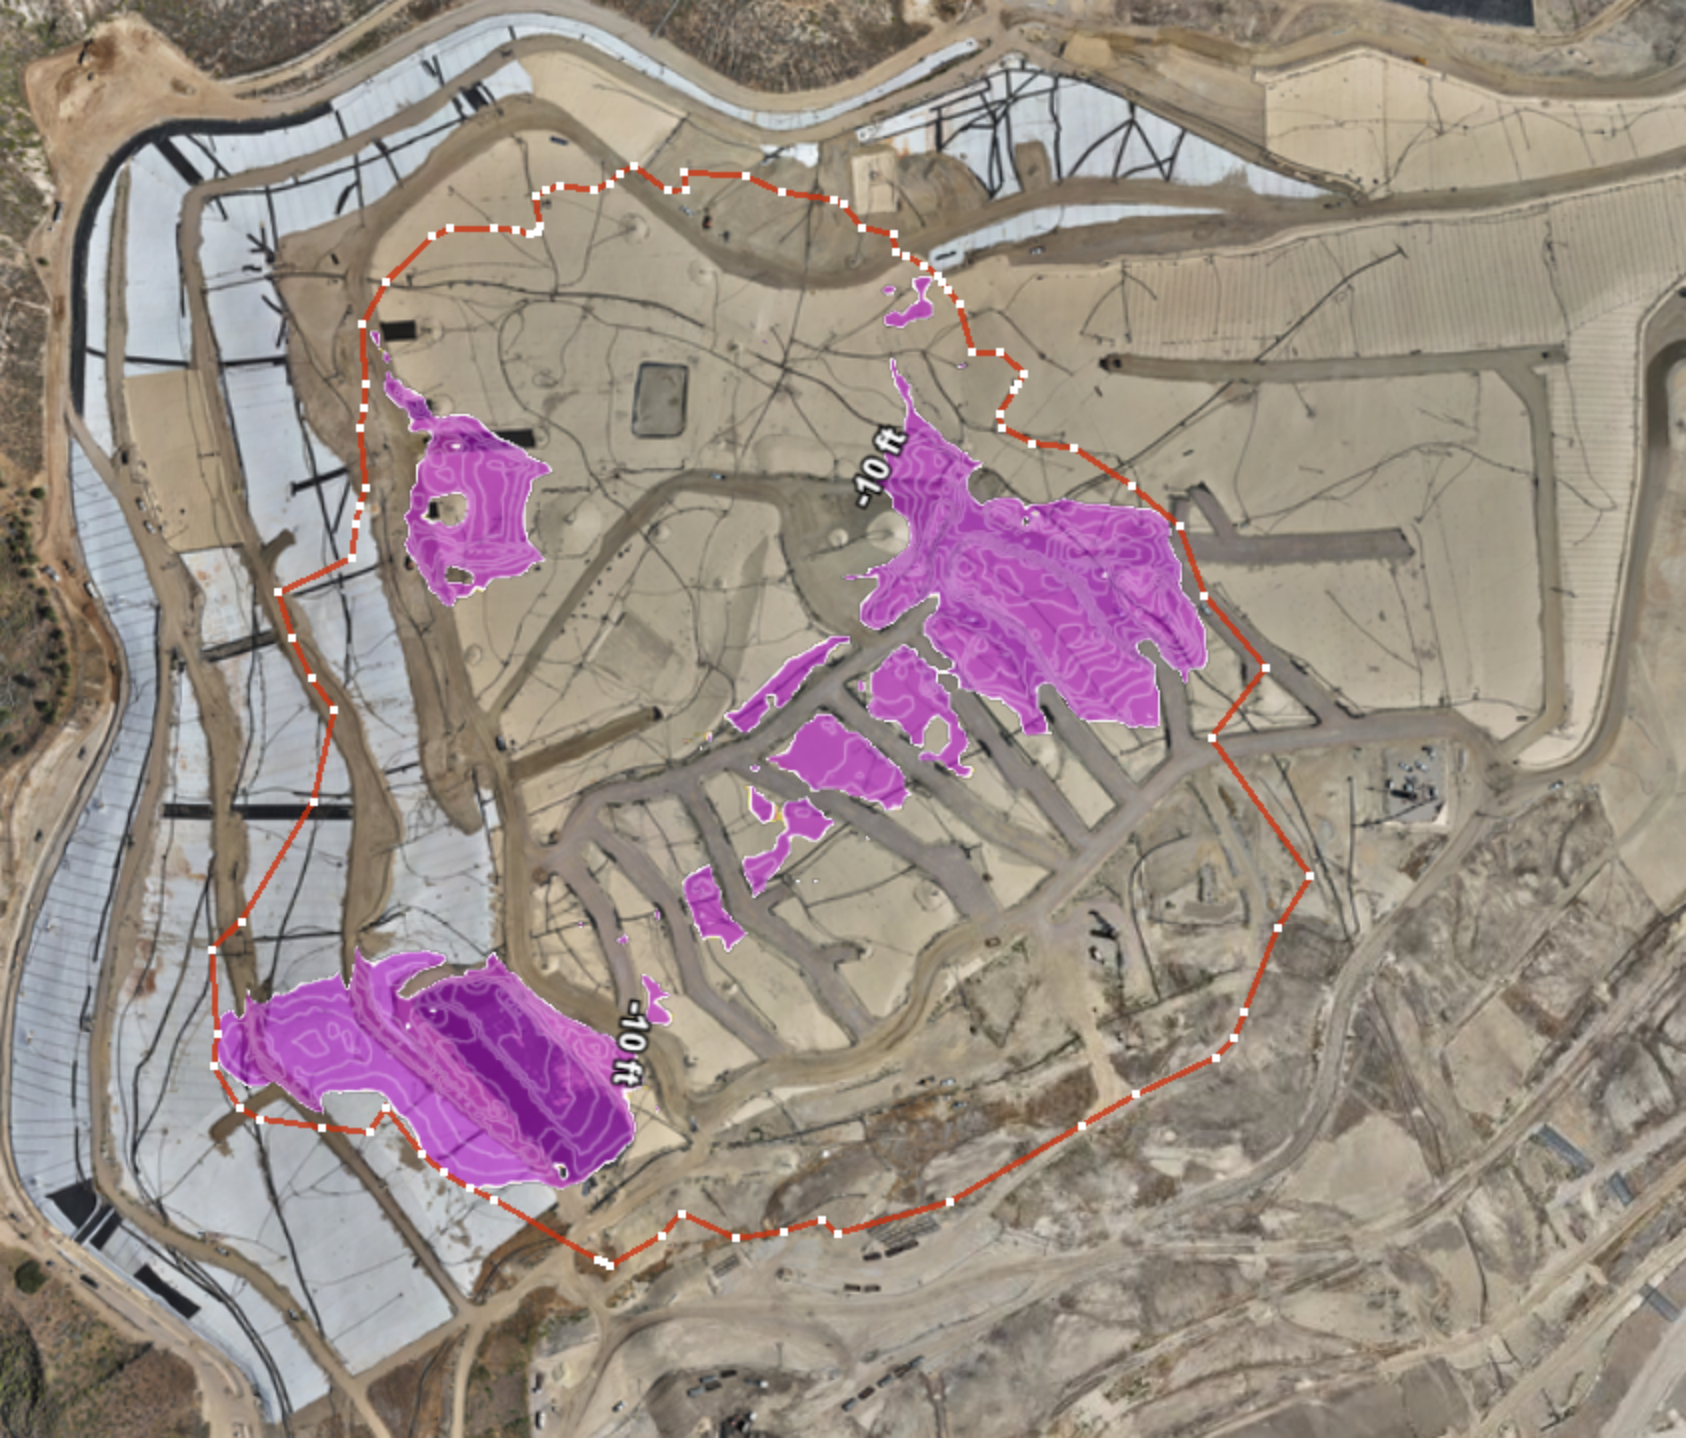
- The map shows the area between 5/21/2025 and 5/20/2026 where the grades have changed more than 10 feet. A typical MSW strain rate is 3% per year - for a landfill with a 300-foot waste column, this would be 9 feet per year.

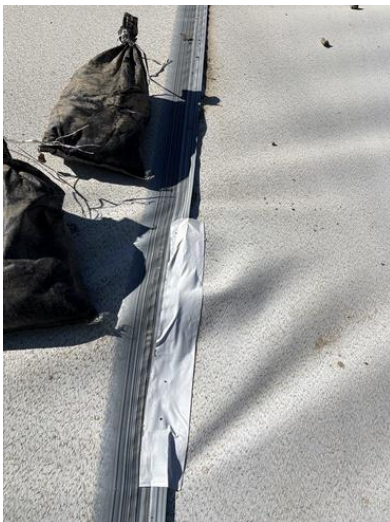
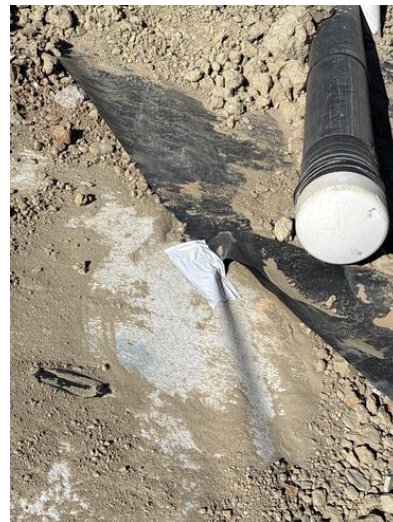
Two tears in liner need to be patched and extrusion welded.

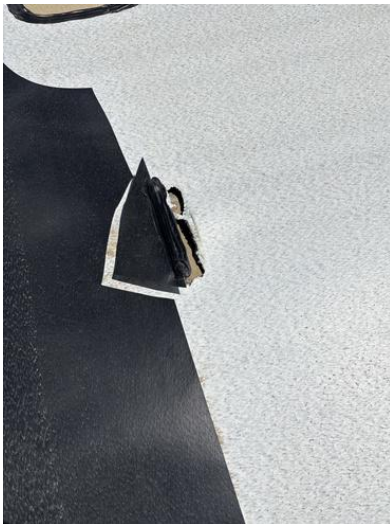
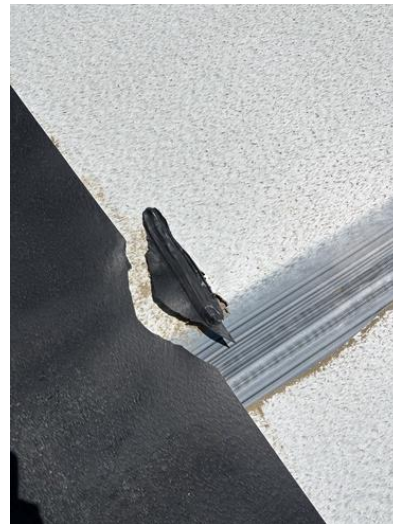
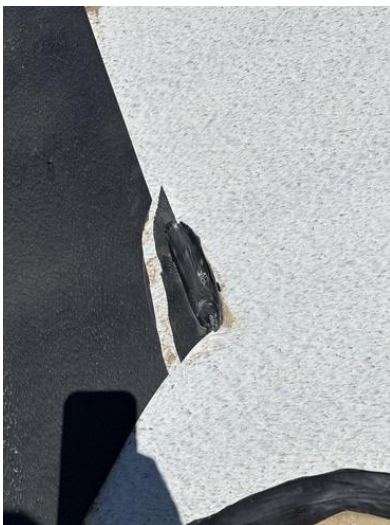
3 tears side by side need to be patched/extrusion welded.
