Re: Chiquita Canyon, LLC's Weekly Leachate Inspection Report for Stipulated Order for Abatement (Case No. 6177-4), Condition 27(c)

Pursuant to Condition 27(c) of the Stipulated Order for Abatement with the South Coast Air Quality Management District in Case No. 6177-4 (the "Order"), Chiquita Canyon, LLC ("Chiquita") encloses a compilation of the twice daily leachate seep inspection logs for the dates of May 25, 2026 through May 31, 2026.

4050 - Chiquita Leachate Seep/Pooling Inspection

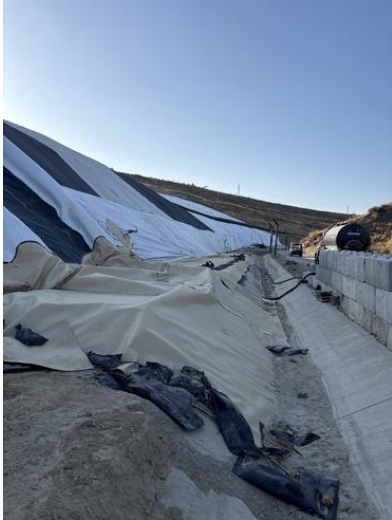
Photo 1

Westside perimeter road. None of the seeps that occurred in this area were observed at the time of this inspection. Area continues to be monitored and vacuumed out as needed to prevent pooling

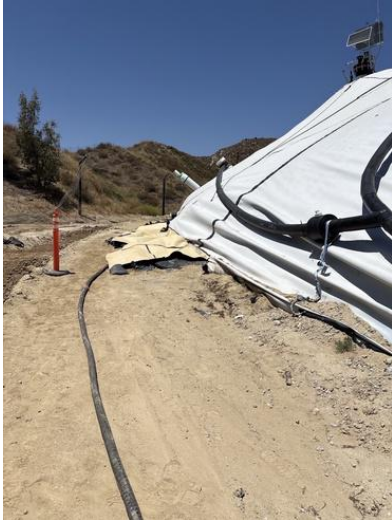
Photo 1

Westside perimeter road. None of the seeps that occurred in this area were observed at the time of this inspection. Area continues to be monitored and vacuumed out as needed to prevent pooling

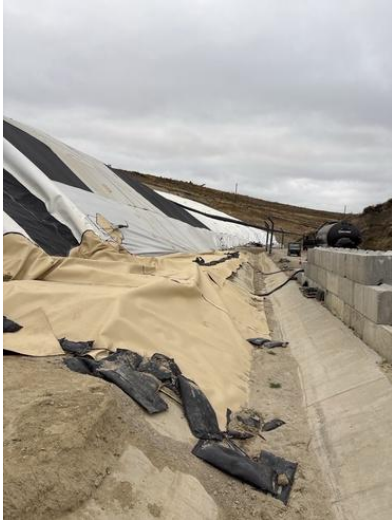
Photo 1

Westside perimeter road. None of the seeps that occurred in this area were observed at the time of this inspection. Area continues to be monitored and vacuumed out as needed to prevent pooling

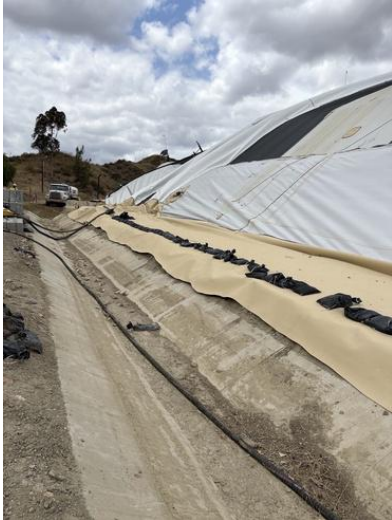
Photo 1

Westside perimeter road. None of the seeps that occurred in this area were observed at the time of this inspection. Area continues to be monitored and vacuumed out as needed to prevent pooling

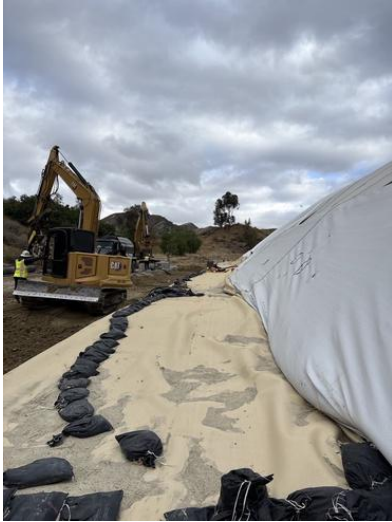
Photo 1

Westside perimeter road. None of the seeps that occurred in this area were observed at the time of this inspection. Area continues to be monitored and vacuumed out as needed to prevent pooling

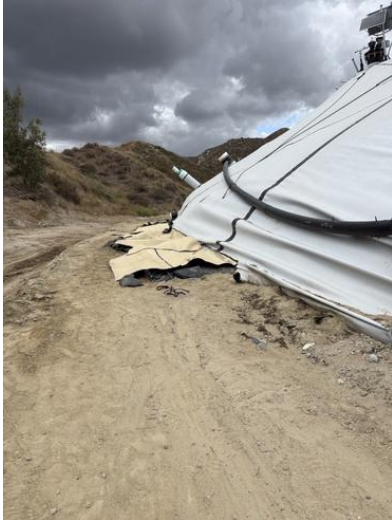
Photo 1

Westside perimeter road. None of the seeps that occurred in this area were observed at the time of this inspection. Area continues to be monitored and vacuumed out as needed to prevent pooling

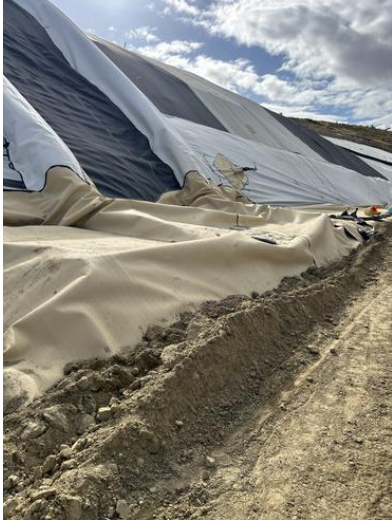
Photo 1

Westside perimeter road. None of the seeps that occurred in this area were observed at the time of this inspection. Area continues to be monitored and vacuumed out as needed to prevent pooling.

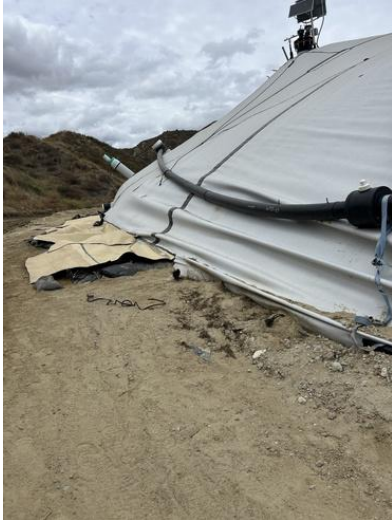
Photo 1

Westside perimeter road. None of the seeps that occurred in this area were observed at the time of this inspection. Area continues to be monitored and vacuumed out as needed to prevent pooling.

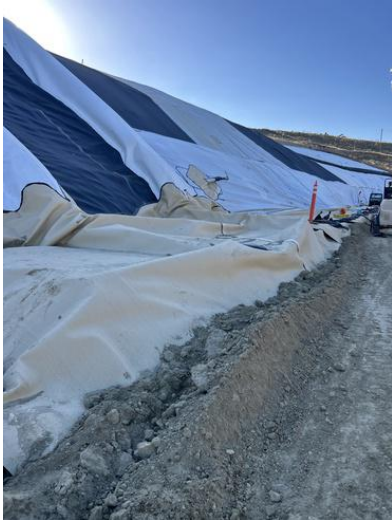
Photo 1

Westside perimeter road. None of the seeps that occurred in this area were observed at the time of this inspection. Area continues to be monitored and vacuumed out as needed to prevent pooling.

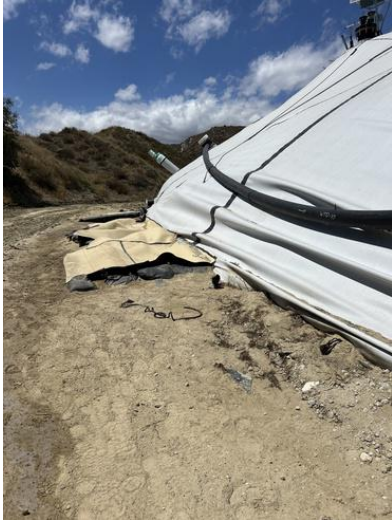
Photo 1

Westside perimeter road. None of the seeps that occurred in this area were observed at the time of this inspection. Area continues to be monitored and vacuumed out as needed to prevent pooling.

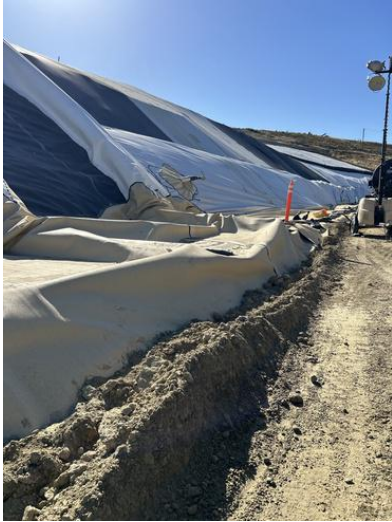
Photo 1

Westside perimeter road. None of the seeps that occurred in this area were observed at the time of this inspection. Area continues to be monitored and vacuumed out as needed to prevent pooling.

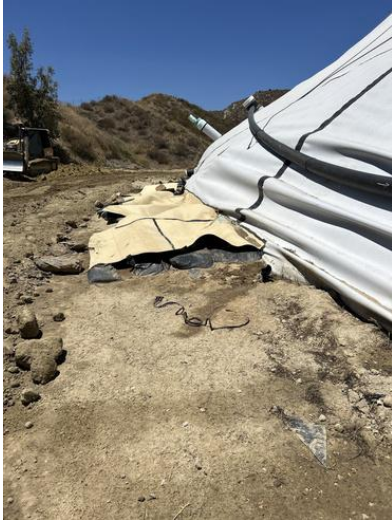
Photo 1

Westside perimeter road. None of the seeps that occurred in this area were observed at the time of this inspection. Area continues to be monitored and vacuumed out as needed to prevent pooling.

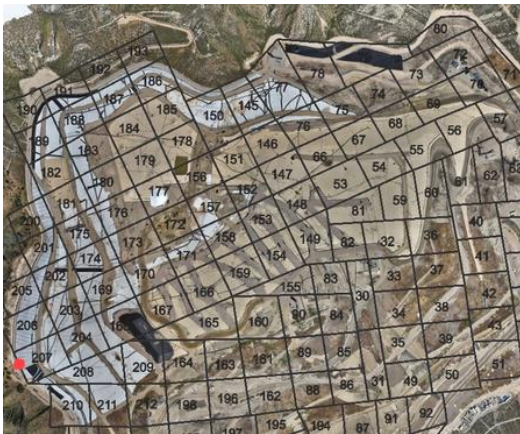
Indicate on the map the location

During this week, a seep was observed on May 31, 2026, at approximately 7:03 a.m., in grid 207 at the Chiquita Canyon Landfill (the "Landfill"). The exact location of this seep is set forth in the maps included in the attachment. This seep is related to the previously reported seep on the west side of the Landfill. Liquid from the seep reached the perimeter road but did not reach the stormwater channel or either sedimentation basin. Upon discovery, Chiquita vacuumed the liquid and added soil to the area. Chiquita covered the containment area with a liner and sandbags to prevent potential emissions. This work was completed by approximately 7:45 a.m. Chiquita is monitoring the area. The total approximate amount of leachate from this seep was between one and five gallons. The extent of the area impacted by the seep was approximately nine square feet. The odor detected was "Light." The saturation of the soil was "Standing Free Liquid."

207

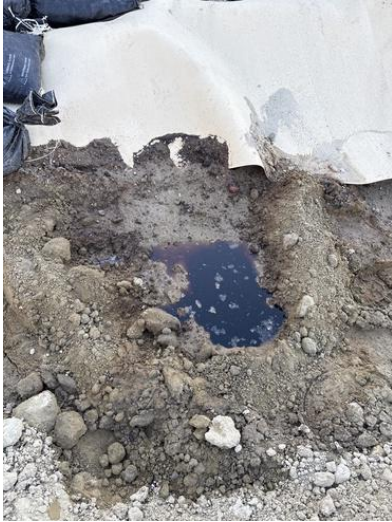
Photo 1

1-5 gallons

9sq ft

2 - Light Odor Detected

Standing free liquid

Leachate was vacuumed out and the area was covered with soil and liner was put in place and sandbagged to prevent exposure to the atmosphere. Westside continues to be monitored and vacuumed out as necessary to prevent pooling.

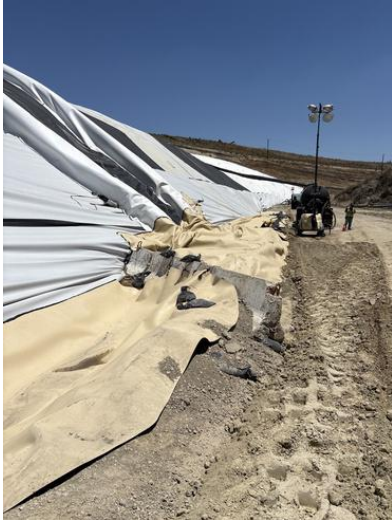
Photo 1

Westside perimeter road. None of the seeps that occurred in this area were observed at the time of this inspection. Area continues to be monitored and vacuumed out as needed to prevent pooling
