Re: Chiquita Canyon, LLC's Weekly Report on the Documentation and Tracking of Cover Issues

4050 - Chiquita Reaction Area Tracking of Fissures and Tension Cracks

4050 - Geosynthetic Cover Inspection

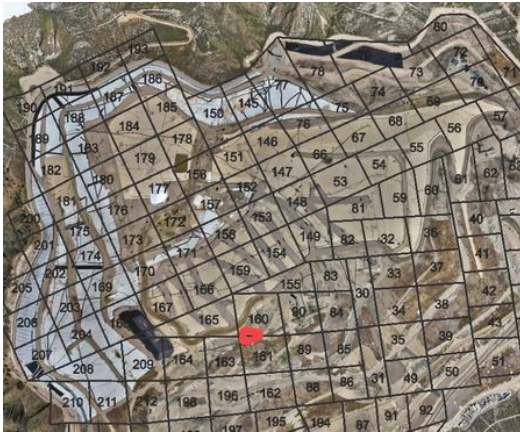
160.161

Using the attached image, annotate all areas where inspectors identified a fissure or tension crack.

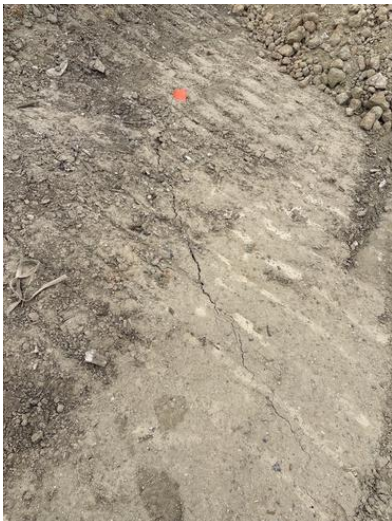
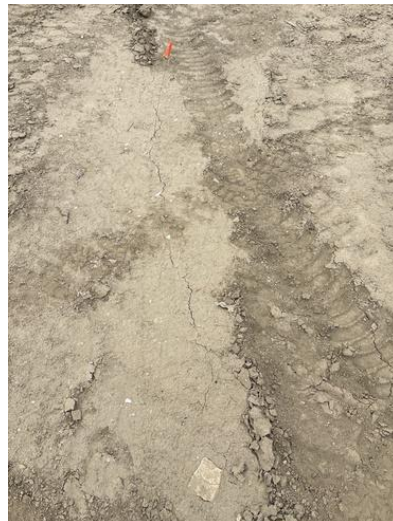
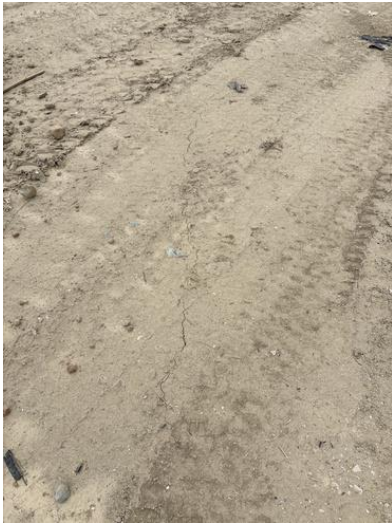
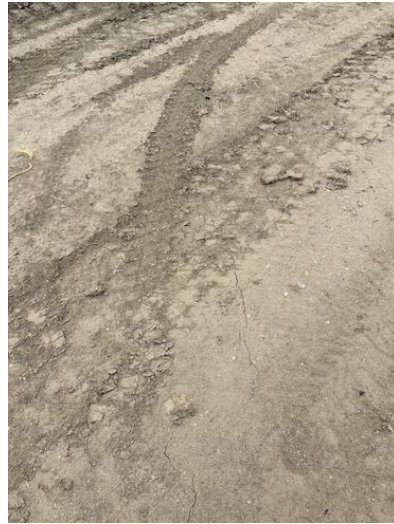
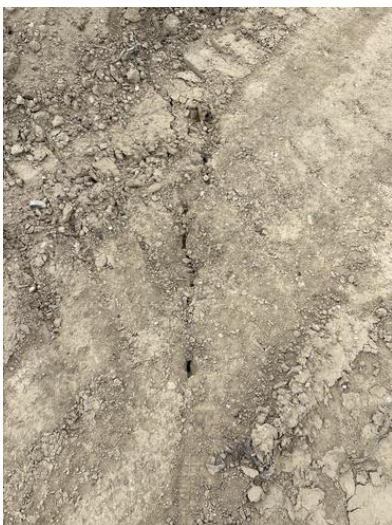
30ft x 55ft

No single crack 50ft or more in length

Small 0.5-2" in width

Extra small <0.5" in height

N to S

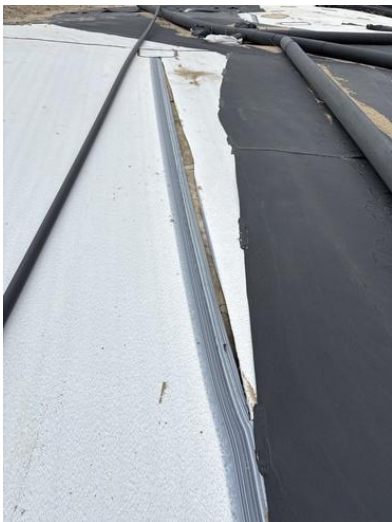
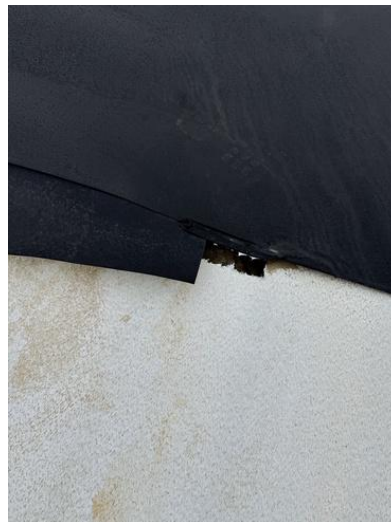
188

Two tears in liner to be patched/extrusion welded.

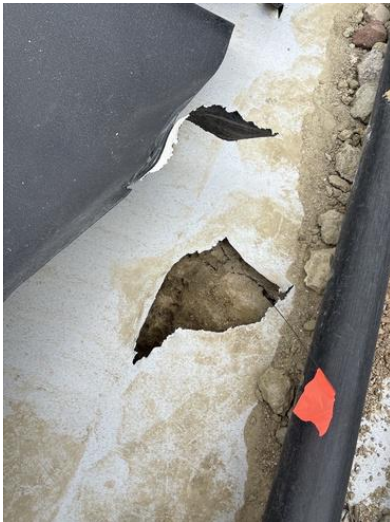
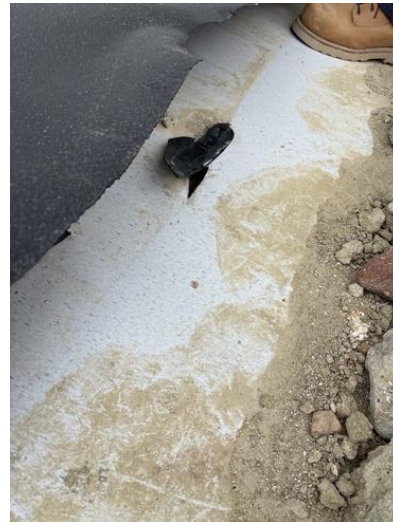
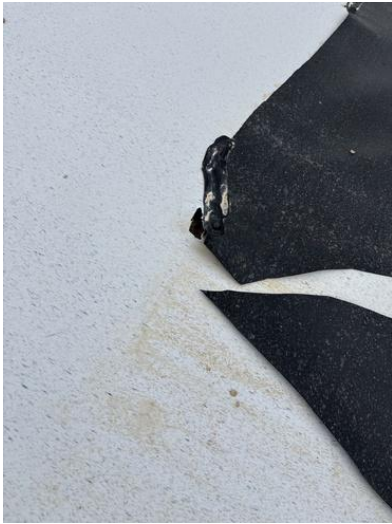
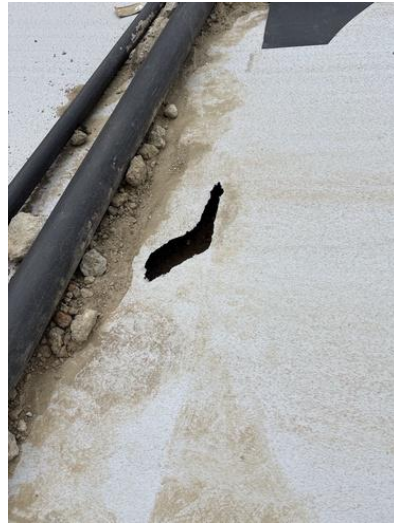
208

Multiple tears in close proximity to each other need to be patched/extrusion welded.

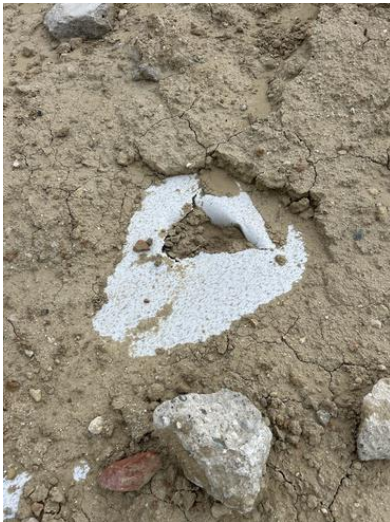
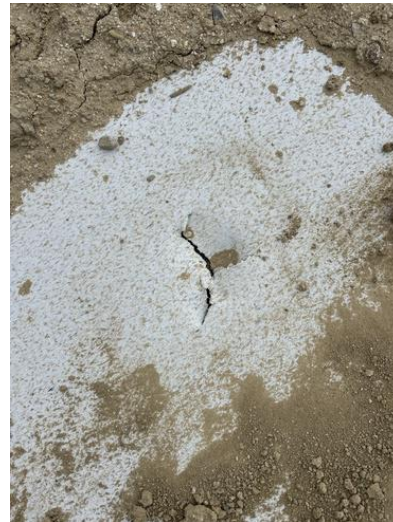
181

Two small tears in close proximity.
Need to be patched and extrusion welded

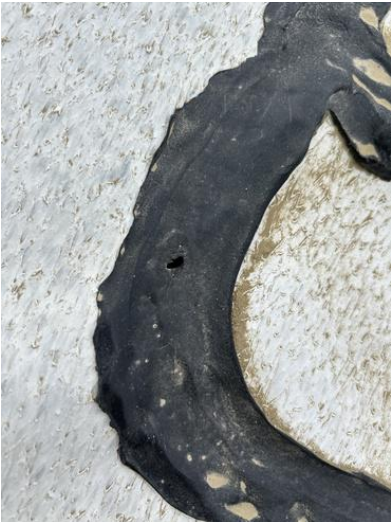
145

Small hole in weld. Needs to be re
extrusion welded

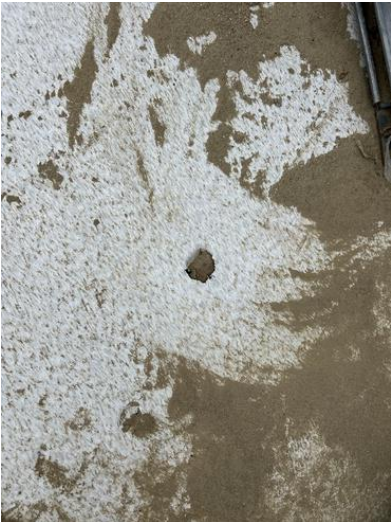
146

Liner torn. Needs to be patched and extrusion welded
