**Re: Chiquita Canyon, LLC's Weekly Leachate Inspection Report for Stipulated Order for Abatement (Case No. 6177-4), Condition 27(c)**

Attachment: Leachate Inspection Logs from June 1 – June 7, 2026

# 4050 - Chiquita Leachate Seep/Pooling Inspection

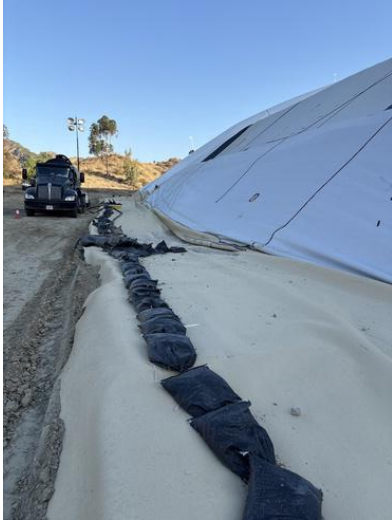
Photo 1

Westside perimeter road. None of the seeps that occurred in this area were observed at the time of this inspection. Area continues to be monitored and vacuumed out as needed to prevent pooling

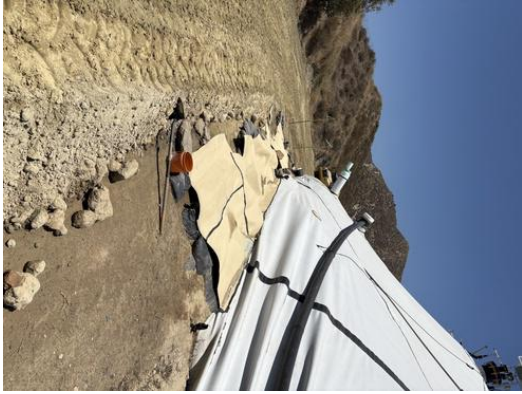
Photo 1

Westside perimeter road. None of the seeps that occurred in this area were observed at the time of this inspection. Area continues to be monitored and vacuumed out as needed to prevent pooling

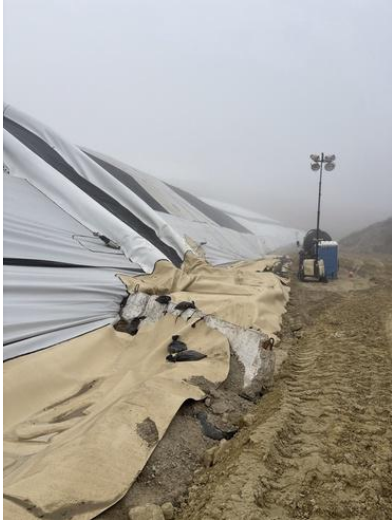
Photo 1

Westside perimeter road. None of the seeps that occurred in this area were observed at the time of this inspection. Area continues to be monitored and vacuumed out as needed to prevent pooling

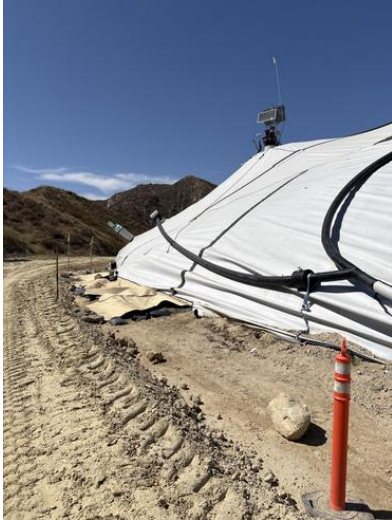
Photo 1

Westside perimeter road. None of the seeps that occurred in this area were observed at the time of this inspection. Area continues to be monitored and vacuumed out as needed to prevent pooling

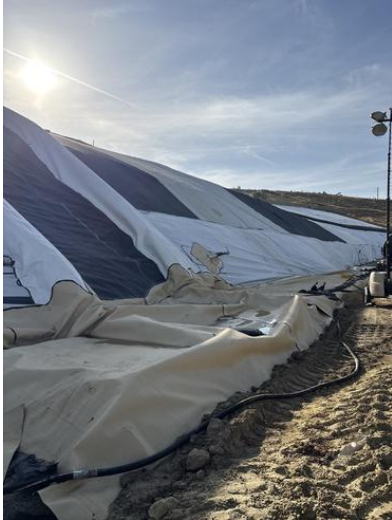
Photo 1

Westside perimeter road. None of the seeps that occurred in this area were observed at the time of this inspection. Area continues to be monitored and vacuumed out as needed to prevent pooling

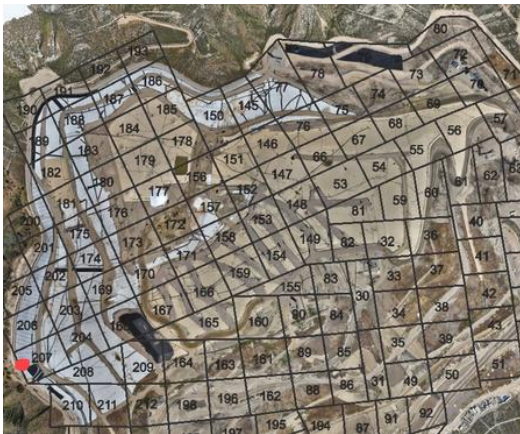
During the week of June 1, 2026 through June 7, 2026, a seep was observed on June 3, 2026, at approximately 2:19 p.m., in grid 207 at the Chiquita Canyon Landfill (the "Landfill"). The exact location of this seep is set forth in the maps included in the attachment. This seep is related to the previously reported seepage along the west slope of the Landfill. Chiquita promptly implemented mitigation measures to contain the liquid, including adding soil to the affected area. This work was completed by approximately 4:00 p.m. that same day. To address this seepage, and pursuant to Work Order Letter: *RE: Additional Work Required Under UAO for West Toe Improvements*, dated March 17, 2026, Chiquita is in the process of designing, planning, and installing a soil buttress. Chiquita will continue to monitor this area and implement similar mitigation measures, as needed, until this seepage along the west slope is mitigated by the West Toe Buttress Project. The total approximate amount of leachate from this seep was 6 to 10 gallons. The extent of the area impacted by the seep was approximately 30 square feet. The odor intensity was recorded as "Moderate." The saturation of the soil was recorded as "Saturated."

207

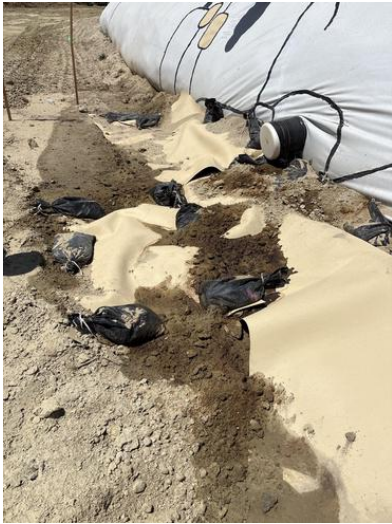
Photo 1

4 hours

6-10 gallons

30sq ft

3 - Moderate Odor

Saturated

Area covered with dirt to contain seep and prevent exposure to the atmosphere.

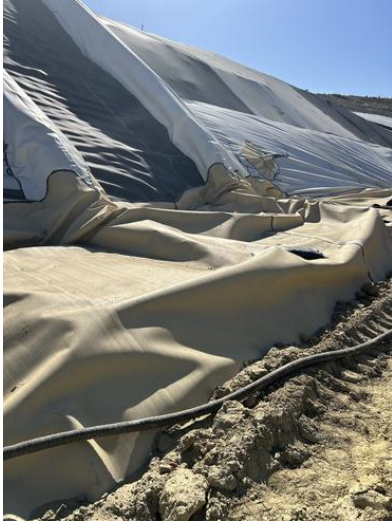
Photo 1

Westside perimeter road. None of the seeps that occurred in this area were observed at the time of this inspection. Area continues to be covered, monitored and vacuumed out as needed to prevent pooling.

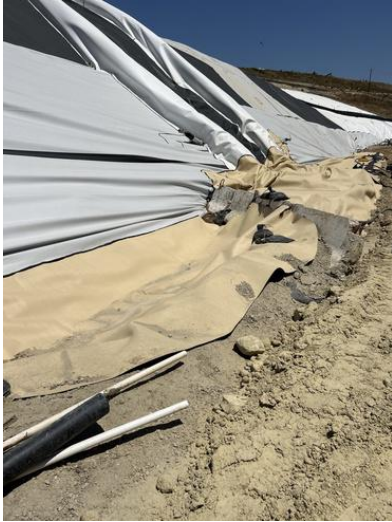
Photo 1

Westside perimeter road. None of the seeps that occurred in this area were observed at the time of this inspection. Area continues to be covered, monitored and vacuumed out as needed to prevent pooling.

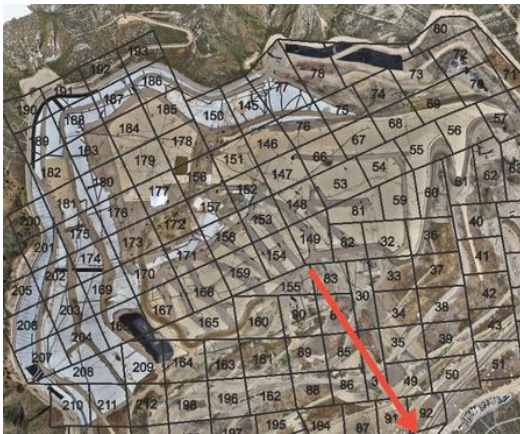
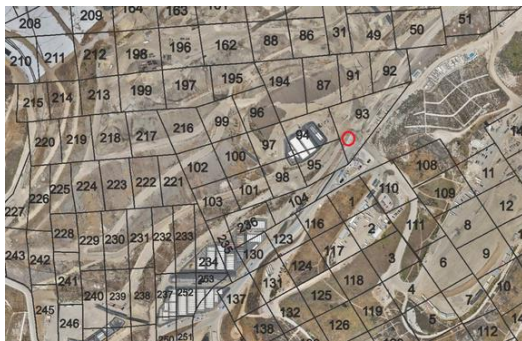
Photo 1

On June 5, 2026, at approximately 7:14 a.m., a second seep was observed in grid 93. The exact location of this seep is set forth in the maps included in the attachment. The total approximate amount of leachate collected from this seep was 0.5 gallons. Liquid from the seep traveled into the stormwater channel but did not reach either sedimentation basin. Upon discovery, Chiquita constructed a check dam in the stormwater channel to contain the liquid. Chiquita constructed a check dam in the stormwater channel and pressure washed the affected concrete while applying vacuum to ensure the proper collection of all wash water. Chiquita also applied silicone to the area to seal concrete where the seep occurred. This work was completed by approximately 10 a.m. that same day. The extent of the area impacted was approximately 5 square feet. The saturation of the soil was recorded as "Semi-dry," and the odor intensity was recorded as "Very Light." Chiquita is continuing to monitor this area.

93

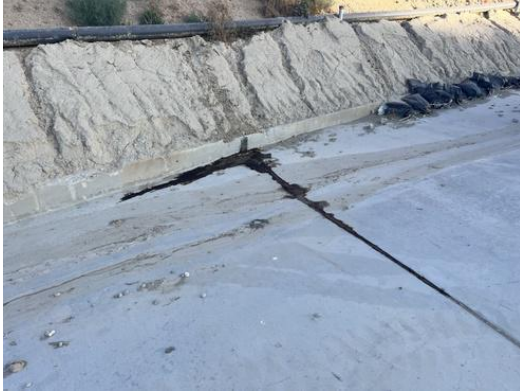
Photo 2

2 hours

<1 gallons

5 sqft

1 - Very Light Odor Detected

Semi-dry

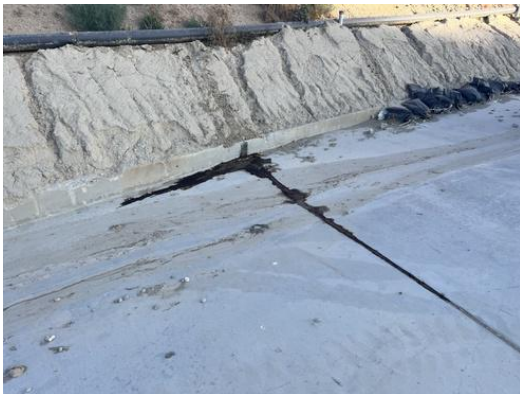
Photo 3

Yes

Constructed a check dam in the stormwater channel, pressure washed the affected concrete area under vacuum and performed additional cleanup. Added silicone to seal concrete.

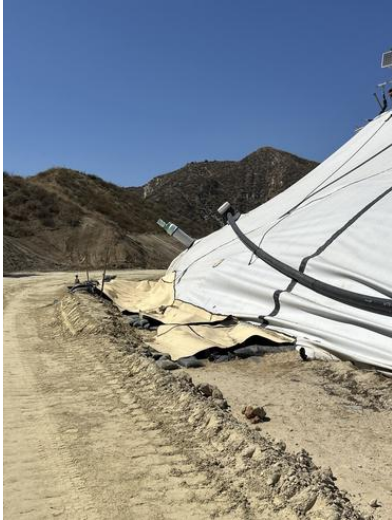
Photo 1

Westside perimeter road. None of the seeps that occurred in this area, as well as the seep occurring in grid 93, were observed at the time of this inspection. Area continues to be covered, monitored and vacuumed out as needed to prevent pooling.

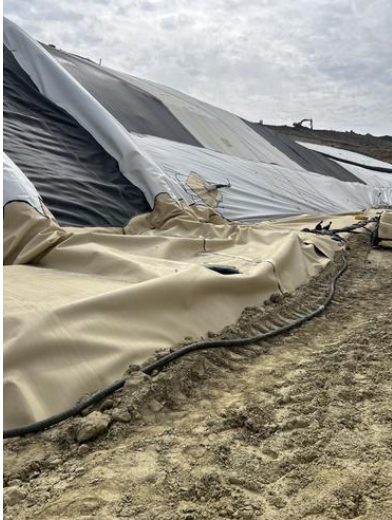
Photo 1

Westside perimeter road. None of the seeps that occurred in this area were observed at the time of this inspection. Area continues to be covered, monitored and vacuumed out as needed to prevent pooling.

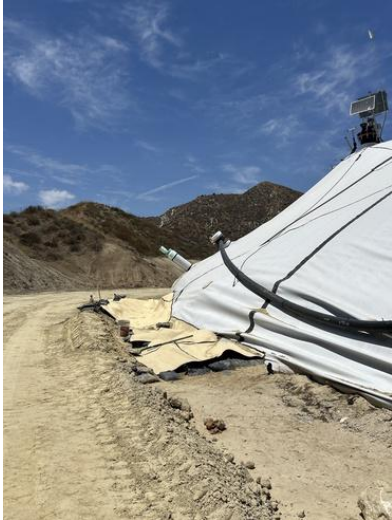
Photo 1

Westside perimeter road. None of the seeps that occurred in this area were observed at the time of this inspection. Area continues to be covered, monitored and vacuumed out as needed to prevent pooling.

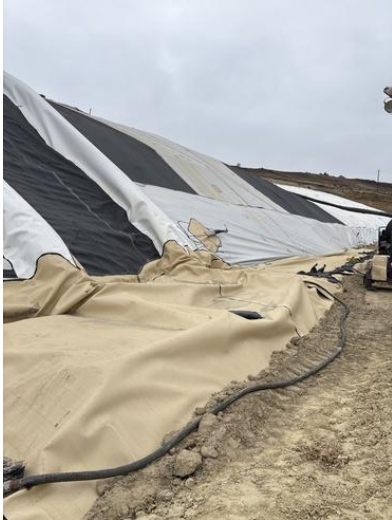
Photo 1

Westside perimeter road. None of the seeps that occurred in this area were observed at the time of this inspection. Area continues to be covered, monitored and vacuumed out as needed to prevent pooling

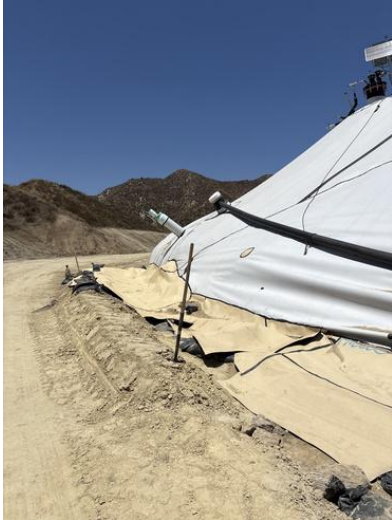
Photo 1

Westside perimeter road. None of the seeps that occurred in this area were observed at the time of this inspection. Area continues to be covered, monitored and vacuumed out as needed to prevent pooling
