CHIQUITA CANYON
A Waste Connections Company

Re: Chiquita Canyon, LLC's Weekly Report on the Documentation and Tracking of Cover Issues, Monthly Summary, and Monthly Isopach Map

4050 - Chiquita Reaction Area Tracking of Fissures and Tension Cracks

MAY 2026 FISSURE AND TENSION CRACK MONITORING SUMMARY
CHIQUITA CANYON LANDFILL
CASTAIC, CALIFORNIA

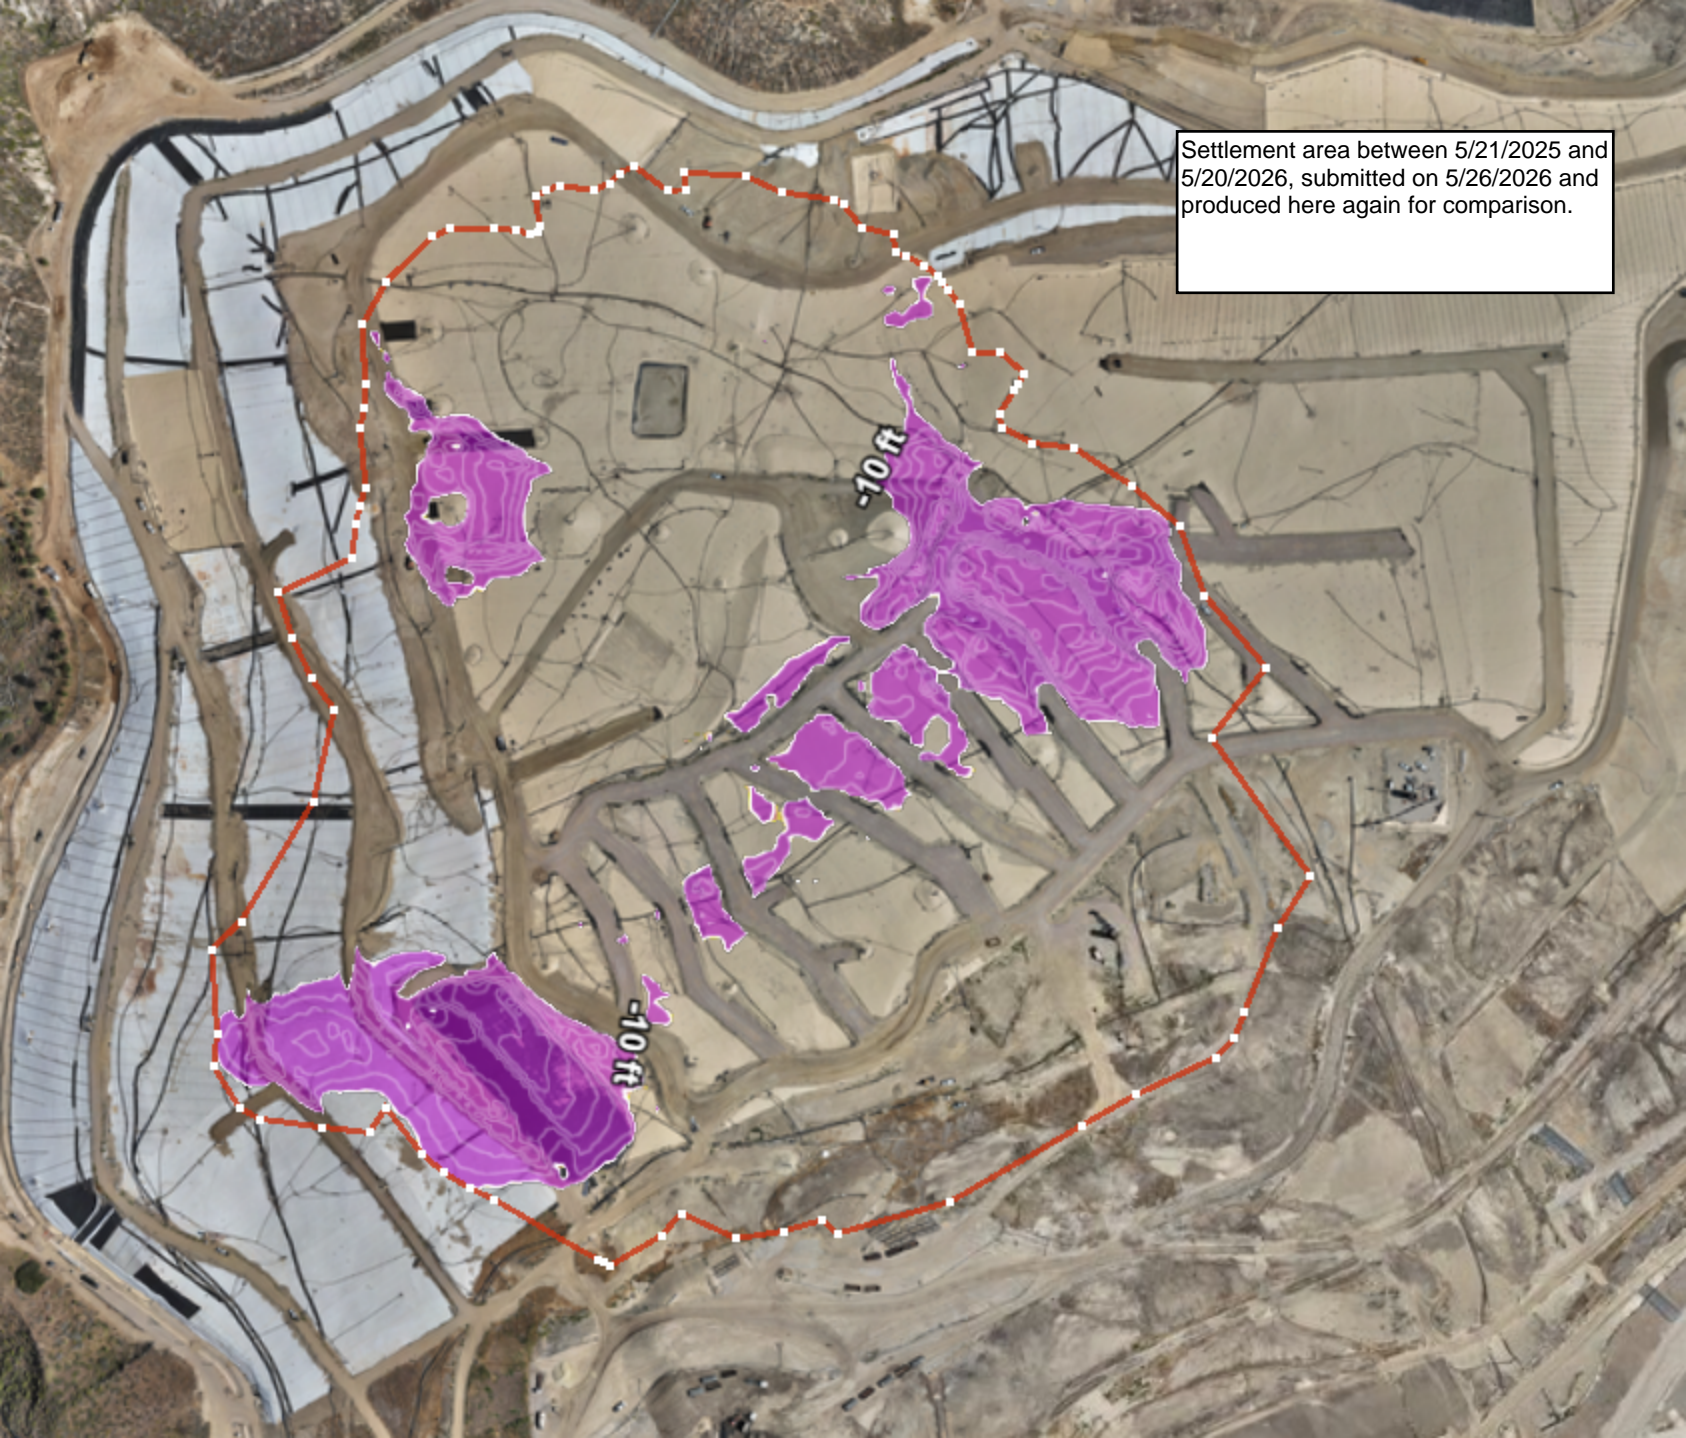
Settlement area between 5/21/2025 and 5/20/2026, submitted on 5/26/2026 and produced here again for comparison.

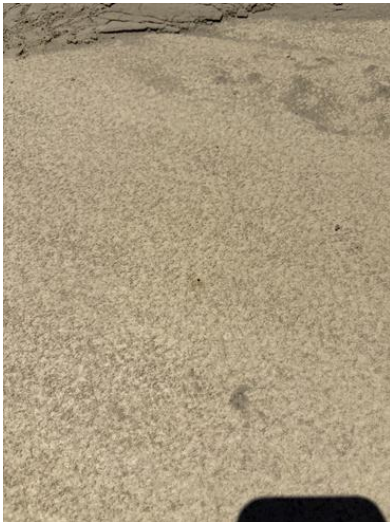
Photo 1

Pinhole in liner needs to be extrusion welded.

Permanent repairs scheduled for 6/9/26

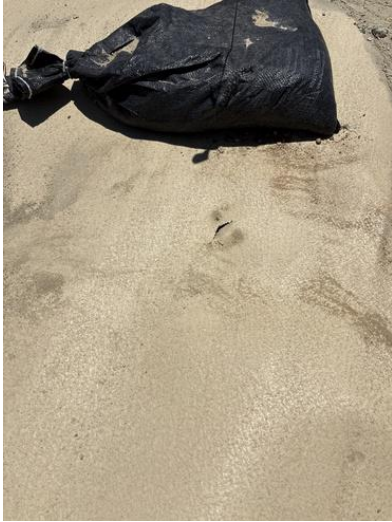
Photo 3

Tear in liner needs to be patched/extrusion welded.

Permanent repairs scheduled for 6/9/26

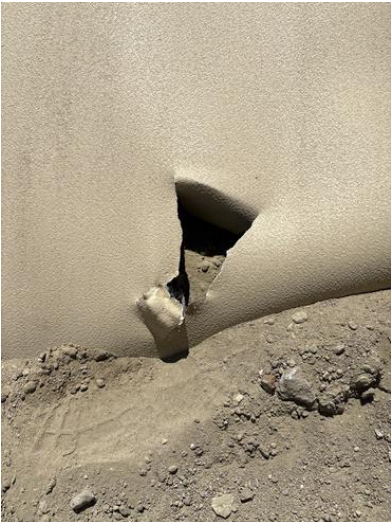
Photo 5

Tear in liner needs to be patched/extrusion welded.

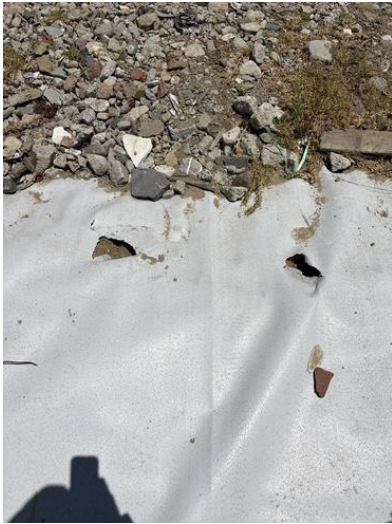
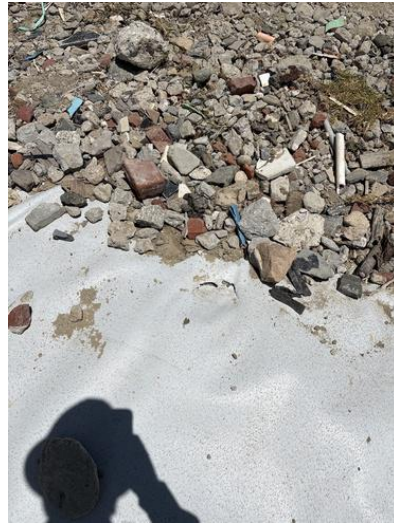
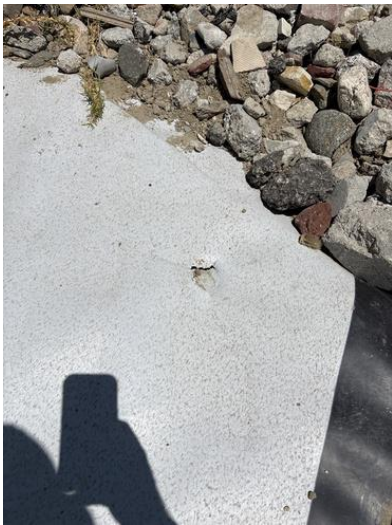
6 small tears side by side need to be patched/extrusion welded.

Description of repair work	Tears taped upon discovery
Date and time of repair (within 2 hours)	3 Jun 2026 2:05 PM PDT
Are further permanent repairs required?	No
Date and Time of final repair (if necessary)	8 Jun 2026 1:00 PM PDT
Instability under the cover	
Are there any anomalous (unusual or unexpected) areas of cover damage or deformation that may indicate underlying instability?	No
Are there any signs of a downslope tension crack at the top of the slope or bulging at or near the toe of the slope?	No
Is there any movement of the equipment that vertically penetrates the cover (e.g., tilting)?	No
