Re: Chiquita Canyon, LLC's Weekly Report on the Documentation and Tracking of Cover Issues

4050 - Chiquita Reaction Area Tracking of Fissures and Tension Cracks

4050 - Geosynthetic Cover Inspection

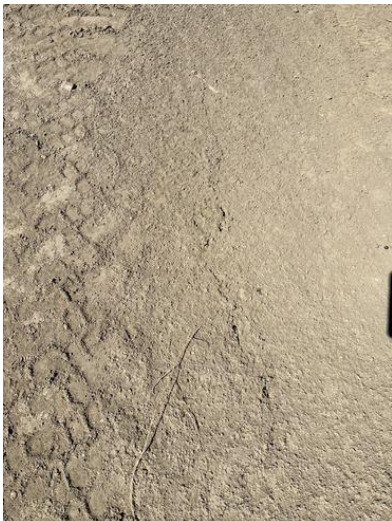
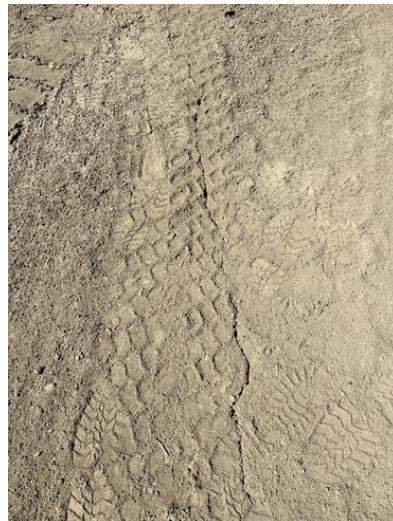
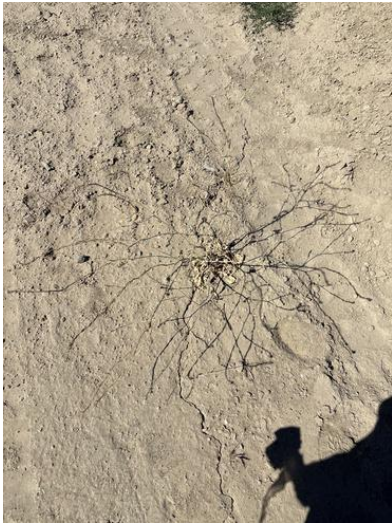
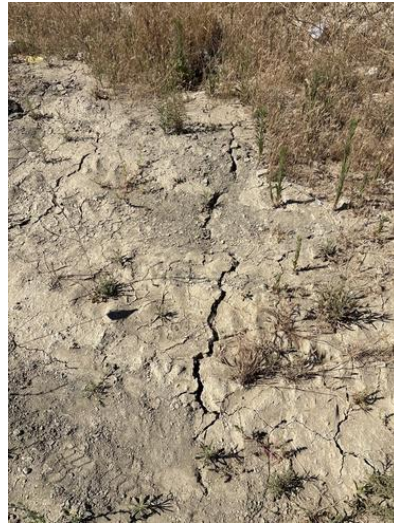
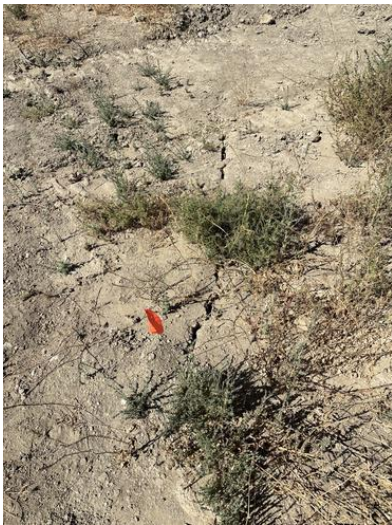
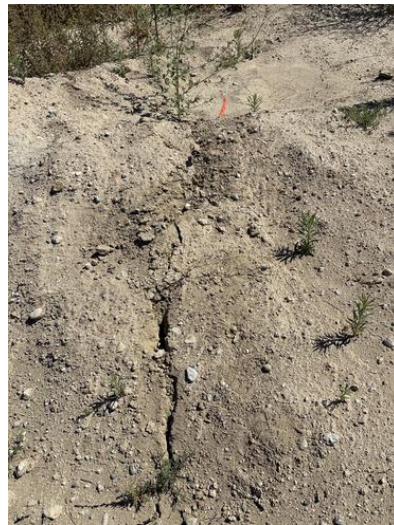
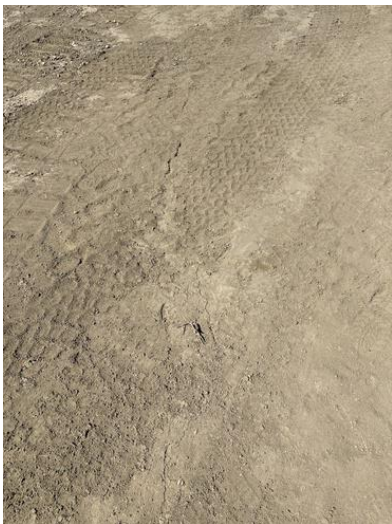
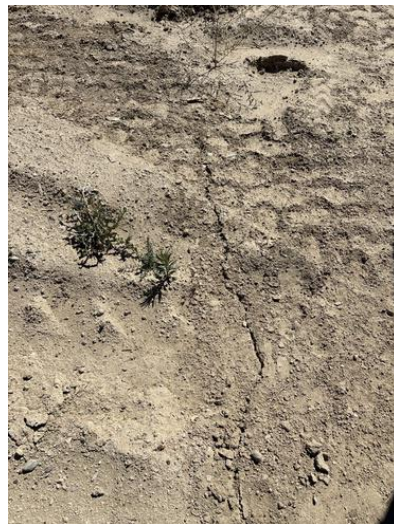
Yes

160

Length of crack (ft) or area containing multiple cracks (ft x ft)

80ft x 85ft

No individual crack 50 ft or longer.

Horizontal Offset (width)	Small 0.5-2" in width
Vertical Offset (height)	Extra small <0.5" in height
Orientation (direction)	NE to SW
Location	Castaic CA 91384 United States (34.43354994527477, -118.64691956911109)
Was Fissure or Crack fixed? If yes, add photo and description of repairs performed	Yes

Photo 9	
Date and time of repairs	9 Jun 2026 11:05 AM PDT
Description of repairs	Cracks were track walked.
Instability	
Are there any indications of slope stability concerns?	No

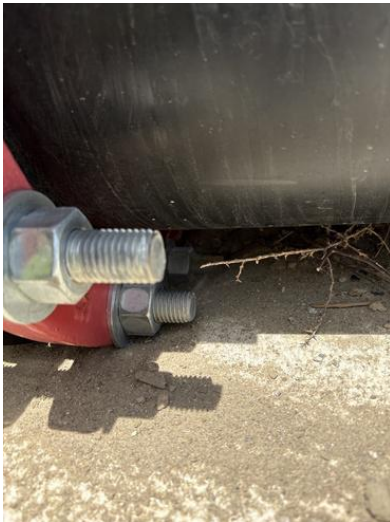
Photo 1

207

Tear in liner needs to be patched/extrusion welded. Pipework needs to be lifted and placed back down on sandbags to prevent further tears

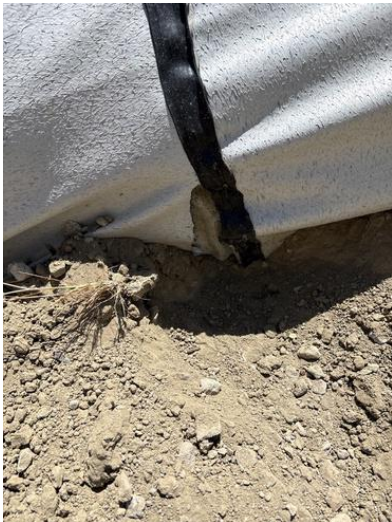
Photo 1

201

Tear in liner needs to be patched/extrusion welded
