Re: Chiquita Canyon, LLC's Weekly Leachate Inspection Report for Stipulated Order for Abatement (Case No. 6177-4), Condition 27(c)

Attachment: Leachate Inspection Logs from June 8 – June 14, 2026

4050 - Chiquita Leachate Seep/Pooling Inspection

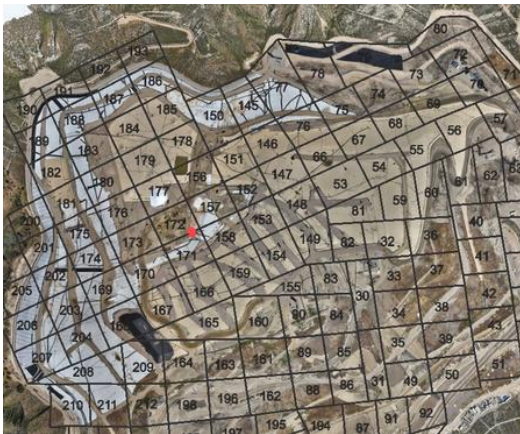
171/172

Castaic CA 91384
United States
(34.434594594496964,
-118.64838093287761)

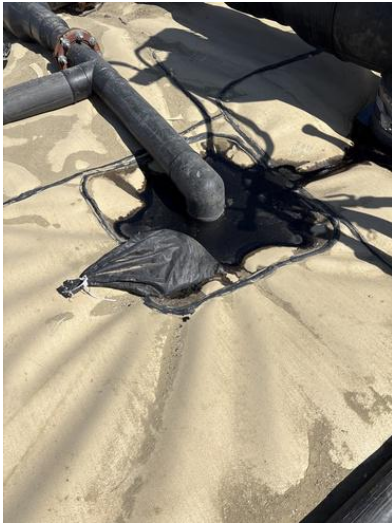
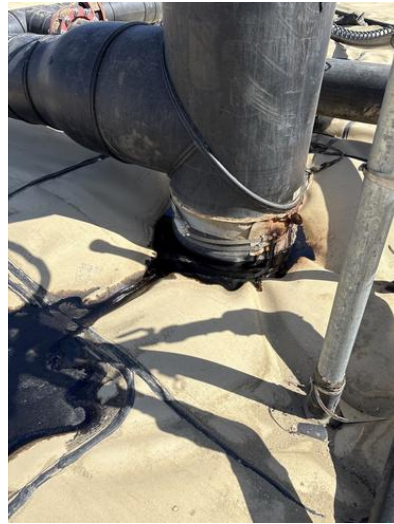
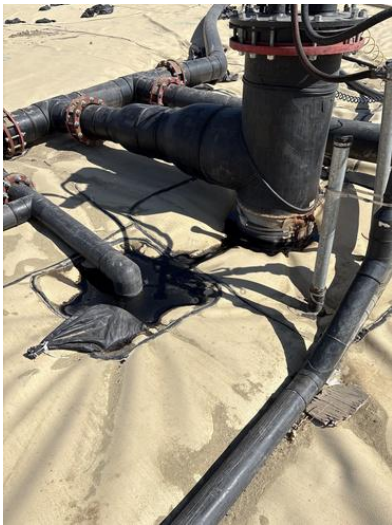
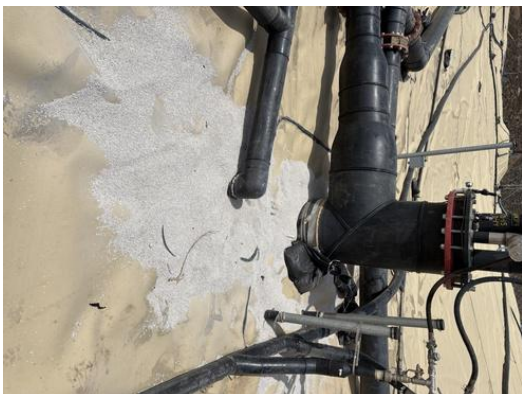
8 Jun 2026 9:44 AM PDT

1 hour

6-10 gallons

8 sq ft

3 - Moderate Odor

Standing free liquid

Liquid vacuumed off liner and from clean out pipe that goes under the liner. Absorbent applied to area to contain any further seepage. Silicone and flex seal tape applied to areas around the sump where leachate leaked out. Clean out will be vacuumed out daily to prevent further seepage. Permanent repair will involve drilling a new sump in the area. The drill arrival is approximately 3 weeks out.

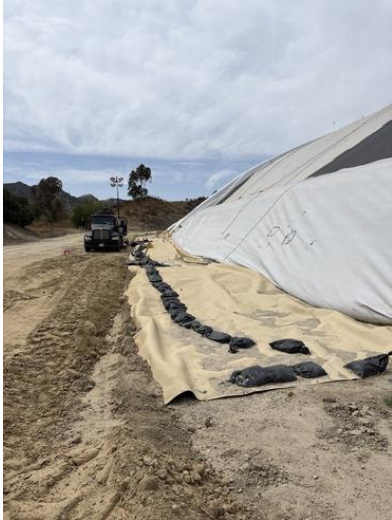
Photo 1

Westside perimeter road. None of the seepage that previously occurred in this area or in Grids 171/172 was observed at the time of this inspection.

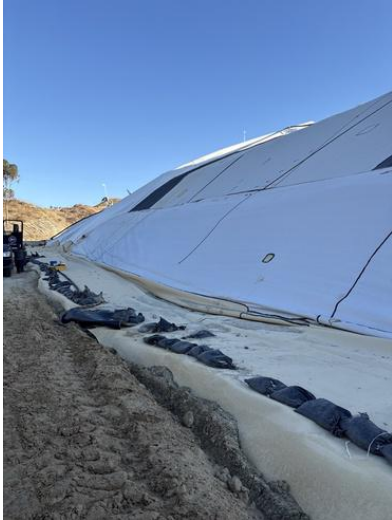
Photo 1

Westside perimeter road. None of the seepage that previously occurred in this area was observed at the time of this inspection.

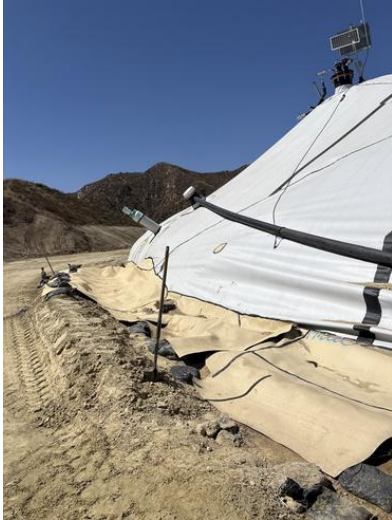
Photo 1

Westside perimeter road. None of the seepage that previously occurred in this area was observed at the time of this inspection.

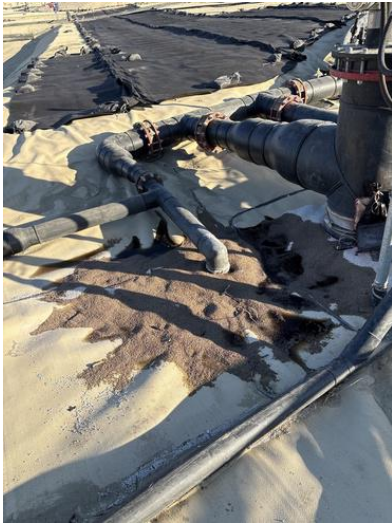
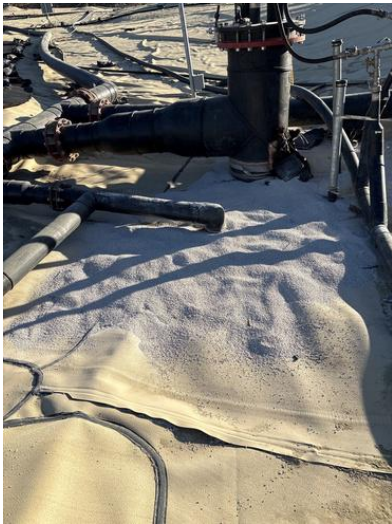
10 Jun 2026 7:06 AM PDT

4 hours

1-5 gallons

20 sq ft

4 - Strong Odor

Standing free liquid

Liquid continues to be vacuumed from under liner from when seep first occurred. Additional absorbent added to contain pooling. Additional temporary containment measures being evaluated so seep can be contained until permanent corrective action can be taken.

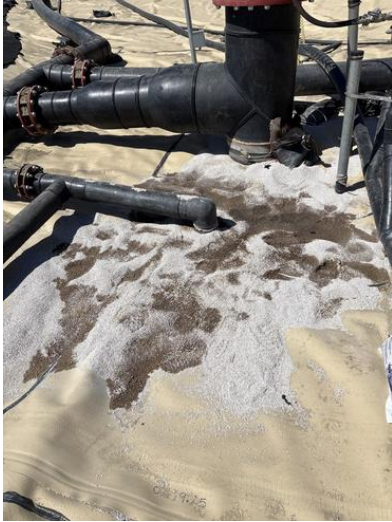
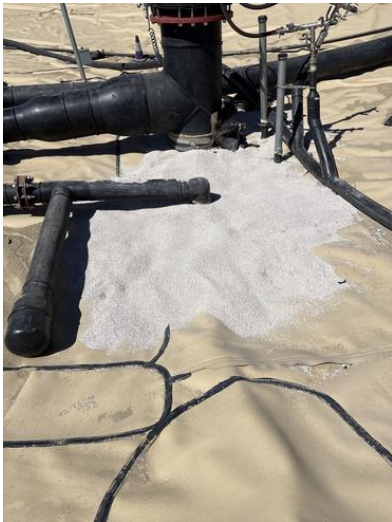
10 Jun 2026 3:42 PM PDT

13 hours

1-5 gallons

20sq ft

4 - Strong Odor

Saturated

Liquid continues to be vacuumed from under liner from when seep first occurred. Additional absorbent added to contain pooling. Additional temporary containment measures being evaluated so seep can be contained until permanent corrective action can be taken.

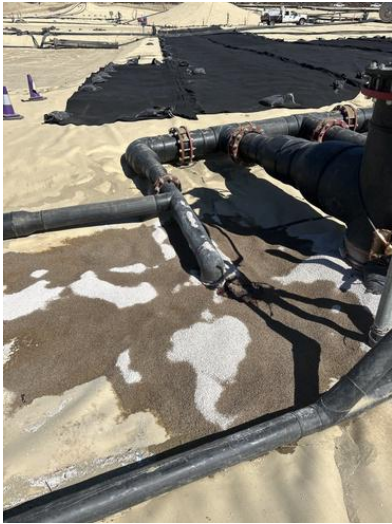
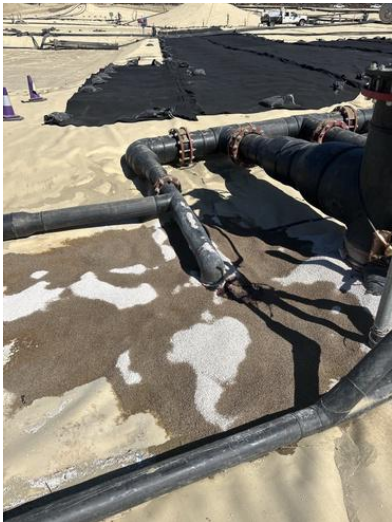
11 Jun 2026 9:33 AM PDT

28.5 hours

1-5 gallons

20 sq ft

1 - Very Light Odor Detected

Saturated

Liquid continues to be vacuumed from under liner from when seep first occurred. Additional absorbent added to contain pooling. Additional temporary containment measures being evaluated so seep can be contained until permanent corrective action can be taken.

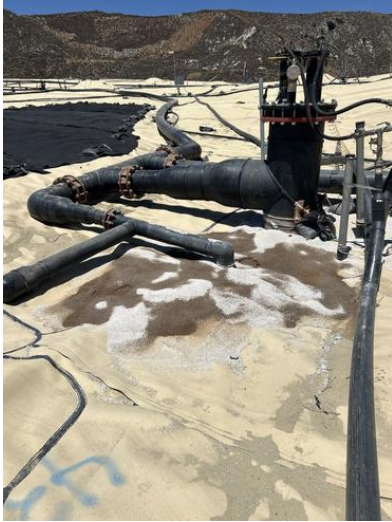
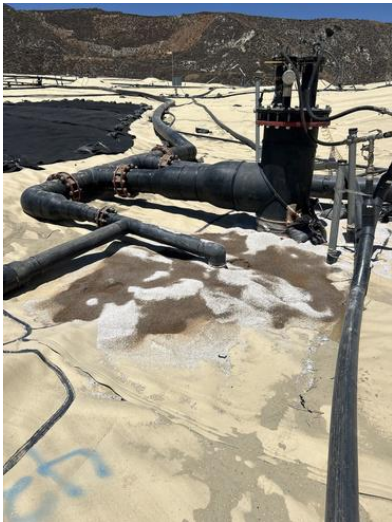
11 Jun 2026 1:36 PM PDT

34.5

<1 gallons

20sq ft

1 - Very Light Odor Detected

Saturated

Liquid continues to be vacuumed from under liner from when seep first occurred. Additional absorbent added to contain pooling. Additional temporary containment measures being evaluated so seep can be contained until permanent corrective action can be taken.

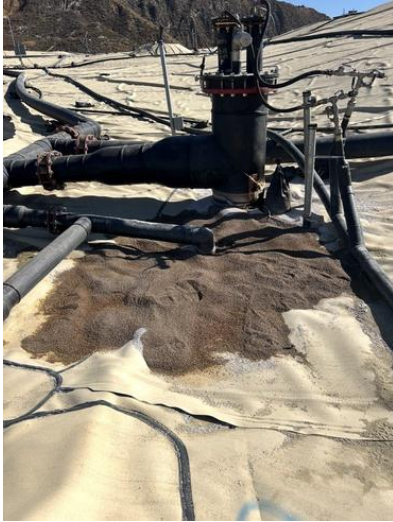
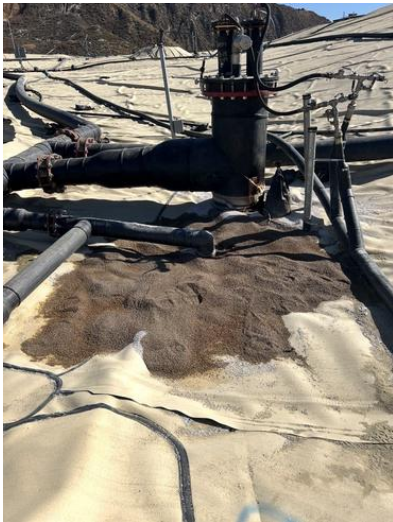
12 Jun 2026 8:51 AM PDT

54.5 hours

1-5 gallons

20sq ft

2 - Light Odor Detected

Saturated

Liquid continues to be vacuumed from under liner from when seep first occurred. Additional absorbent added to contain pooling. Additional temporary containment measures being evaluated so seep can be contained until permanent corrective action can be taken.

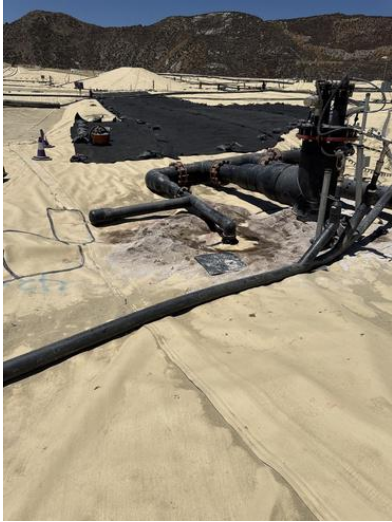
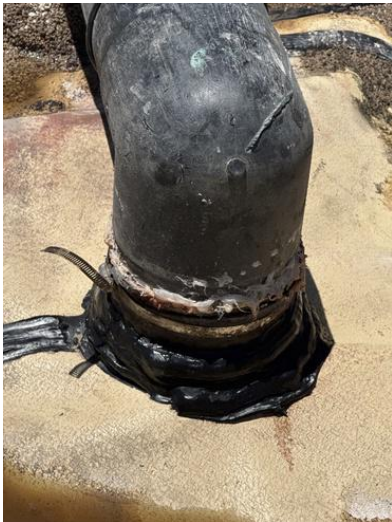
12 Jun 2026 1:41 PM PDT

59 hours

1-5 gallons

20sq ft

1 - Very Light Odor Detected

Standing free liquid

Liner patched and extrusion welded, liquid vacuumed off liner and saturated absorbent remediated. Fresh absorbent applied to area as a precaution. Temporary repairs completed by 3 pm on 6/12/26. Permanent repair will involve drilling a new sump in the area. The drill is approximately 3 weeks out.

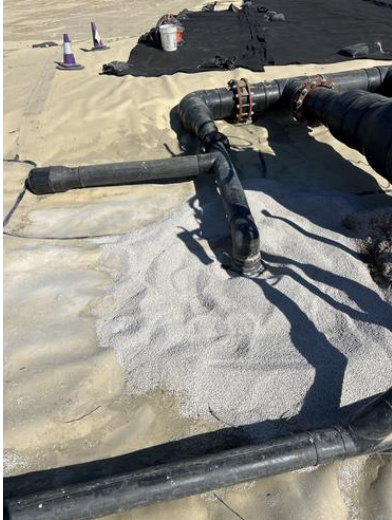
Photo 1

Grid 171/172. The seep from previous inspections was not observed at the time of this inspection. Area continues to be monitored

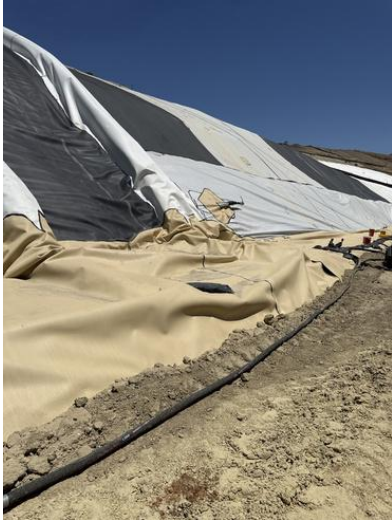
Photo 1

Westside perimeter road. None of the seepage previously observed in this area or in Grids 171/172 was observed at the time of this inspection.

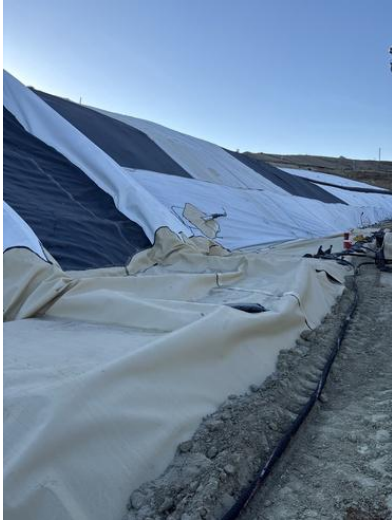
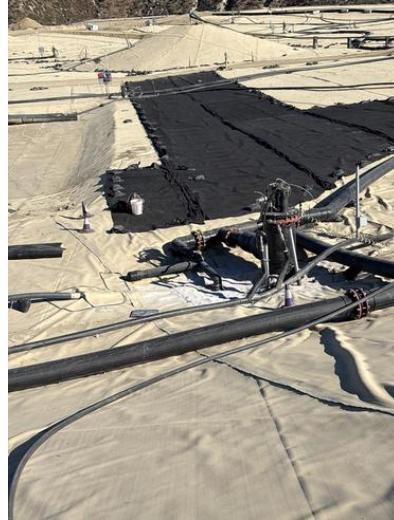
Westside perimeter road and grid 171/172. None of the seeps that occurred in these areas were observed at the time of this inspection. Areas continues to be covered, monitored and vacuumed out as needed to prevent pooling

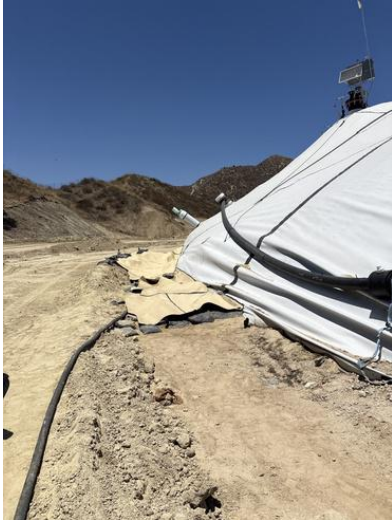
Photo 1

Westside perimeter road. None of the seepage previously observed in this area or in Grids 171/172 was observed at the time of this inspection.
