Re: Chiquita Canyon, LLC's Weekly Leachate Inspection Report for Stipulated Order for Abatement (Case No. 6177-4), Condition 27(c)

Attachment: Leachate Inspection Logs from June 15 – June 21, 2026

4050 - Chiquita Leachate Seep/Pooling Inspection

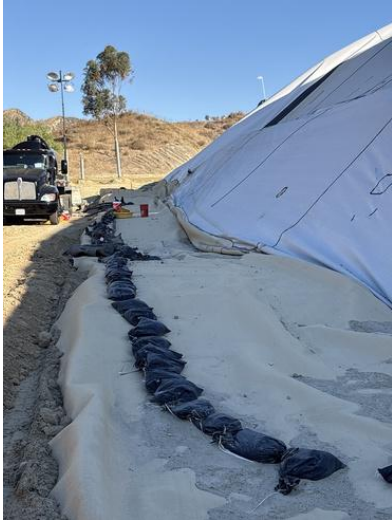
Photo 1

Westside perimeter road. None of the seepage previously observed in this area or in Grids 171/172 was observed at the time of this inspection.

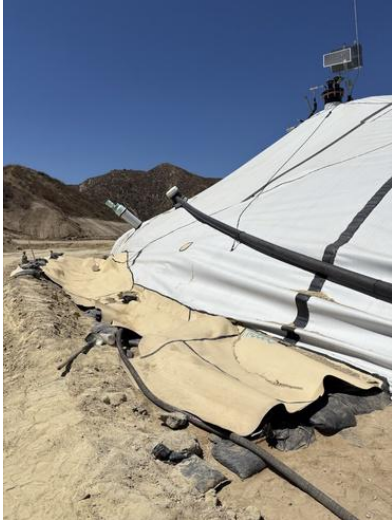
Photo 1

Westside perimeter road. None of the seepage previously observed in this area or in Grids 171/172 was observed at the time of this inspection.

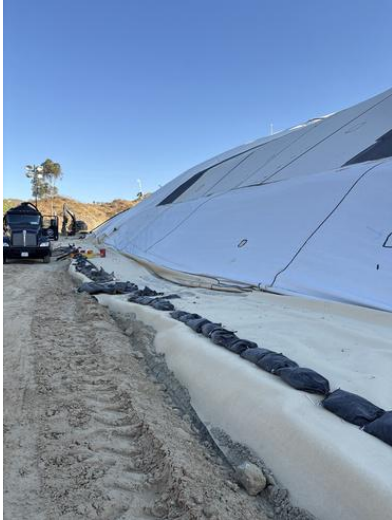
Photo 1

Westside perimeter road. None of the seepage previously observed in this area or in Grids 171/172 was observed at the time of this inspection.

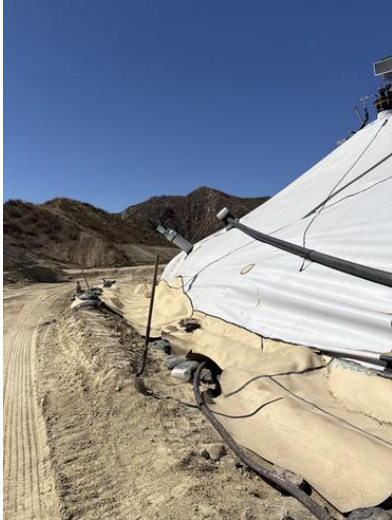
Photo 1

Westside perimeter road. None of the seepage previously observed in this area or in Grids 171/172 was observed at the time of this inspection.

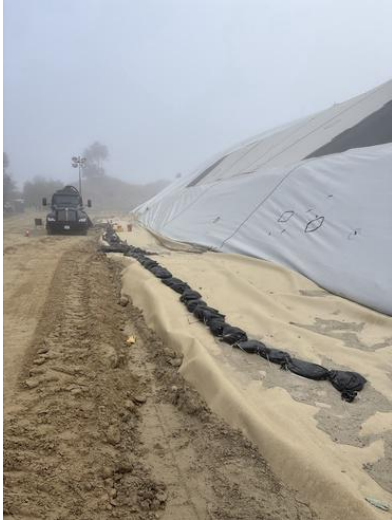
Photo 1

Westside perimeter road. None of the seepage previously observed in this area or in Grids 171/172 was observed at the time of this inspection.

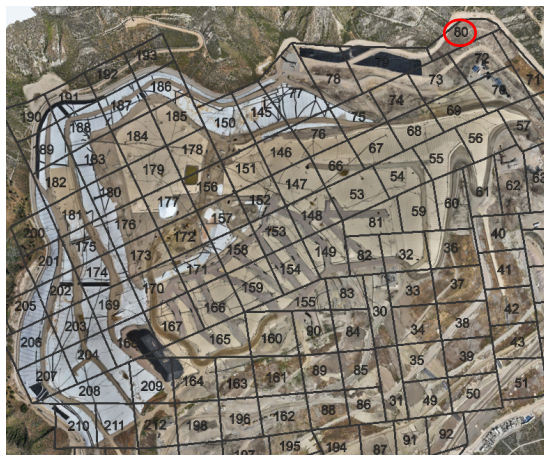
80

(34.437770517858475,
-118.64422001905886)

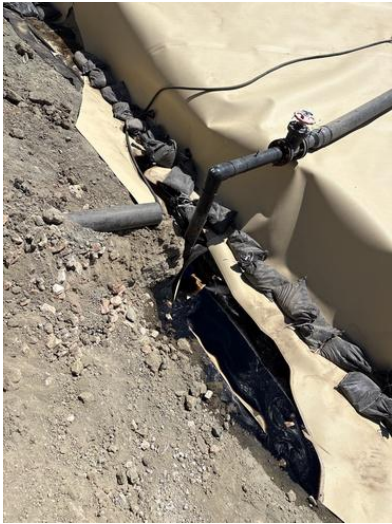
Photo 1

17 Jun 2026 11:35 AM PDT

1 hour

6-10 gallons

50 sq ft

3 - Moderate Odor

Standing free liquid

Planned power outage caused pump to stop in the sump causing seep. Pneumatic pump is being installed in the sump until power is restored. Liquid is being vacuumed off ground and out of the sump until pump is installed.

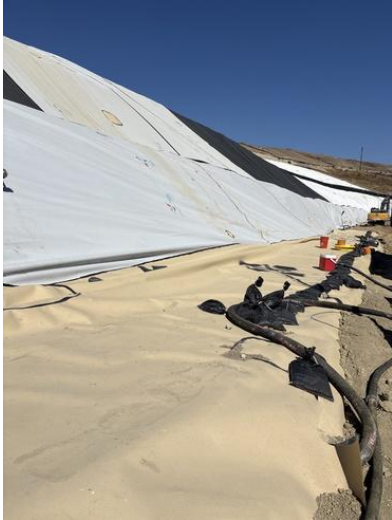
Photo 1

Westside perimeter road. None of the seepage previously observed in this area or in Grids 171/172 was observed at the time of this inspection. Additionally the seep observed today in grid 80 was not observed at the time of this inspection.

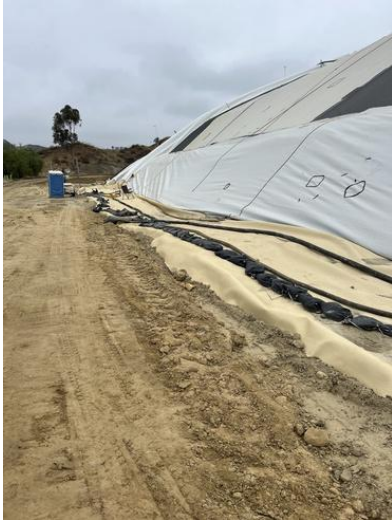
Photo 1

Westside perimeter road. None of the seepage previously observed in this area or in Grids 171/172 was observed at the time of this inspection

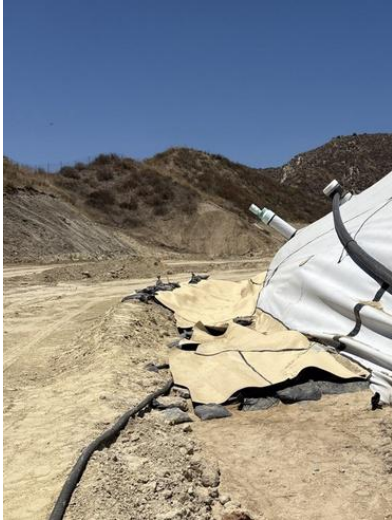
Photo 1

Westside perimeter road. None of the seepage previously observed in this area or in Grids 171/172 was observed at the time of this inspection

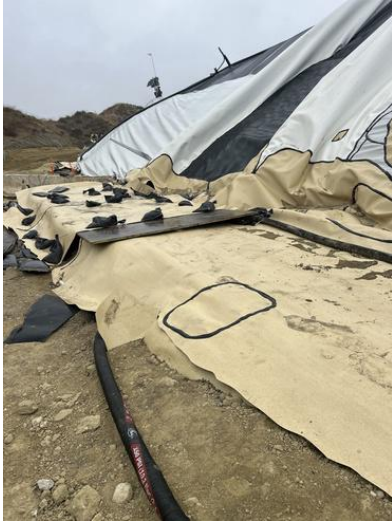
Photo 1

Westside perimeter road. None of the seepage previously observed in this area or in Grids 171/172 was observed at the time of this inspection

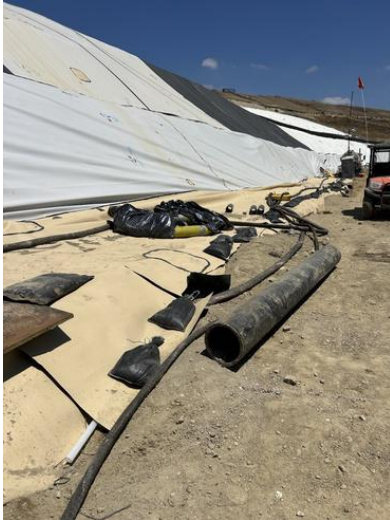
Photo 1

Entire main canyon inspected for 27(b)(ii)

Westside perimeter road. None of the seepage previously observed in this area or in Grids 171/172 was observed at the time of this inspection

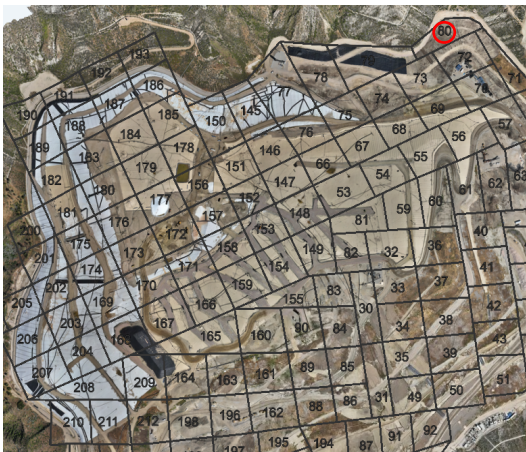
80

Castaic CA 91384
United States
(34.43784210403597,
-118.64424035239314)

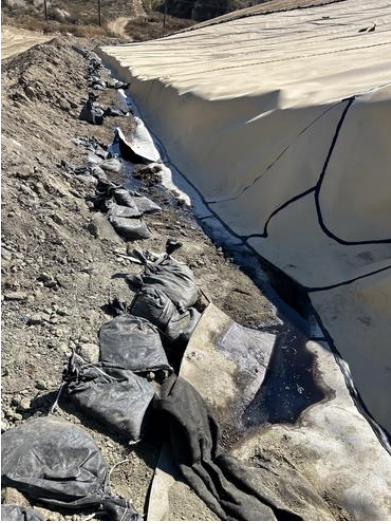
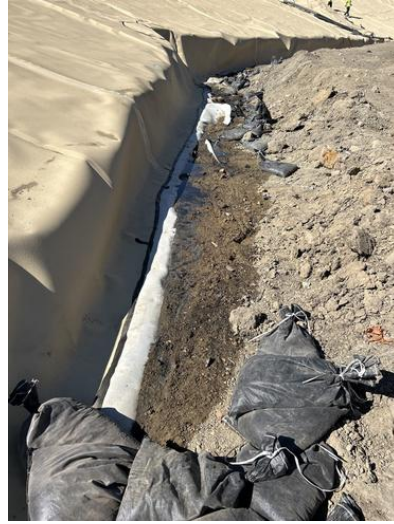
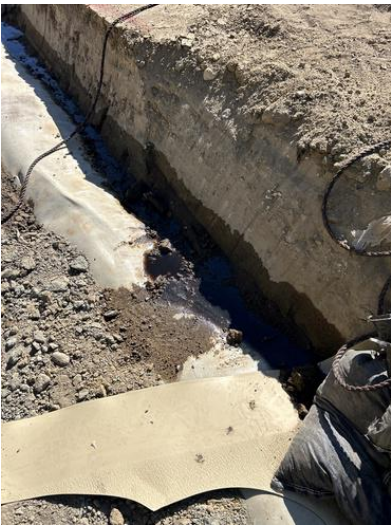
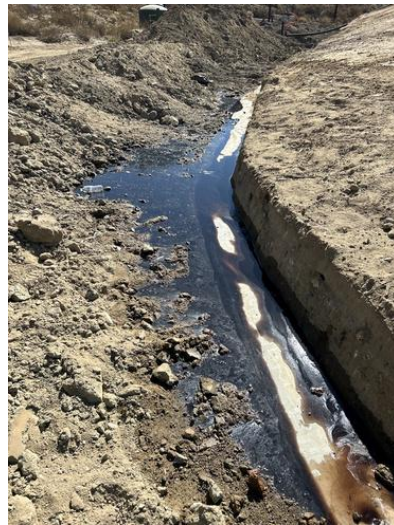
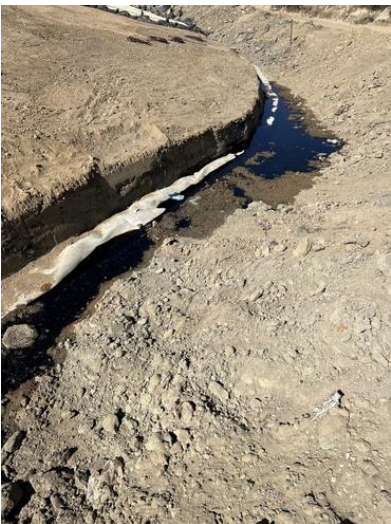
20 Jun 2026 9:07 AM PDT

7 hours

21-50 gallons

240 sq ft

3 - Moderate Odor

Standing free liquid

Pump draining the sump was reactivated at 6/20/26 at 9:20am. Area was vacuumed using guzzler, affected

soil was removed and properly disposed of.

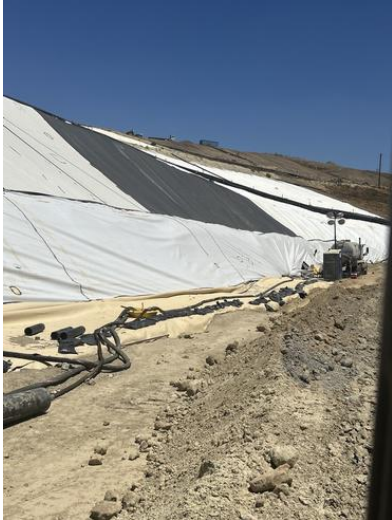
Photo 1

Westside perimeter road. None of the seepage previously observed in this area or in Grids 80/171/172 was observed at the time of this inspection

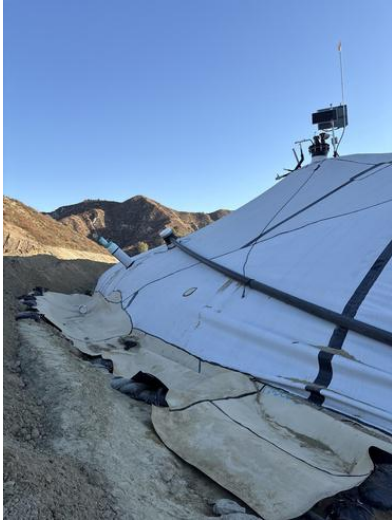
Photo 1

Westside perimeter road. None of the seepage previously observed in this area or in Grids 171/172 or 80 was observed at the time of this inspection.

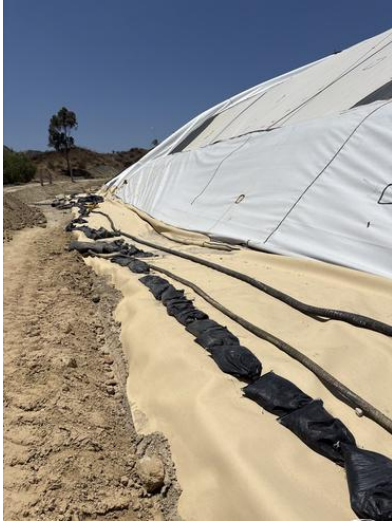
Photo 1

Westside perimeter road. None of the seepage previously observed in this area or in Grids 171/172 or 80 was observed at the time of this inspection.
