Re: Chiquita Canyon, LLC's Weekly Report on the Documentation and Tracking of Cover Issues

4050 - Chiquita Reaction Area Tracking of Fissures and Tension Cracks

4050 - Geosynthetic Cover Inspection

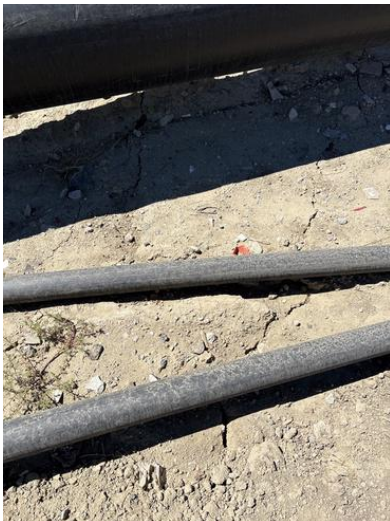
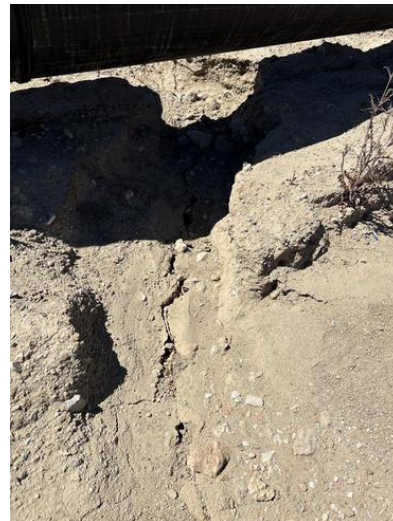
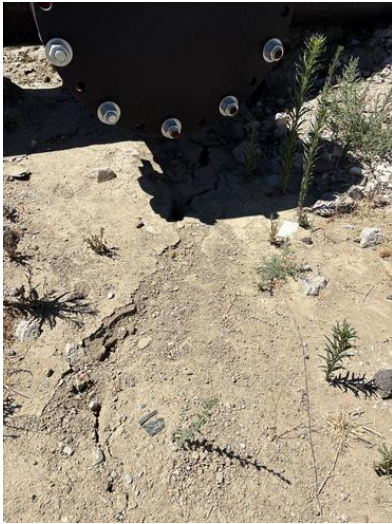
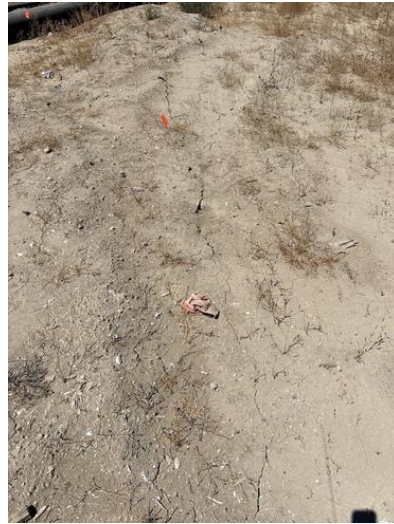
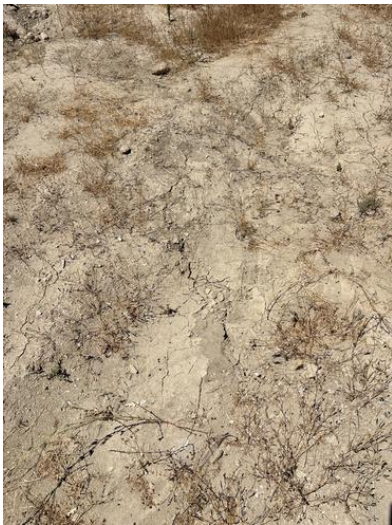
163

Length of crack (ft) or area containing multiple cracks (ft x ft)	25ft x 40ft
Horizontal Offset (width)	Medium 2-4" in width
Vertical Offset (height)	Extra small <0.5" in height
Orientation (direction)	N to S
Location	Castaic CA 91384 United States (34.432890315225514, -118.6478298998814)
Was Fissure or Crack fixed? If yes, add photo and description of repairs performed	Yes

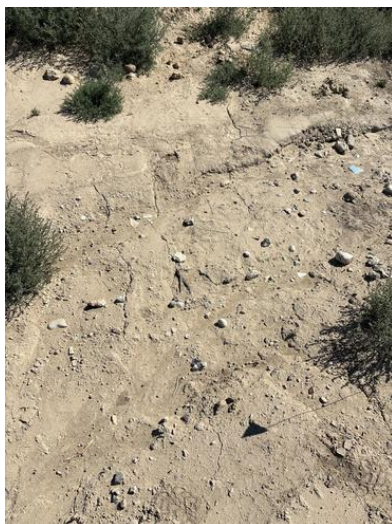
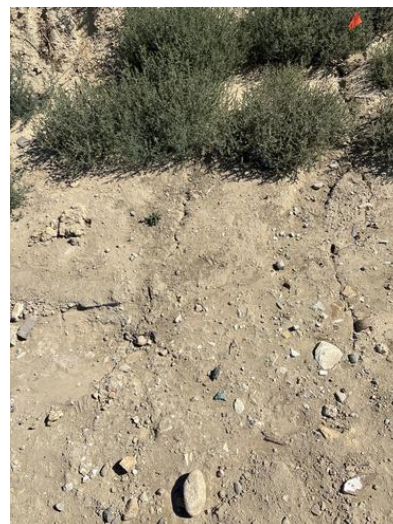
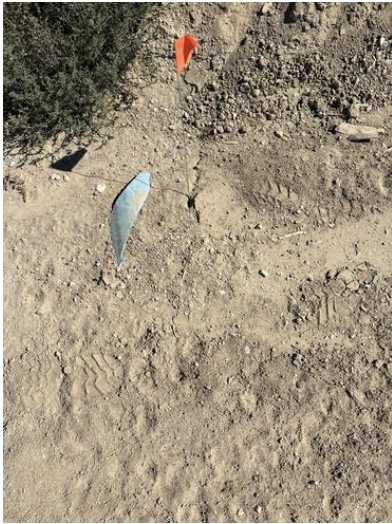
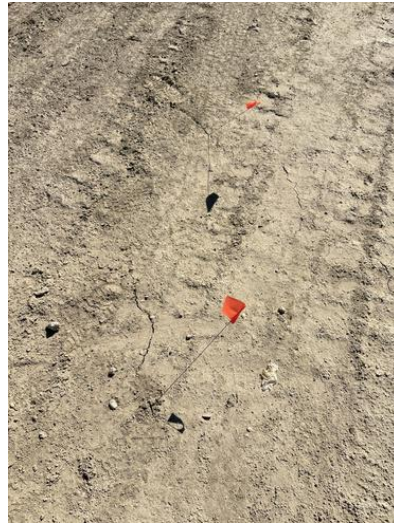
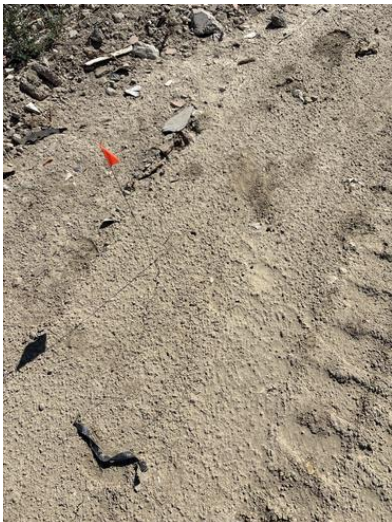
164

95ft x 25ft

Non individual crack 50 ft or longer.

Small 0.5-2" in width

Extra small <0.5" in height

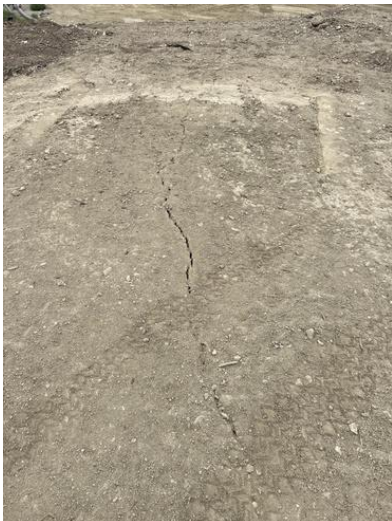
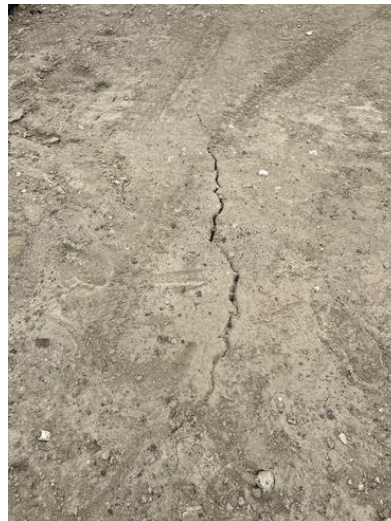
198

7ft x 20ft area

Horizontal Offset (width)	Small 0.5-2" in width
Vertical Offset (height)	Extra small <0.5" in height
Orientation (direction)	NE to SW

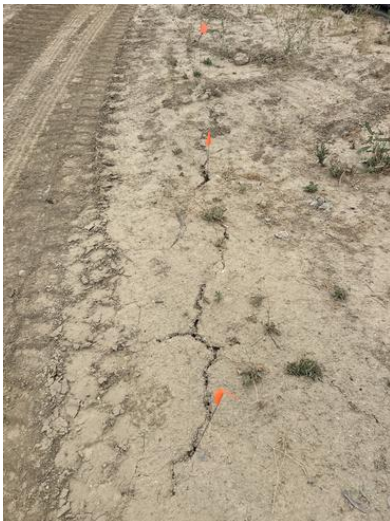
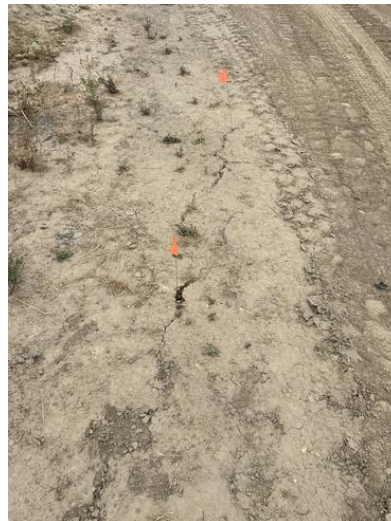
160

6ft

Horizontal Offset (width)	Small 0.5-2" in width
Vertical Offset (height)	Extra small <0.5" in height
Orientation (direction)	NE to SW
Location	Castaic CA 91384 United States (34.43605929520947, -118.64828282428972)

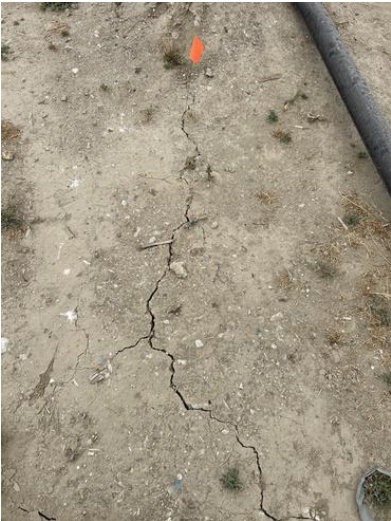
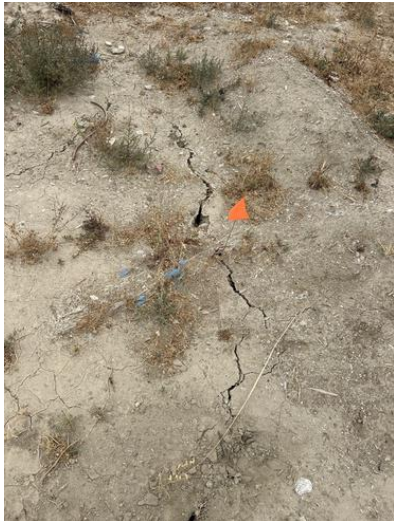
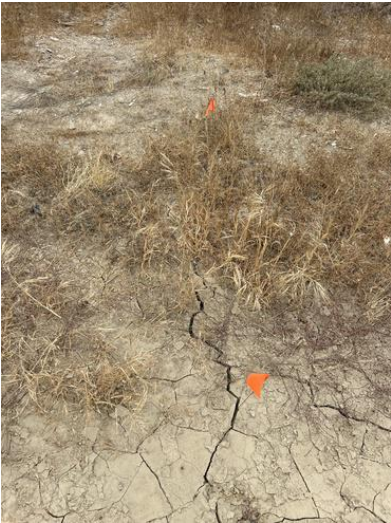
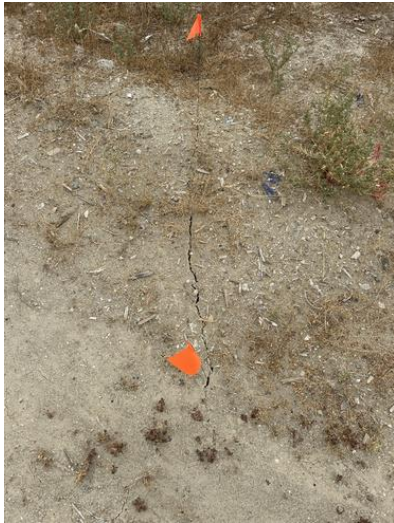
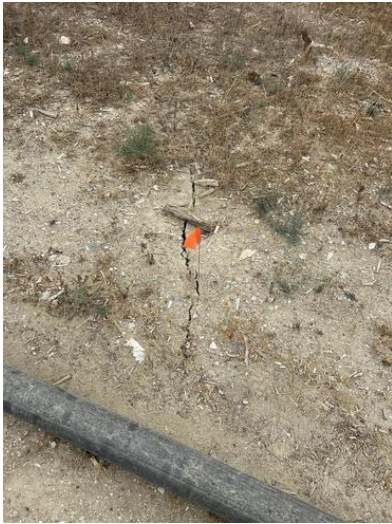
161

Length of crack (ft) or area containing multiple cracks (ft x ft) 13ft x 30ft area

Horizontal Offset (width) Small 0.5-2" in width

Vertical Offset (height) Extra small <0.5" in height

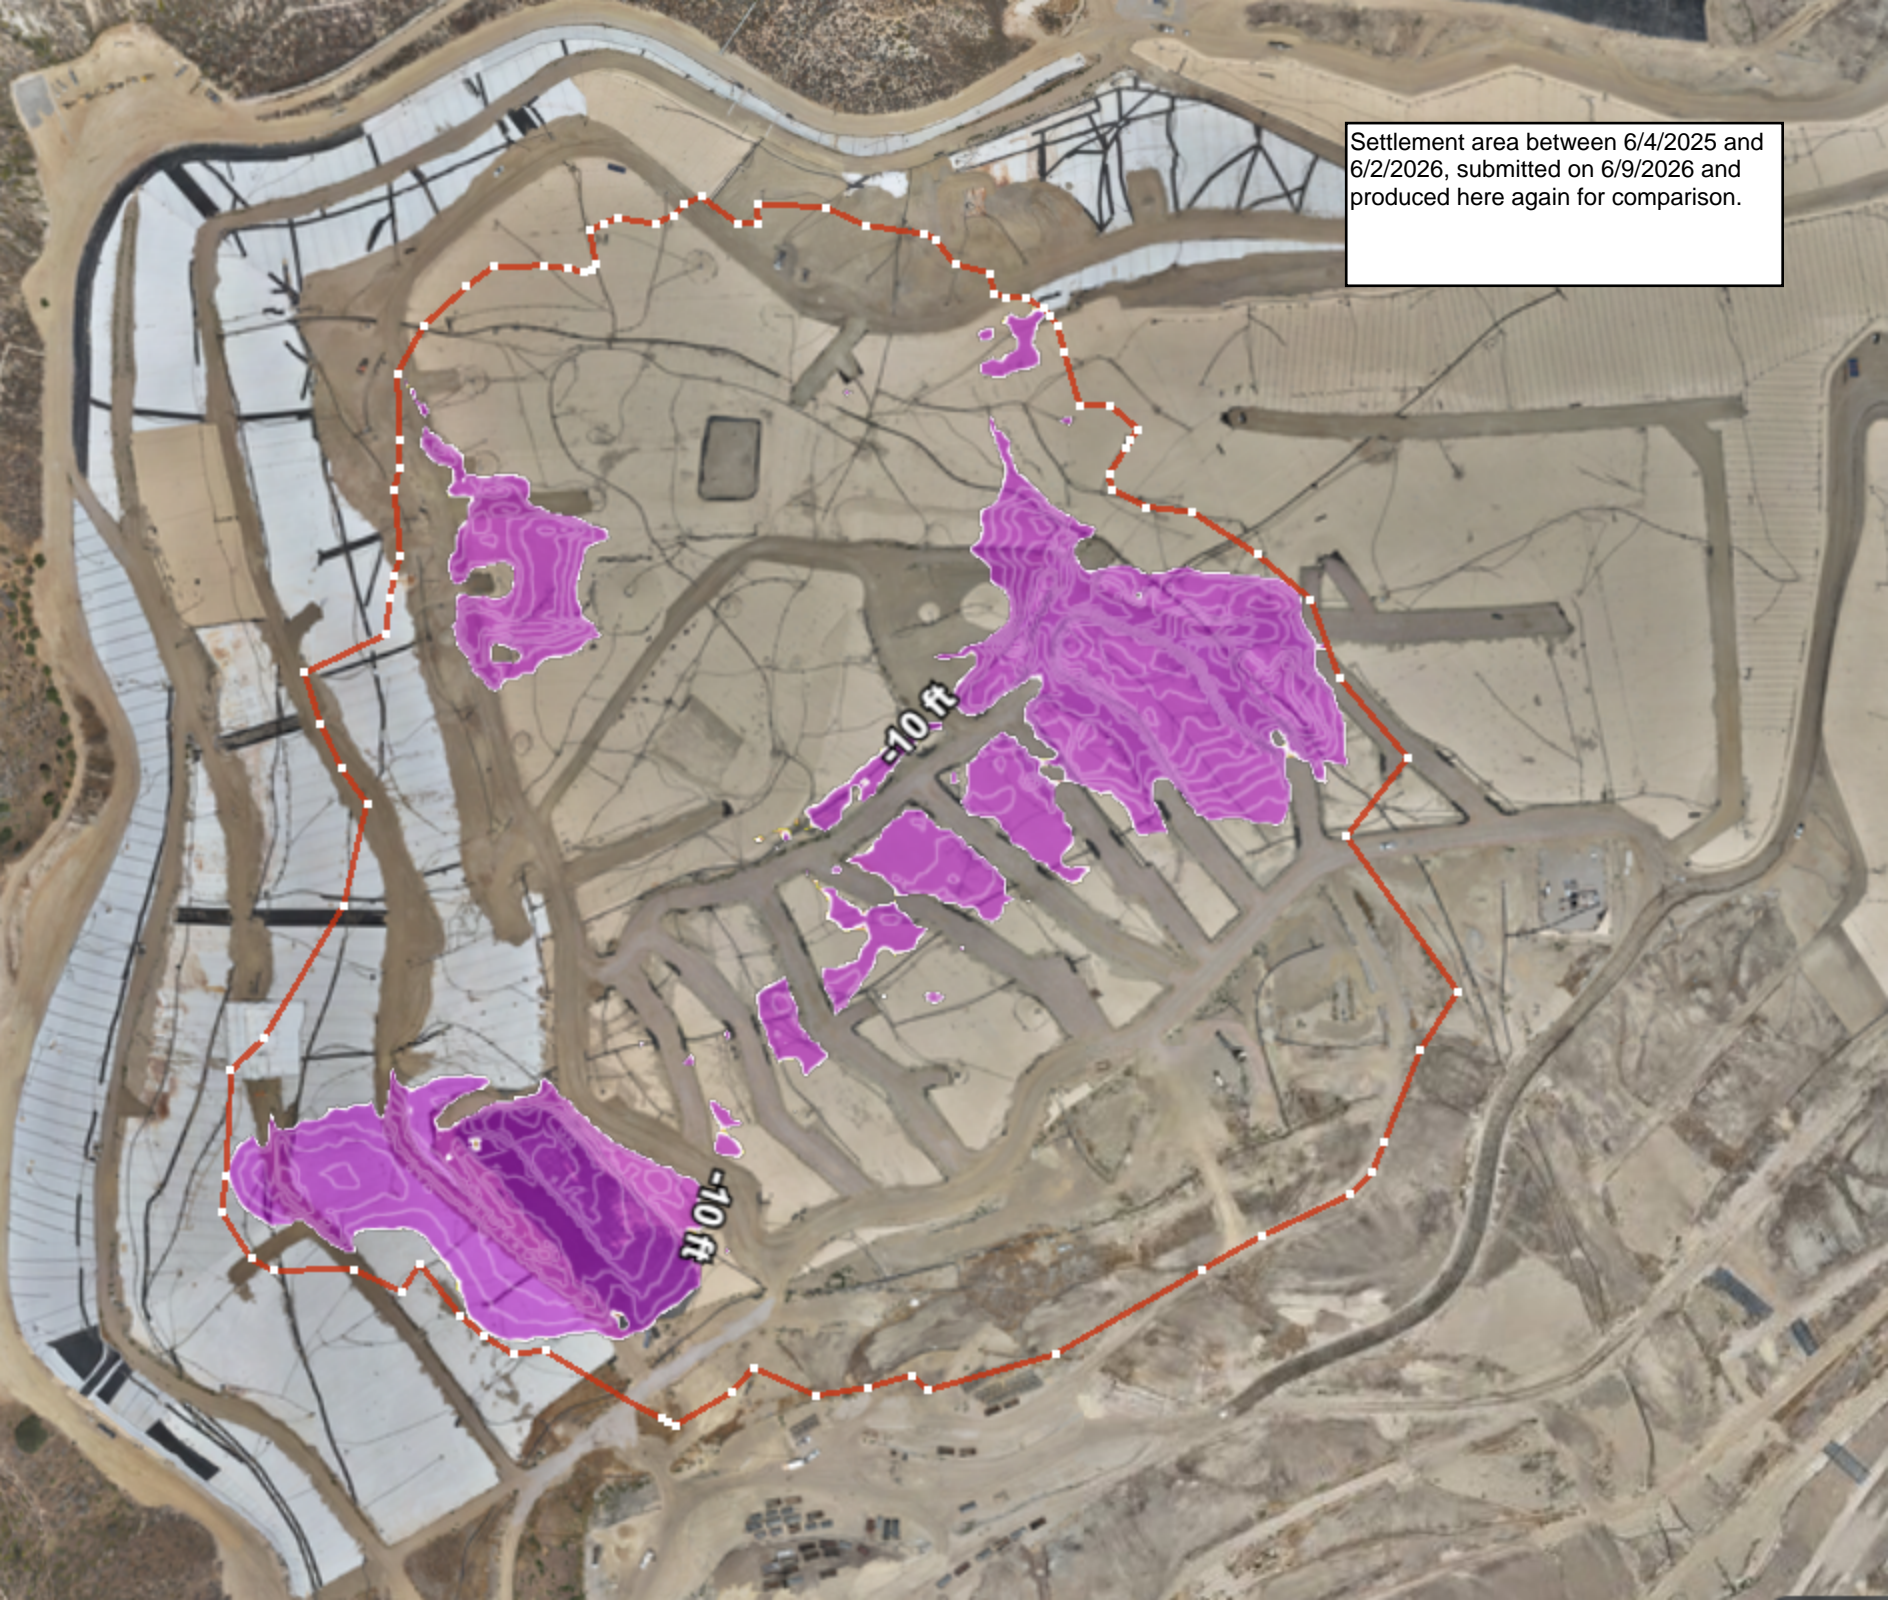
Settlement area between 6/4/2025 and 6/2/2026, submitted on 6/9/2026 and produced here again for comparison.

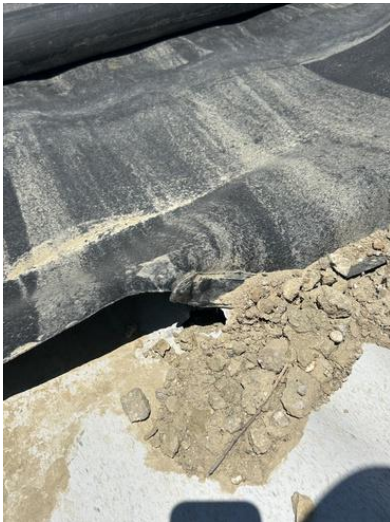
Photo 1

Tear in liner needs to be patched/extrusion welded.
