**CHIQUITA CANYON**  
*A Waste Connections Company*

**Re: Chiquita Canyon, LLC's Weekly Report on the Documentation and Tracking of Cover Issues**

# 4050 - Chiquita Reaction Area Tracking of Fissures and Tension Cracks

# 4050 - Geosynthetic Cover Inspection

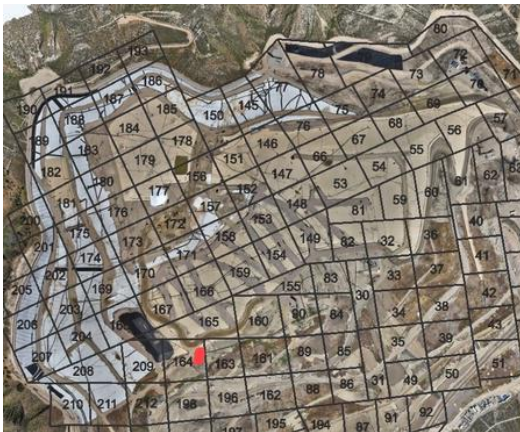
164

Yes

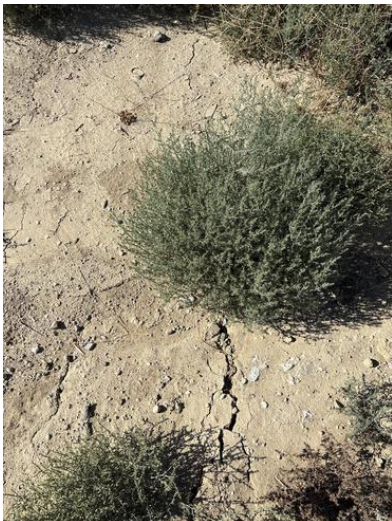
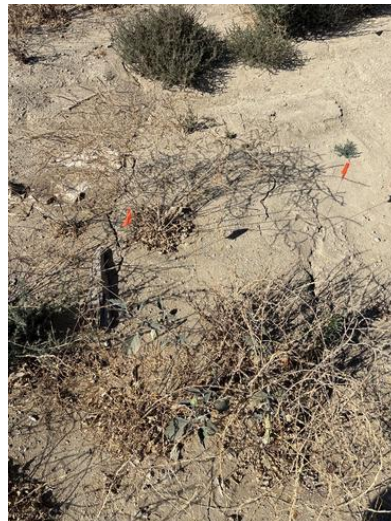
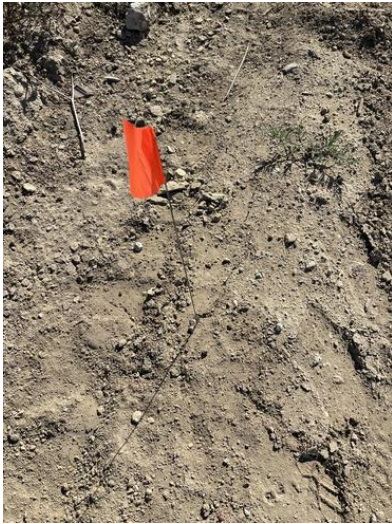
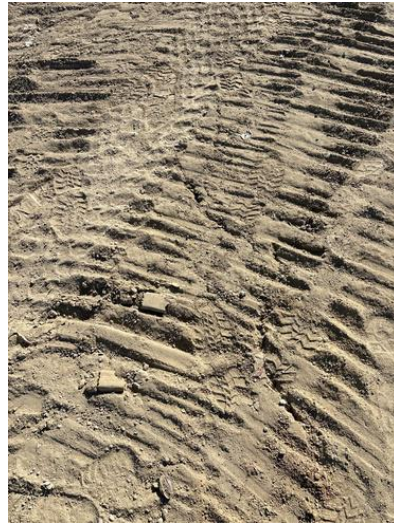
80ft x 55ft

Small 0.5-2" in width

Extra small <0.5" in height

N to S

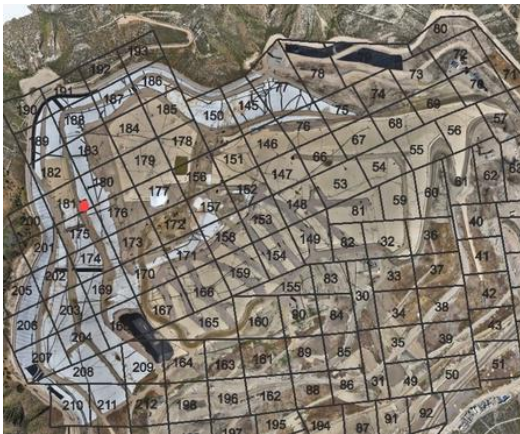
181

Two tears in liner next to each other need to be patched/extrusion welded.
