**Re: Chiquita Canyon, LLC's Weekly Leachate Inspection Report for Stipulated Order for Abatement (Case No. 6177-4), Condition 27(c)**

# 4050 - Chiquita Leachate Seep/Pooling Inspection

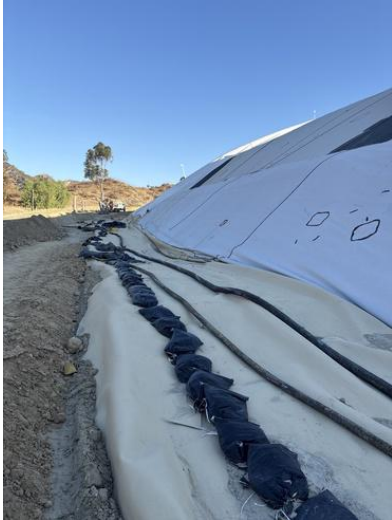
Photo 1

Westside perimeter road. None of the seepage previously observed in this area or in Grids 171/172 was observed at the time of this inspection.

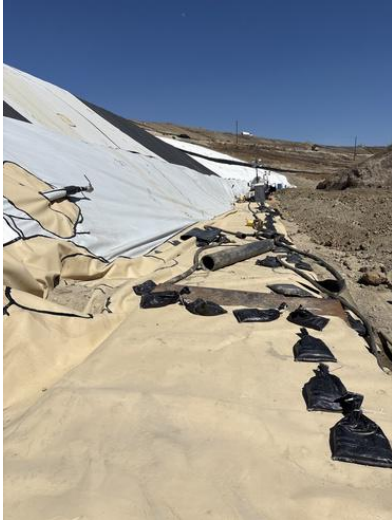
Photo 1

Westside perimeter road. None of the seepage previously observed in this area or in Grids 171/172 was observed at the time of this inspection.

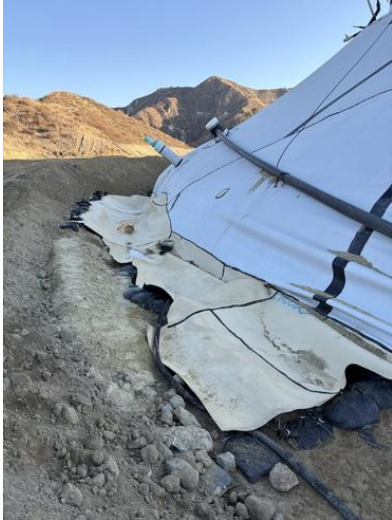
Photo 1

Westside perimeter road. None of the seepage previously observed in this area or in Grids 171/172 was observed at the time of this inspection.

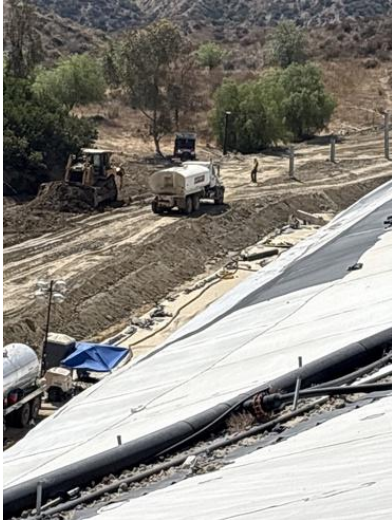
Photo 1

Westside perimeter road. None of the seepage previously observed in this area or in Grids 171/172 was observed at the time of this inspection.

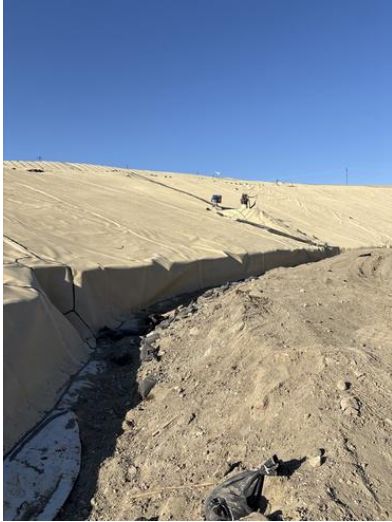
Photo 1

Grid 80. None of the seepage previously observed in this area, the Westside or in Grids 171/172 was observed at the time of this inspection.

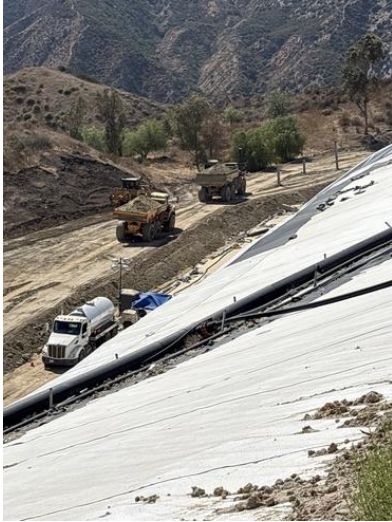
Photo 1

Westside perimeter road. None of the seepage previously observed in this area or in Grids 171/172 was observed at the time of this inspection.

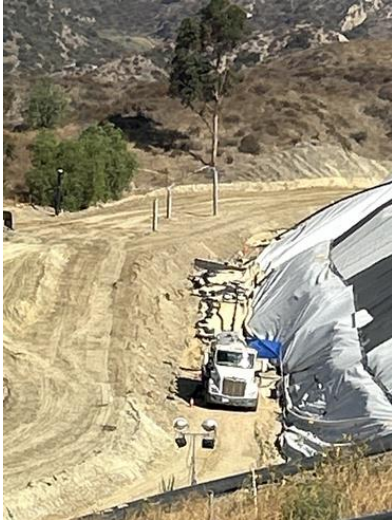
Photo 1

Westside perimeter road. None of the seepage previously observed in this area or in Grids 171/172 was observed at the time of this inspection

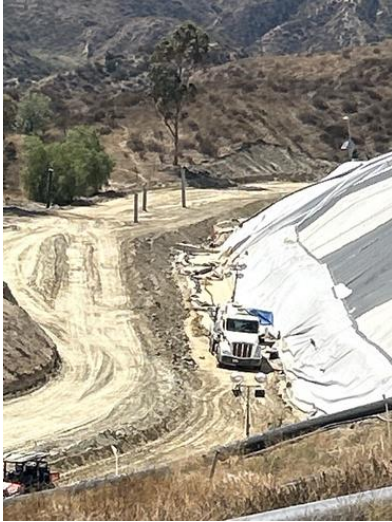
Photo 1

Westside perimeter road. None of the seepage previously observed in this area or in Grids 171/172 was observed at the time of this inspection

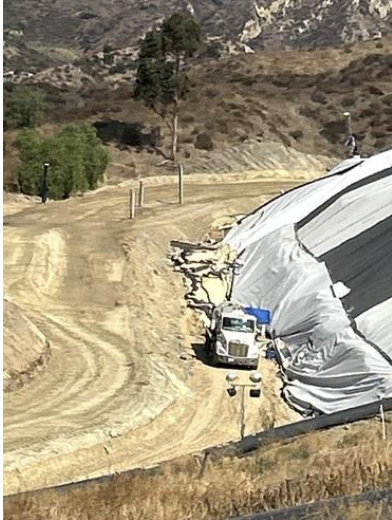
Photo 1

Westside perimeter road. None of the seepage previously observed in this area or in Grids 171/172 was observed at the time of this inspection

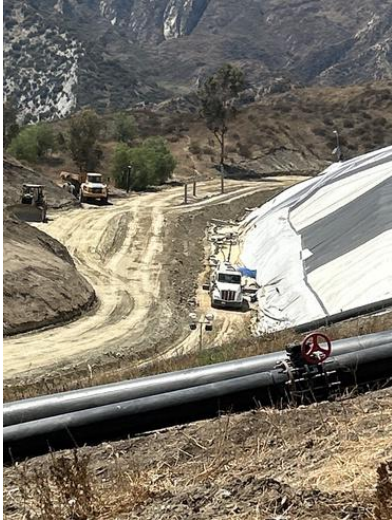
Photo 1

Westside perimeter road. None of the seepage previously observed in this area or in Grids 171/172 was observed at the time of this inspection

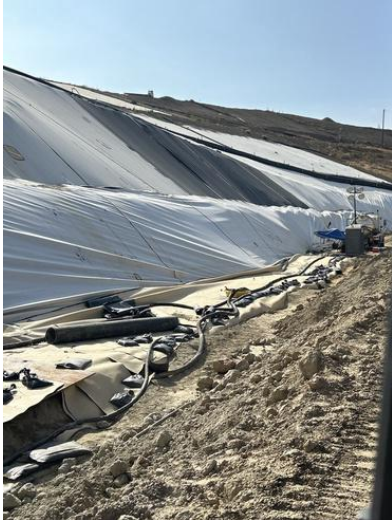
Photo 1

Westside perimeter road. None of the seepage previously observed in this area or in Grids 171/172 was observed at the time of this inspection

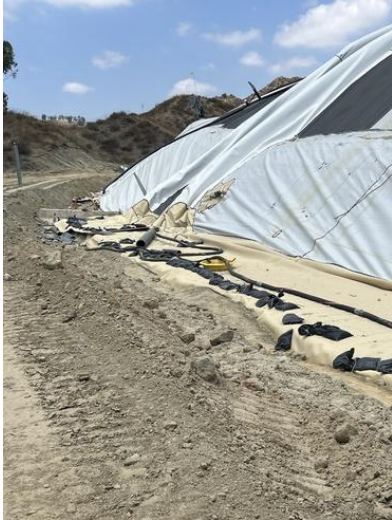
Photo 1

Westside perimeter road. None of the seepage previously observed in this area or in Grids 171/172 was observed at the time of this inspection

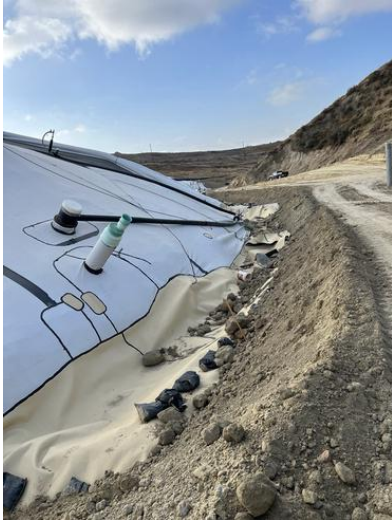
Photo 1

Westside perimeter road. None of the seepage previously observed in this area or in Grids 171/172 was observed at the time of this inspection.

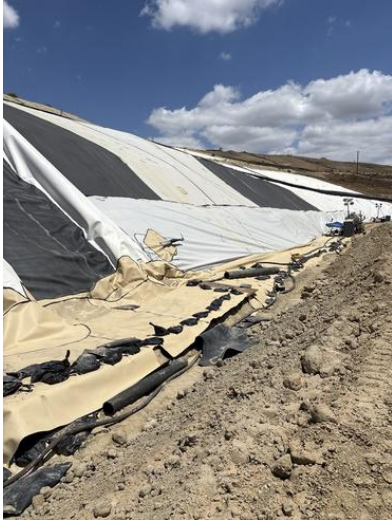
Photo 1

Westside perimeter road. None of the seepage previously observed in this area or in Grids 171/172 was observed at the time of this inspection.
