**Re: Chiquita Canyon, LLC's Weekly Report on the Documentation and Tracking of Cover Issues**

# 4050 - Chiquita Reaction Area Tracking of Fissures and Tension Cracks

# 4050 - Geosynthetic Cover Inspection

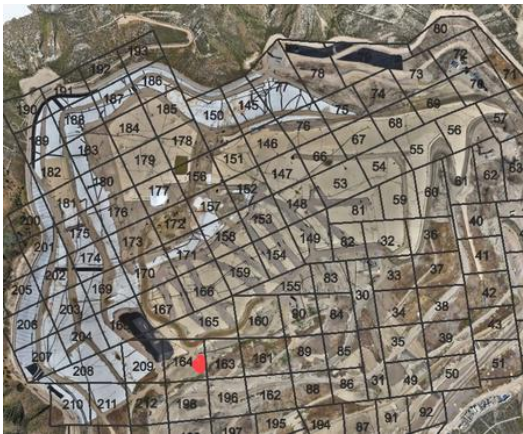
164

Fissure or Tension Crack Found?

Yes

Using the attached image, annotate all areas where inspectors identified a fissure or tension crack.

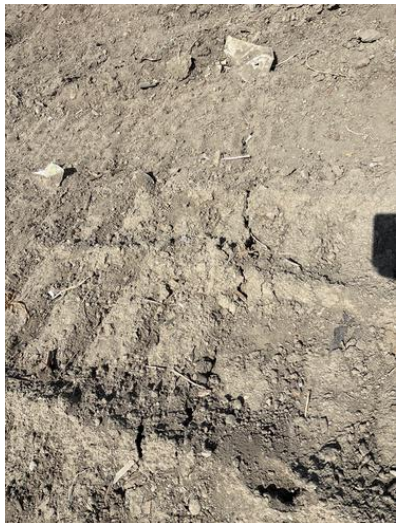
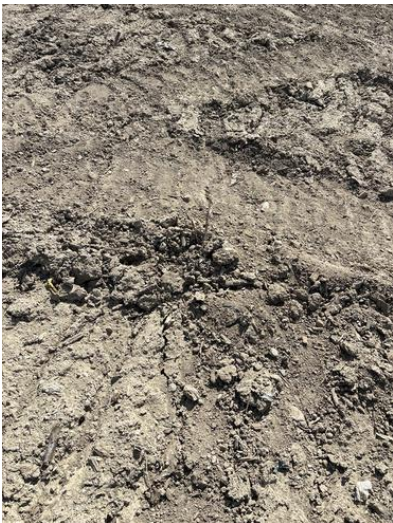
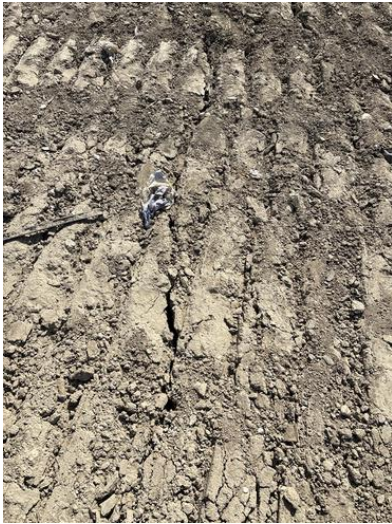
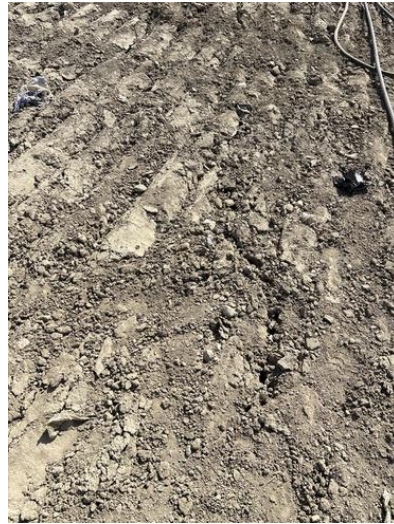
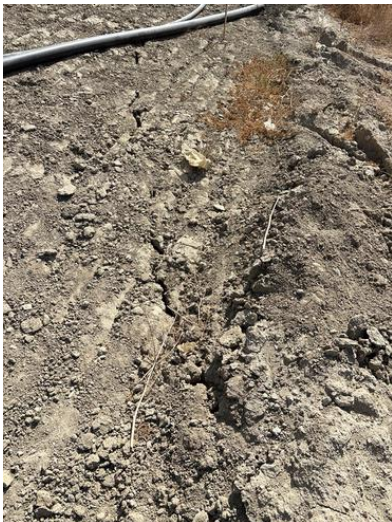
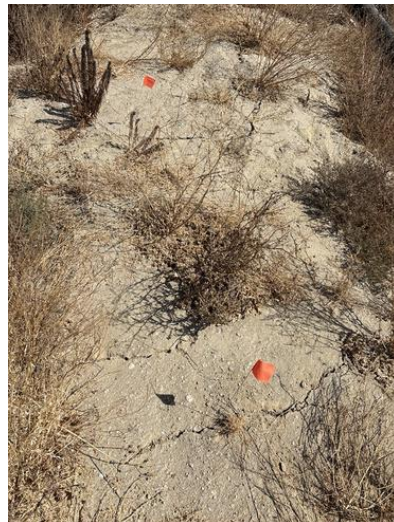
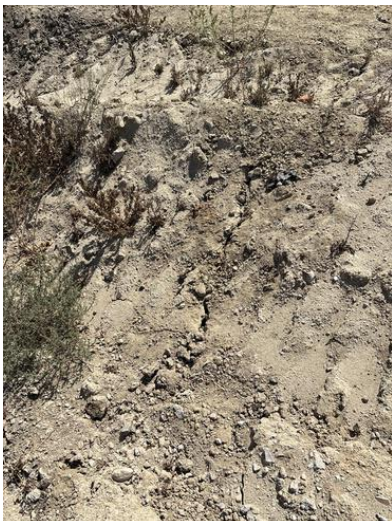
**Length of crack (ft) or area containing multiple cracks (ft x ft)**

75ft x 50ft

No individual crack 50ft or longer

| Horizontal Offset (width) | Medium 2-4" in width |
| Vertical Offset (height) | Extra small <0.5" in height |
| Orientation (direction) | NE to SW |

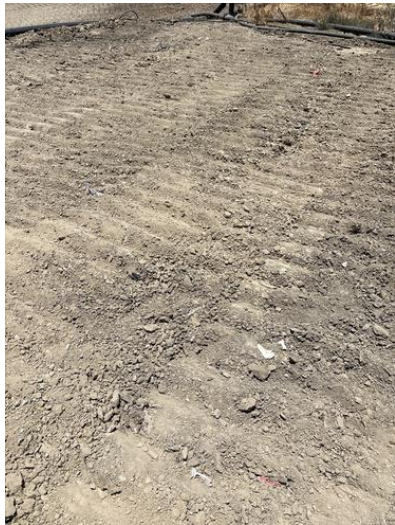
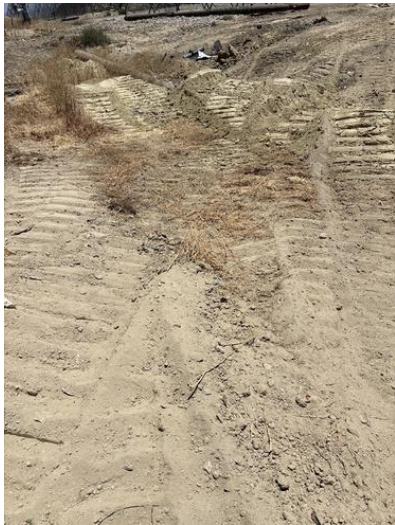
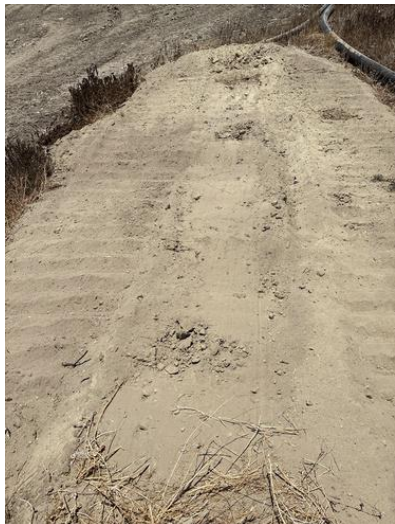
| Was Fissure or Crack fixed? If yes, add photo and description of repairs performed | Yes |

| Description of repairs | Cracks were track walked. |

Dirt added and compacted to some cracks

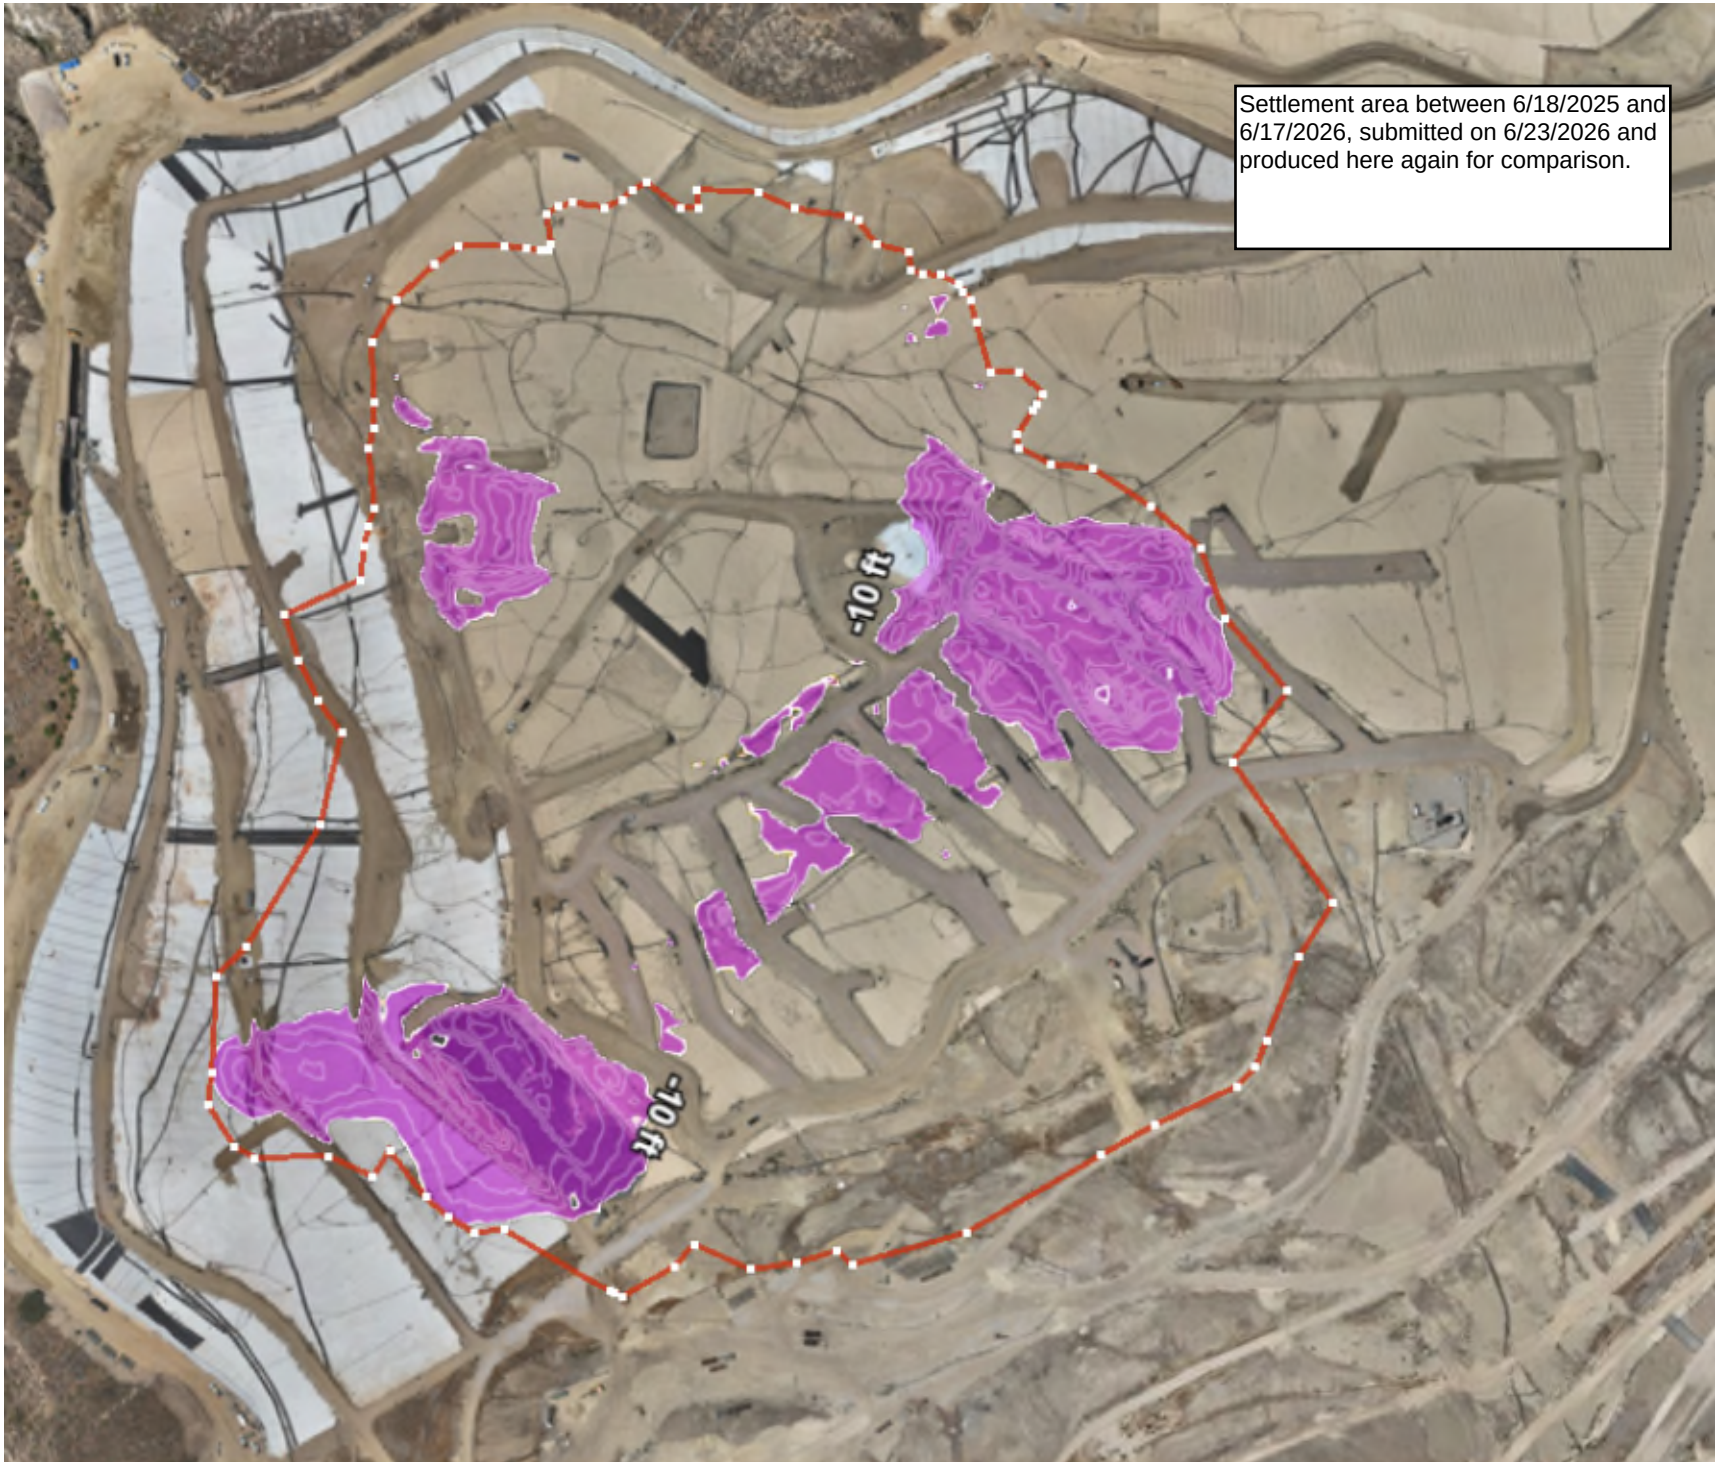
- The map shows the area between 7/2/2025 and 7/1/2026 where the grades have changed more than 10 feet. A typical MSW strain rate is 3% per year - for a landfill with a 300-foot waste column, this would be 9 feet per year.

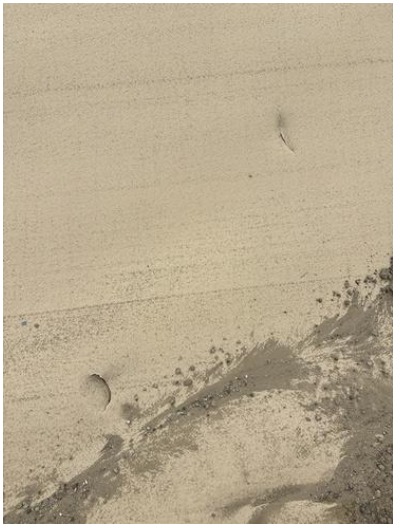
Photo 1

Two tears in liner need to be patched/extrusion welded.
