**Re: Chiquita Canyon, LLC's Weekly Leachate Inspection Report for Stipulated Order for Abatement (Case No. 6177-4), Condition 27(c)**

Attachment: Leachate Inspection Logs from June 29 – July 5, 2026

# 4050 - Chiquita Leachate Seep/Pooling Inspection

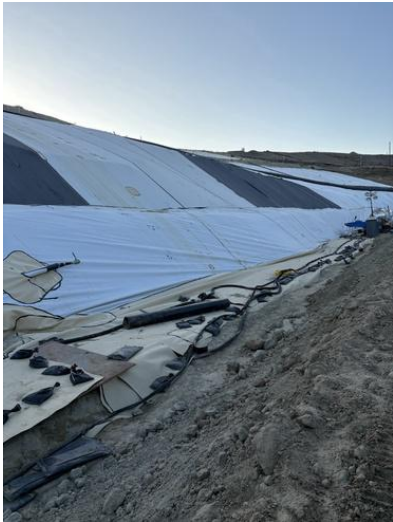
Photo 1

Westside perimeter road. None of the seepage previously observed in this area or in Grids 171/172 was observed at the time of this inspection.

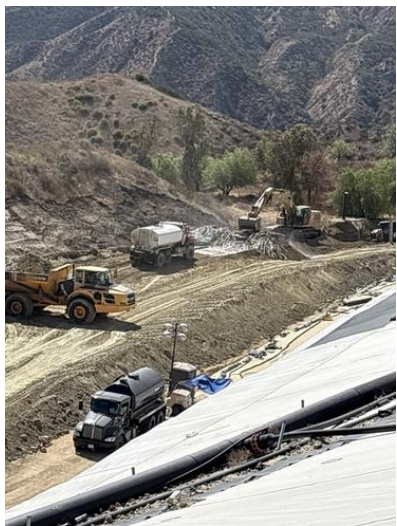
Photo 1

Westside perimeter road. None of the seepage previously observed in this area or in Grids 171/172 was observed at the time of this inspection.

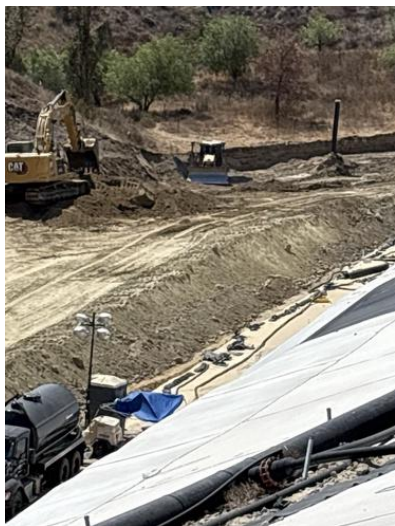
Photo 1

Westside perimeter road. None of the seepage previously observed in this area or or 171/172 was observed at the time of this inspection.

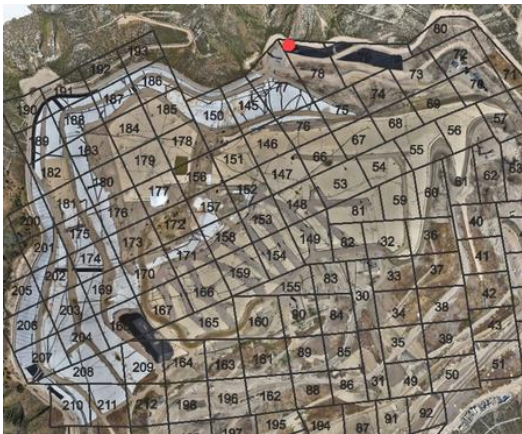
78

Valencia CA 91355  
United States  
(34.435672505962486,  
-118.63811489404661)

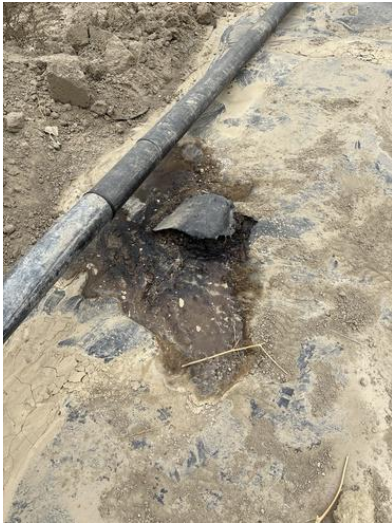
Photo 1

For the week of June 29 through July 5, 2026, leachate seepage was observed on July 1, 2026, at approximately 8:31 a.m., in Grid 78 at the Chiquita Canyon Landfill (the "Landfill"). The specific location of this seep is shown on the maps included in the attachment. The seepage occurred through a tear in the liner caused by equipment working in the area. The sump in the area did not have a pump installed because liquids had not been observed in the area recently. Upon discovery of the seep, Chiquita promptly initiated response and mitigation measures, including vacuuming liquid from the sump, removing affected soil and placing it in an appropriate container for disposal. Chiquita temporarily patched the area and covered the tear to prevent further seepage through the liner. This initial response work was completed by approximately 3:00 p.m. on July 1, 2026. Chiquita permanently patched and welded the tear on July 6, 2026. The seepage was not observed during subsequent inspections conducted that week. The seepage is estimated to have been present for approximately 14 total hours. The total volume of leachate associated with this seepage during that period is estimated to have been up to 5 gallons. The observed area impacted by the seepage

was approximately 5 square feet. The saturation of the soil was characterized as “Saturated.” The odor was characterized as “Very Light.”

14 hours

1-5 gallons

5sq ft

1 - Very Light Odor Detected

Saturated

Contaminated soil removed and disposed of properly. Temporary patch flex taped over the hole in liner to prevent any further seepage.

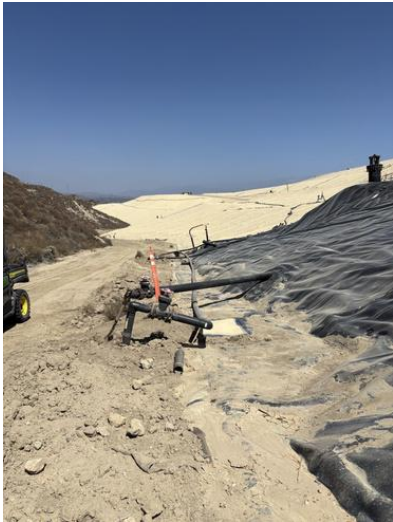
Photo 1

Grid 78. None of the seepage previously observed in this area or on the Westside or 171/172 was observed at the time of this inspection.

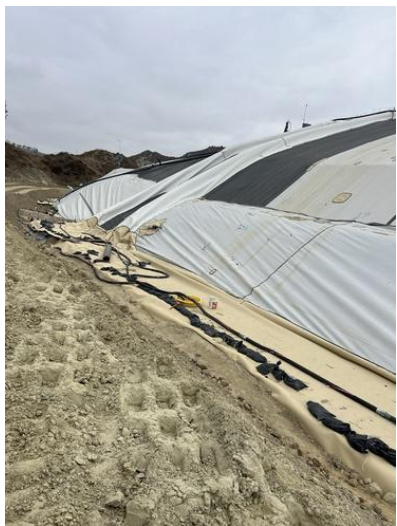
Photo 1

Westside perimeter road. None of the seepage previously observed in this area or in Grids 171/172 was observed at the time of this inspection

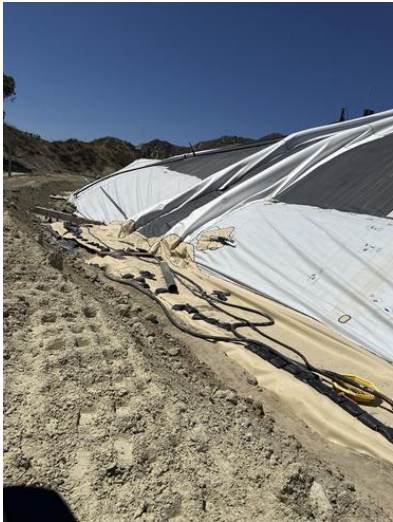
Photo 1

Westside perimeter road. None of the seepage previously observed in this area or in Grids 171/172 was observed at the time of this inspection

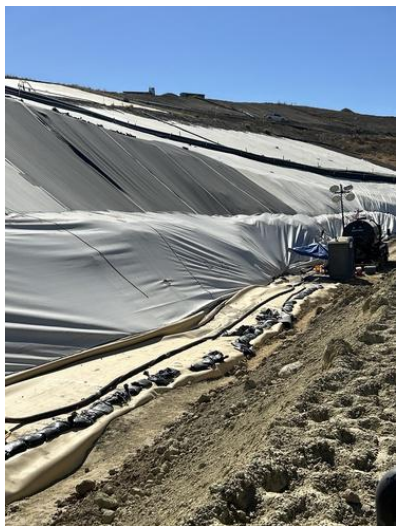
Photo 1

Westside perimeter road. None of the seepage previously observed in this area or in Grids 171/172 was observed at the time of this inspection

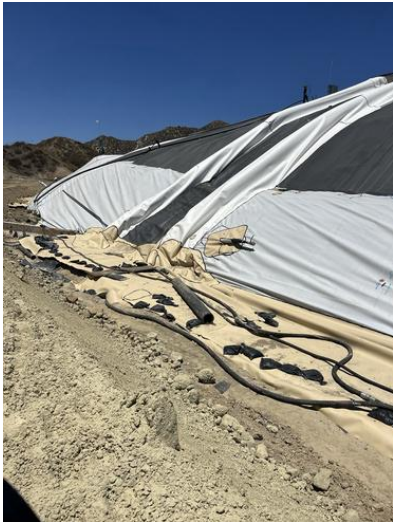
Photo 1

Westside perimeter road. None of the seepage previously observed in this area or in Grids 171/172 was observed at the time of this inspection

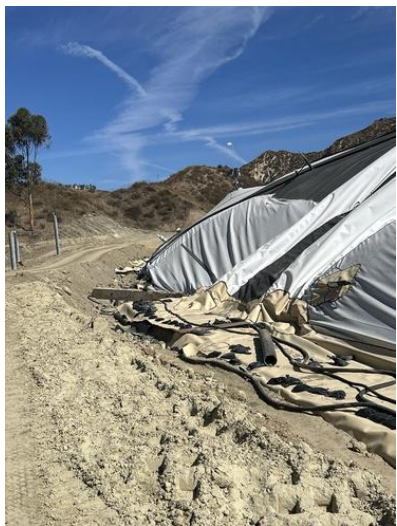
Photo 1

Westside perimeter road. None of the seepage previously observed in this area or in Grids 171/172 was observed at the time of this inspection

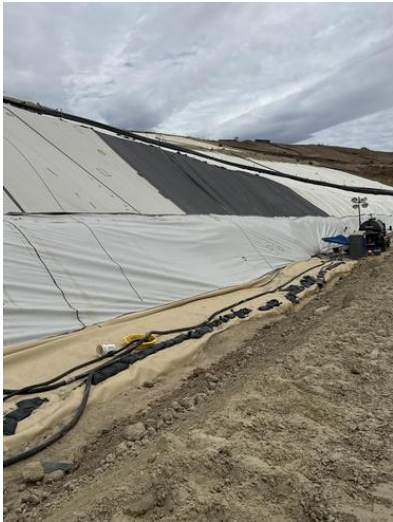
Photo 1

Westside perimeter road. None of the seepage previously observed in this area or in Grids 171/172 was observed at the time of this inspection

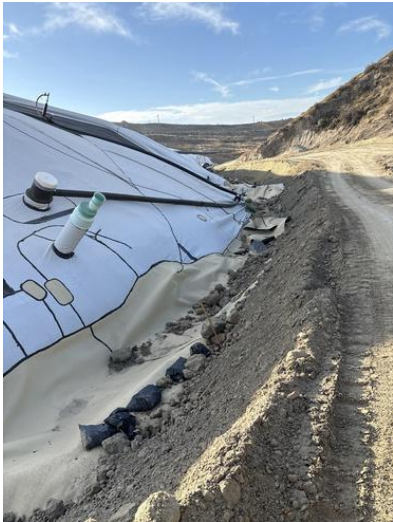
Photo 1

Westside perimeter road. None of the seepage previously observed in this area or or 171/172 was observed at the time of this inspection.

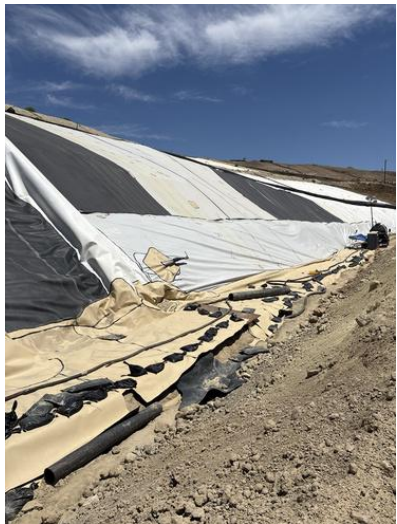
Photo 1

Westside perimeter road. None of the seepage previously observed in this area or or 171/172 was observed at the time of this inspection.
