**Re: Chiquita Canyon, LLC's Weekly Leachate Inspection Report for Stipulated Order for Abatement (Case No. 6177-4), Condition 27(c)**

# 4050 - Chiquita Leachate Seep/Pooling Inspection

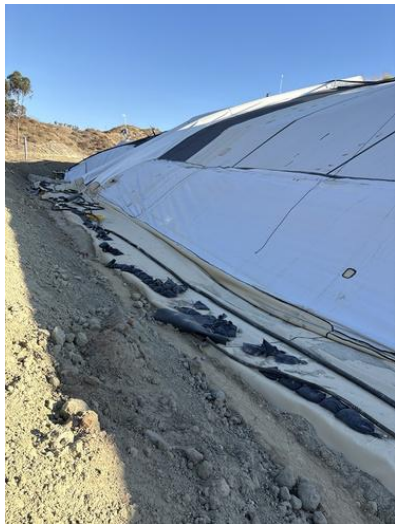
Photo 1

Westside perimeter road. None of the seepage previously observed in this area or or 171/172 was observed at the time of this inspection.

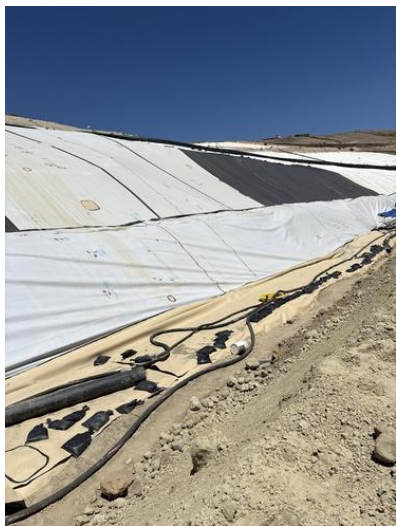
Photo 1

Westside perimeter road. None of the seepage previously observed in this area or or 171/172 was observed at the time of this inspection.

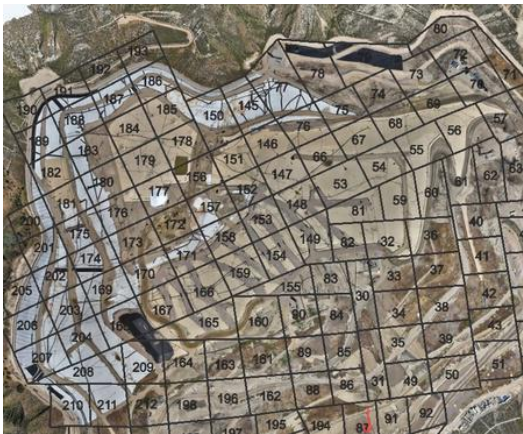
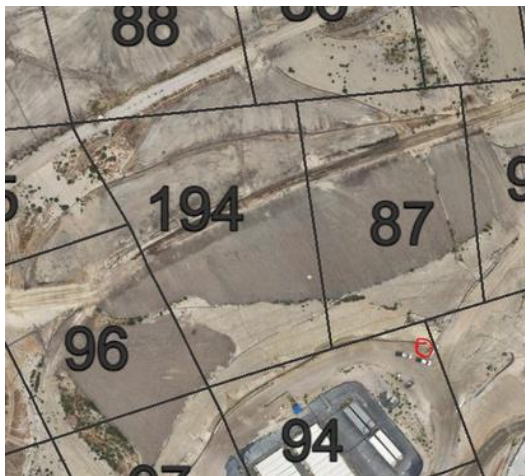
Photo 1

94

Castaic CA 91384  
United States  
(34.43112151863758,  
-118.64522615046)

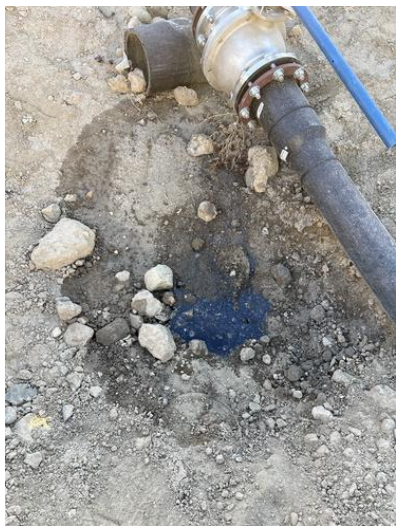
Photo 2

For the week of July 6 through July 12, 2026, leachate seepage was observed on July 7, 2026, at approximately 6:45 a.m., in Grid 94 at the Chiquita Canyon Landfill (the "Landfill"). The specific location of this seep is shown on the maps included in the attachment. Upon discovery of the seep, Chiquita promptly initiated response and mitigation measures, including adding fresh soil to the affected area. This initial response work was completed by approximately 8:00 a.m. on July 7, 2026. Chiquita is also planning to install a seep collector, similar to a leachate toe drain, in the area to prevent future recurrence. The installation is scheduled to begin next week. The seepage was not observed during subsequent inspections conducted that week. The seepage is estimated to have been present for approximately 4 total hours. The total volume of leachate associated with this seepage during that period is estimated to have been up to 5 gallons. The observed area impacted by the seepage was approximately 20 square feet. The saturation of the soil was characterized as "Standing Free Liquid." The odor was characterized as "Moderate."

4 hours

1-5 gallons

20 sq ft

| Odor intensity | 3 - Moderate Odor |

| Surrounding soil saturation level | Standing free liquid |

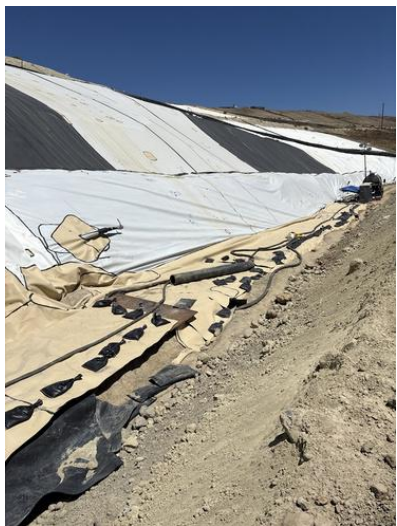
Photo 1

Westside perimeter road. None of the seepage previously observed in this area, Grid 94 or 171/172 was observed at the time of this inspection.

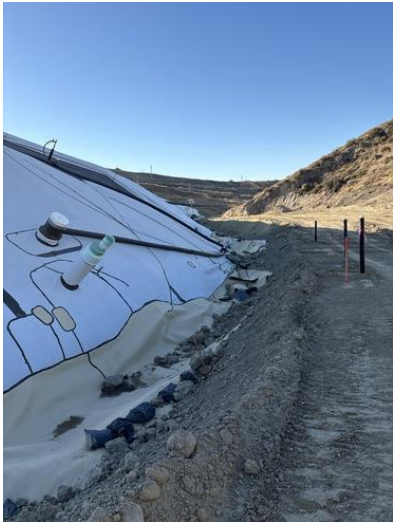
Photo 1

Westside perimeter road. None of the seepage previously observed in this area, Grid 94 or 171/172 was observed at the time of this inspection.

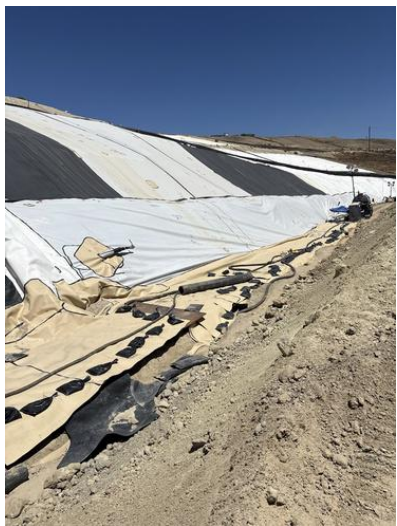
Photo 1

Westside perimeter road. None of the seepage previously observed in this area, Grid 94 or 171/172 was observed at the time of this inspection.

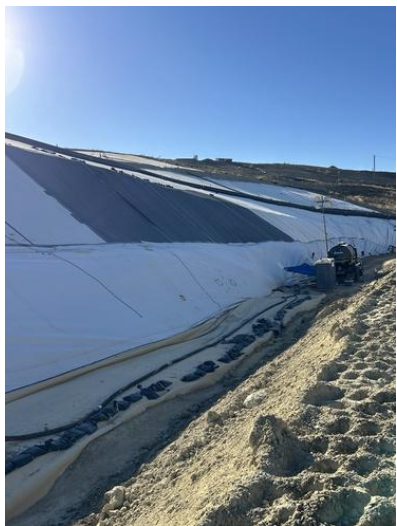
Photo 1

Westside perimeter road. None of the seepage previously observed in this area or in Grids 171/172 was observed at the time of this inspection

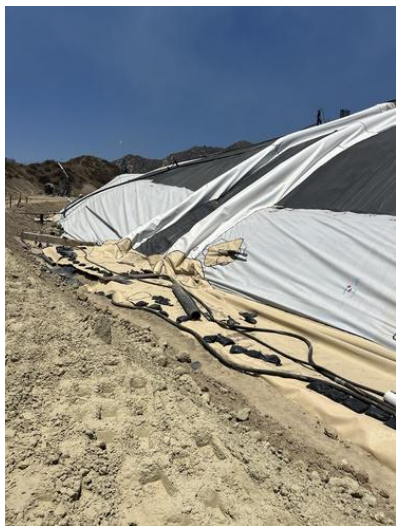
Photo 1

Westside perimeter road. None of the seepage previously observed in this area or in Grids 171/172 was observed at the time of this inspection

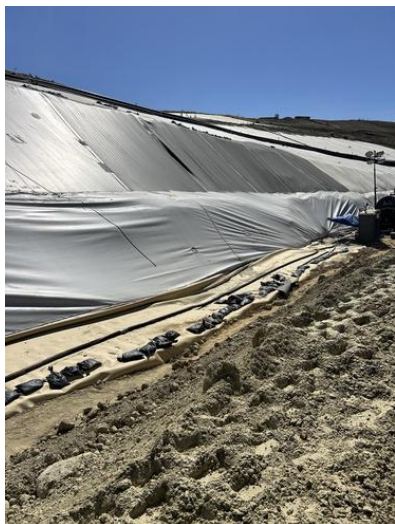
Photo 1

Westside perimeter road. None of the seepage previously observed in this area or in Grids 171/172 was observed at the time of this inspection

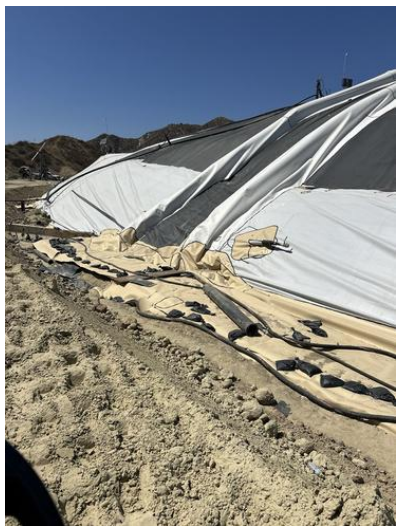
Photo 1

Westside perimeter road. None of the seepage previously observed in this area or in Grids 171/172 was observed at the time of this inspection

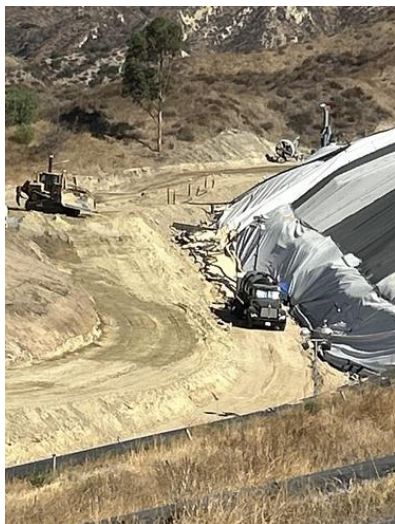
Photo 1

Westside perimeter road. None of the seepage previously observed in this area or in Grids 171/172 was observed at the time of this inspection

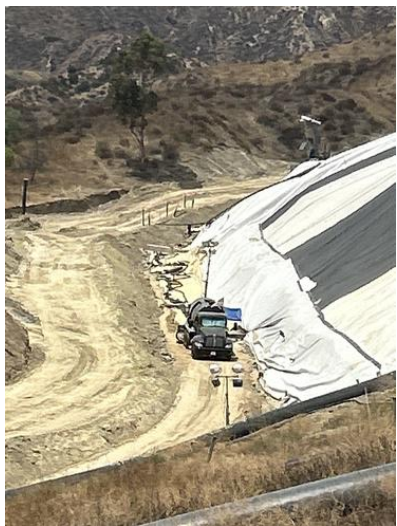
Photo 1

Westside perimeter road. None of the seepage previously observed in this area or in Grids 171/172 was observed at the time of this inspection

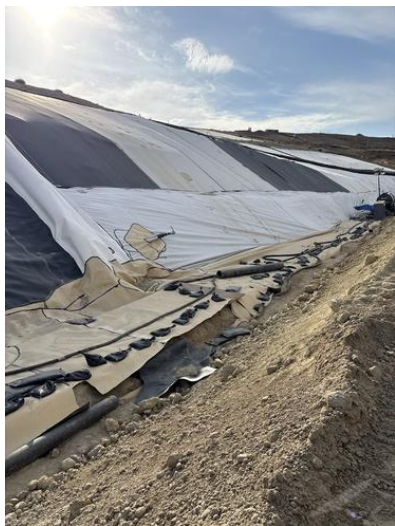
Photo 1

Westside perimeter road. None of the seepage previously observed in this area or in Grids 171/172 was observed at the time of this inspection

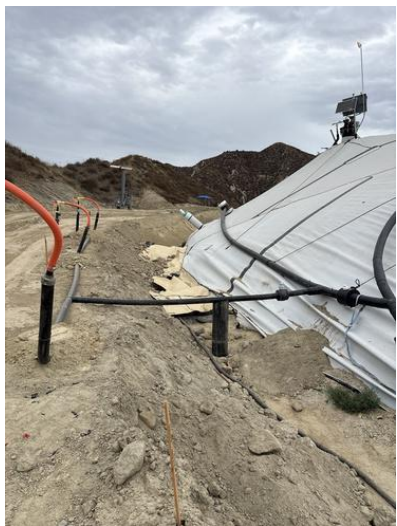
Photo 1

Westside perimeter road. None of the seepage previously observed in this area or in Grids 171/172 was observed at the time of this inspection
