**Re: Chiquita Canyon, LLC's Weekly Report on the Documentation and Tracking of Cover Issues, Monthly Summary, and Monthly Isopach Map**

# 4050 - Chiquita Reaction Area Tracking of Fissures and Tension Cracks

**JUNE 2026 FISSURE AND TENSION CRACK MONITORING SUMMARY**  
**CHIQUITA CANYON LANDFILL**  
**CASTAIC, CALIFORNIA**

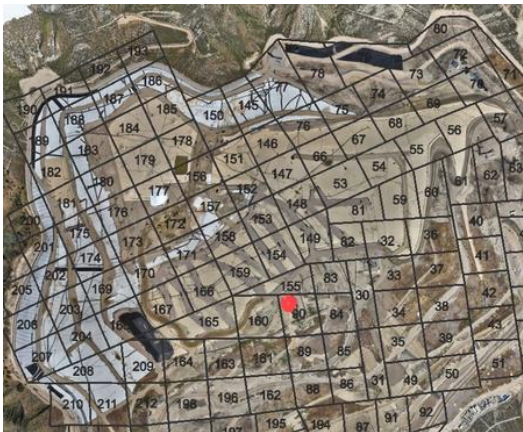
Using the attached image, annotate all areas where inspectors identified a fissure or tension crack.

90

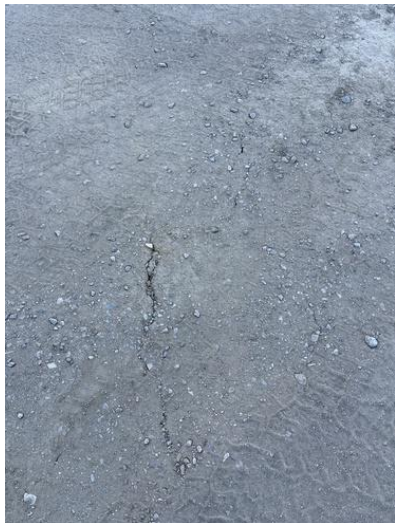
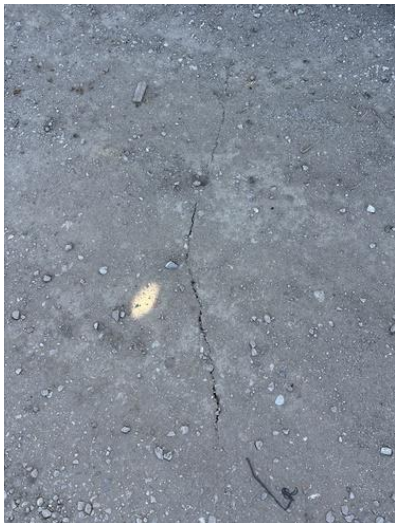
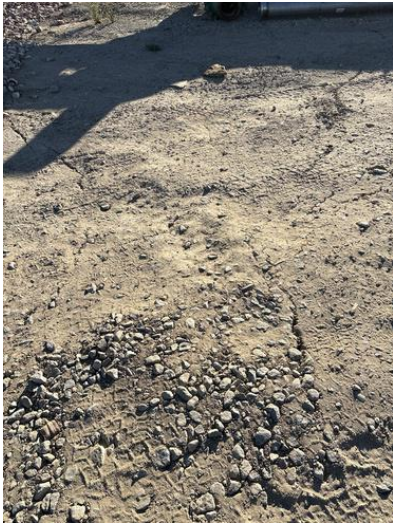
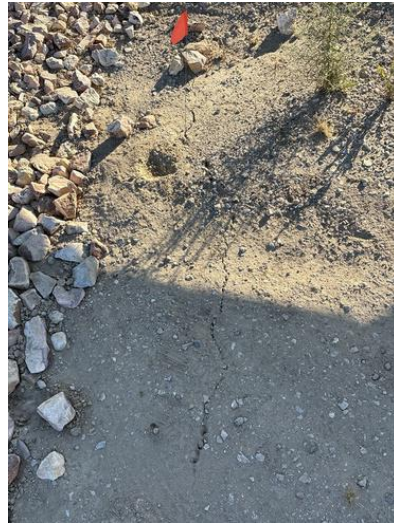
**Length of crack (ft) or area containing multiple cracks (ft x ft)**

35ft x 70ft

No individual crack 50ft or longer.

**Horizontal Offset (width)**

Small 0.5-2" in width

**Vertical Offset (height)**

Extra small <0.5" in height

**Orientation (direction)**

N to S

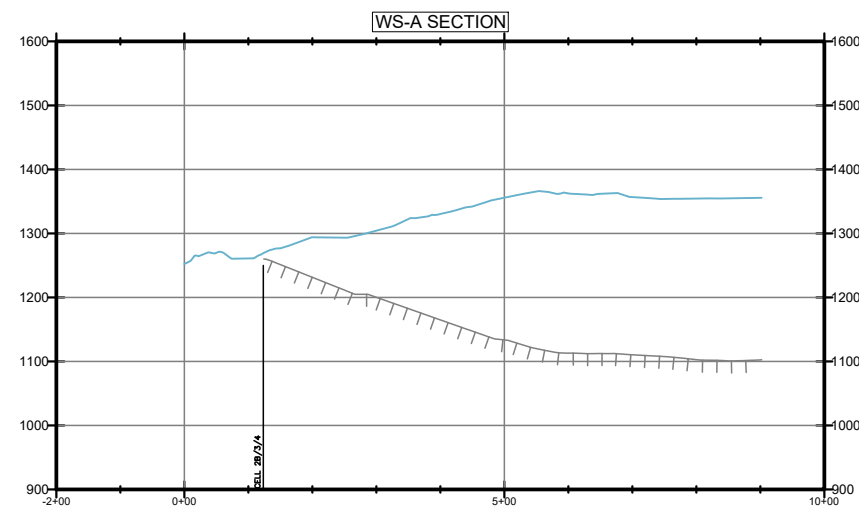
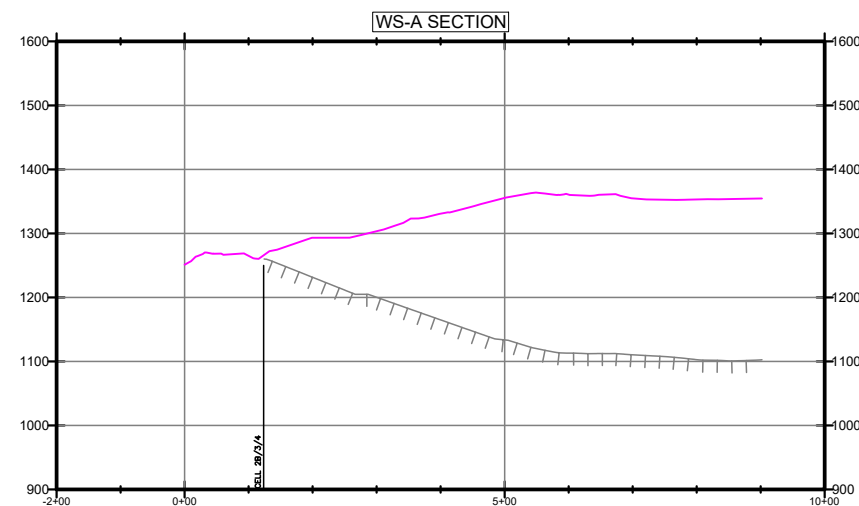
FIGURE 2A

All the cracks identified in Table 1 were repaired. Cross sections that compare May 27, 2026 and June 24, 2026 topography are shown in Figures 2A through 2E. The locations of these cross sections are shown in Figure 1. The sections show no significant difference in slope or evidence of instability between the May 2026 and June 2026 profiles, which is consistent with the observational records summarized in Tables 1 and 2. All the sections show minor changes in ground surface elevation at the toe of the slope; however, these changes do not indicate slope movement or instability. Rather, these changes reflect the placement of soil in June as part of the western slope toe buttress project.
