# 2026 Carbon Media Vessel Evaluation Report, Chiquita Canyon Landfill

Chiquita Canyon Landfill  
29201 Henry Mayo Dr,  
Castaic, CA 91384

**SCS ENGINEERS**

01204123.45 | July 17, 2026

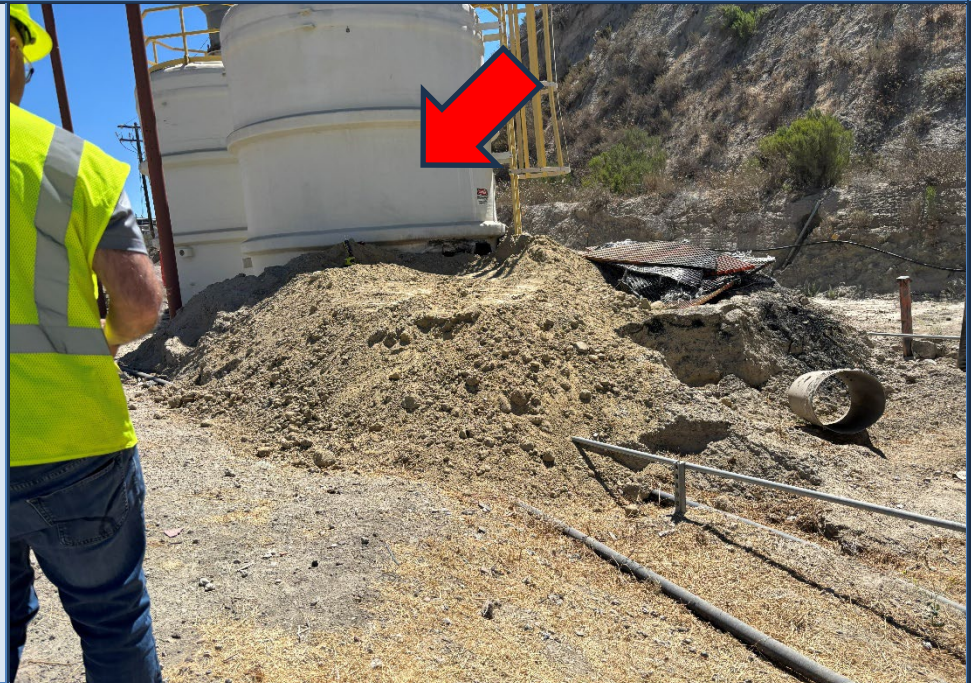
Photograph No.: 001

Carbon Media Vessel  
No.2.

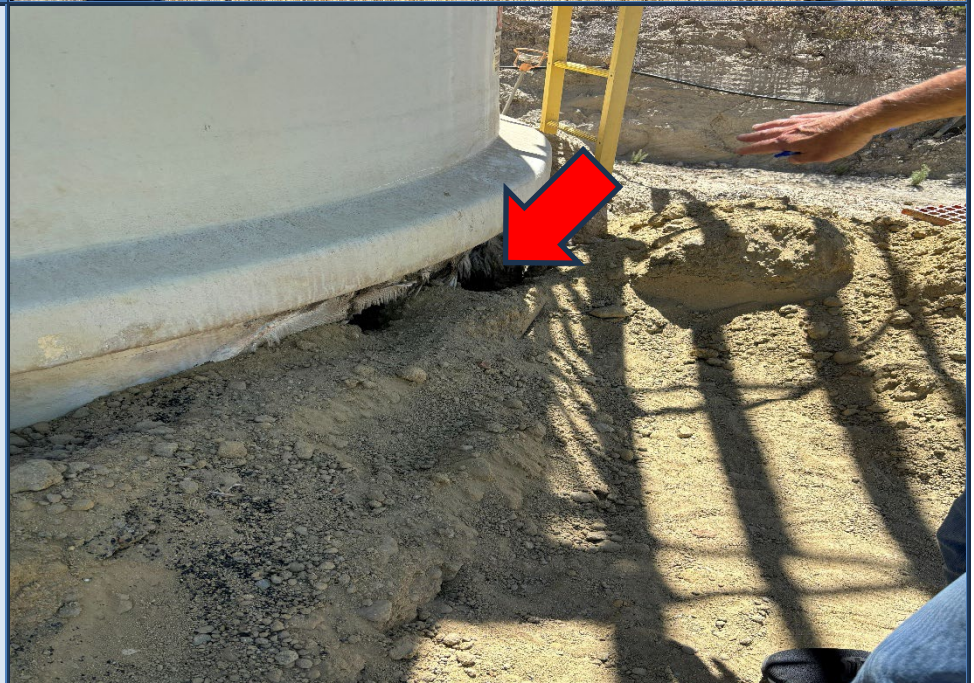
Photograph No.: 002

According to 4XForensic's preliminary observations and findings, the damage observed in the H<sub>2</sub>S Treatment Tank No. 2 appears to be associated with the combined effects of a prior repair condition and elevated operating temperatures. 4XForensic's review of the tank drawings indicated the vessel was designed with glass-fiber reinforcement; however, no glass fiber was identified in the submitted samples from the repaired area. The apparent absence of glass fiber reinforcement is considered a potential contributing factor in reducing the temperature resistance and structural integrity of the affected area.

Carbon Media Vessel –  
Thermal Event Location

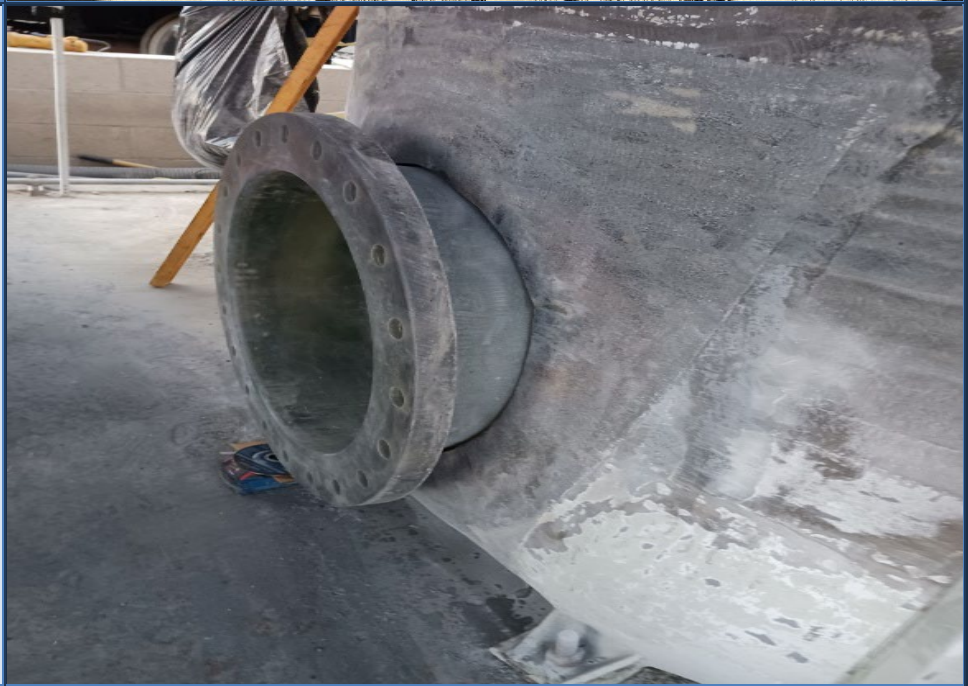
Photograph No.: 008

Carbon Media Vessel –  
July 2024 Repair

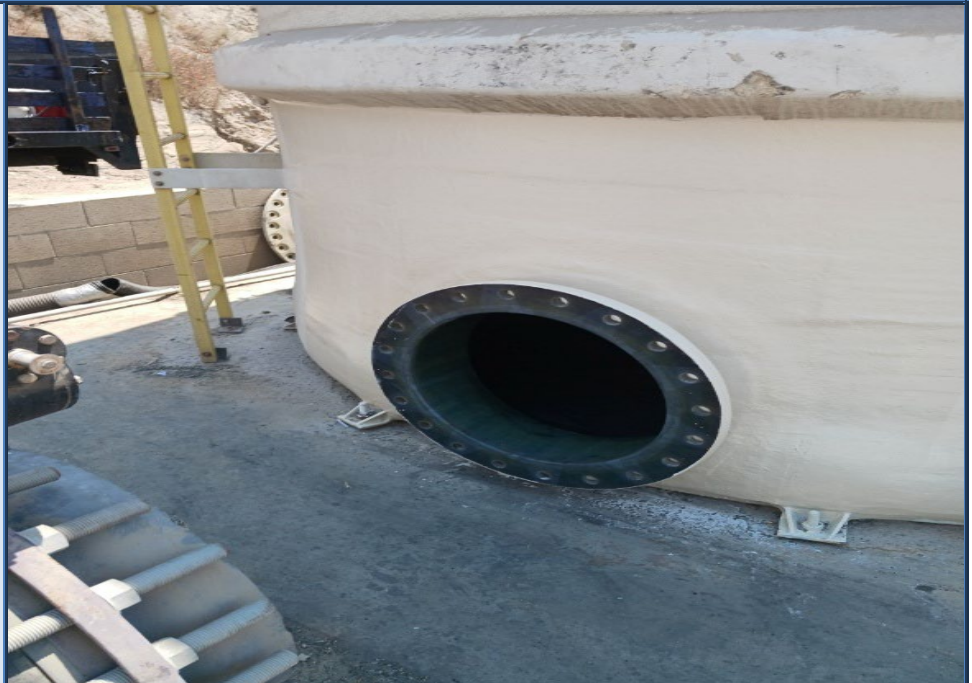
Photograph No.: 015

Carbon Media Vessel –  
July 2024 Repair
