**Re: Chiquita Canyon, LLC's Weekly Report on the Documentation and Tracking of Cover Issues**

# 4050 - Chiquita Reaction Area Tracking of Fissures and Tension Cracks

# 4050 - Geosynthetic Cover Inspection

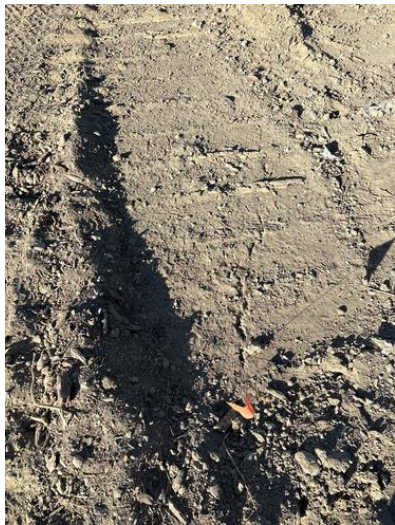
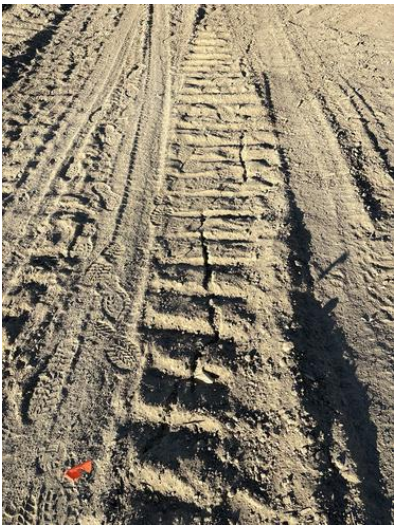
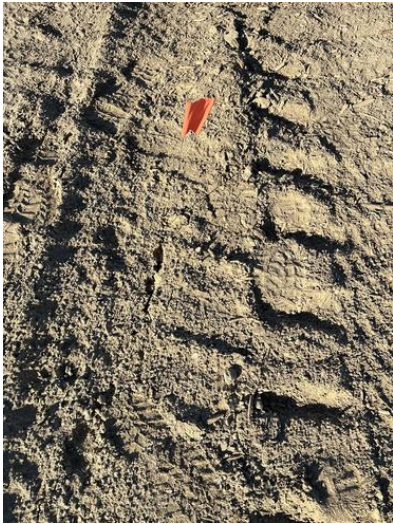
Grid Location

163

**Length of crack (ft) or area containing multiple cracks (ft x ft)**

50ft x 6ft

No individual crack 50ft or longer.

Small 0.5-2" in width

Extra small <0.5" in height

N to S

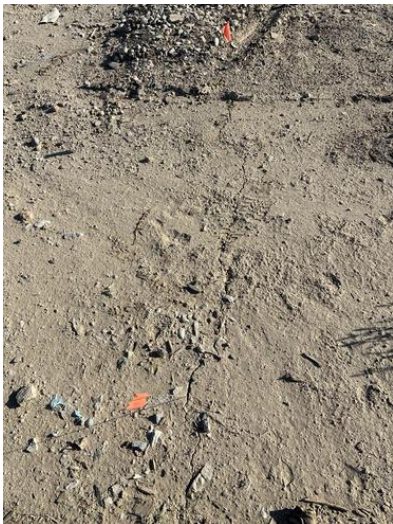
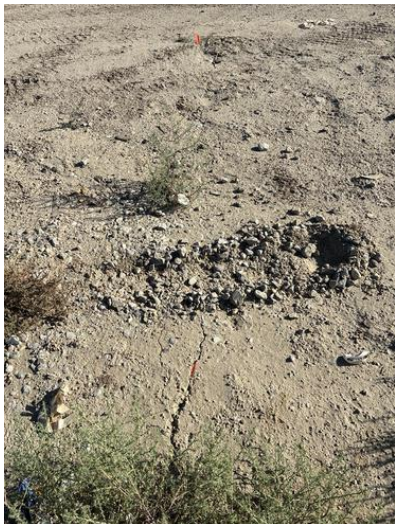
Grid Location

196

25ft x 15ft

Small 0.5-2" in width

| <b>Vertical Offset (height)</b> | Extra small <0.5" in height |
| <b>Orientation (direction)</b> | N to S |

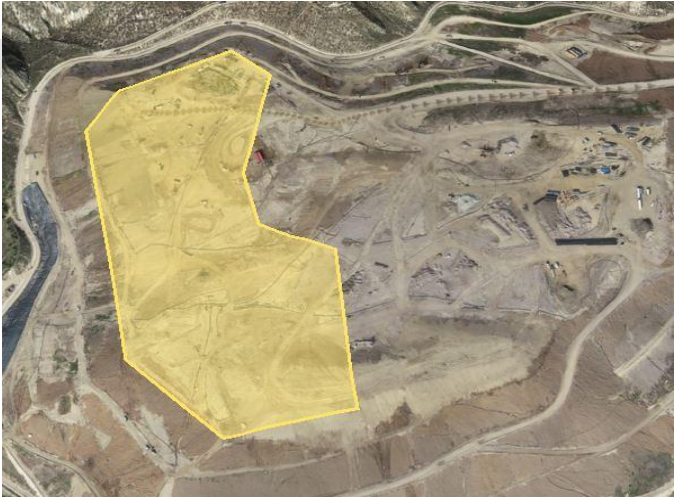
\*Waste fill near reaction area

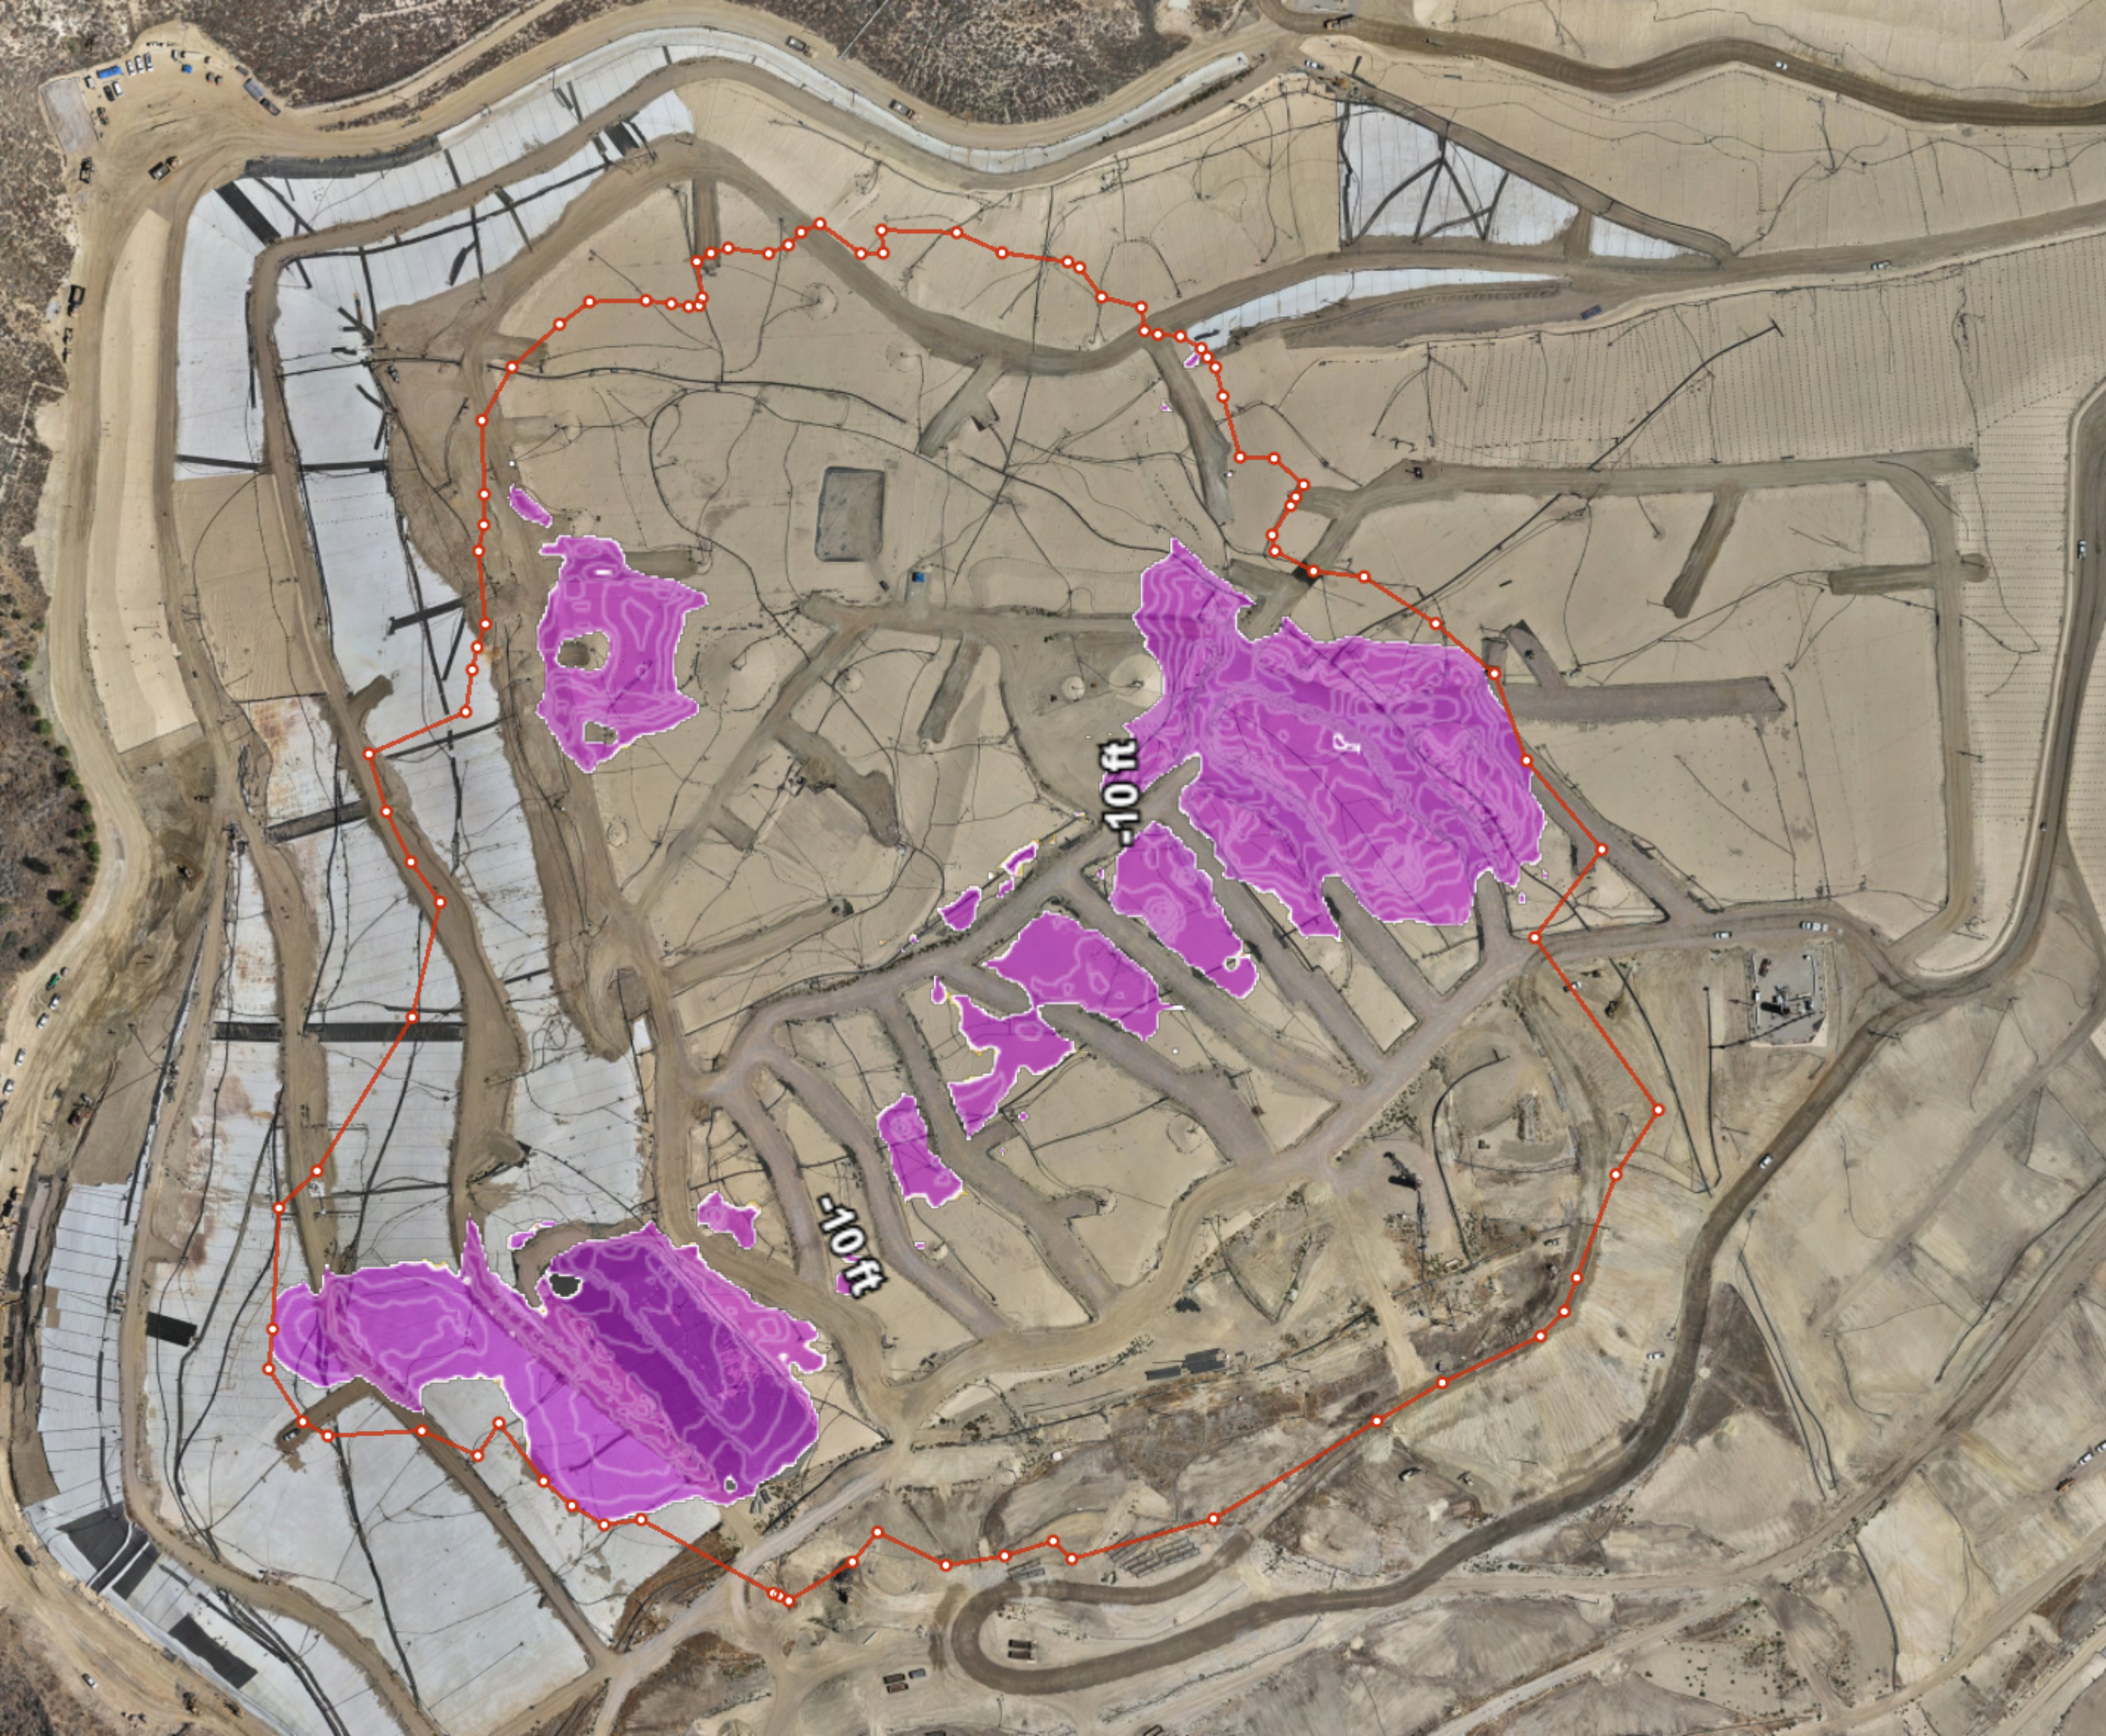
- The map shows the area between 7/16/2025 and 7/15/2026 where the grades have changed more than 10 feet. A typical MSW strain rate is 3% per year - for a landfill with a 300-foot waste column, this would be 9 feet per year.

Settlement area between 7/2/2025 and 7/1/2026, submitted on 7/7/2026 and produced here again for comparison.

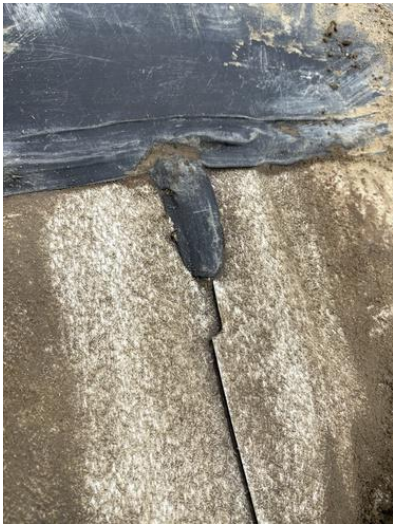
Photo 1

Grid Number

79

Hole in liner needs to be patched/extrusion welded.

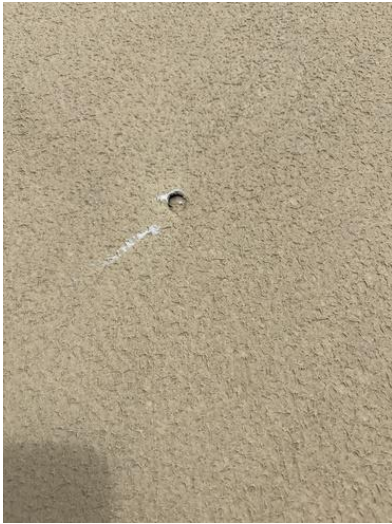
Photo 3

| Grid Number | 149 |

Small hole in liner needs to be patched/extrusion welded.

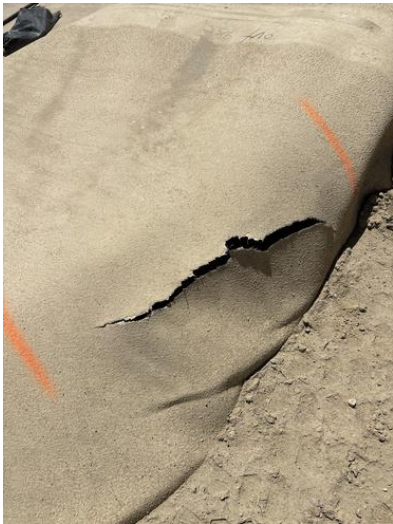
Photo 1

Grid Number

77

Tear in liner needs to be patched/extrusion welded.
