**Re: Chiquita Canyon, LLC's Weekly Leachate Inspection Report for Stipulated Order for Abatement (Case No. 6177-4), Condition 27(c)**

# 4050 - Chiquita Leachate Seep/Pooling Inspection

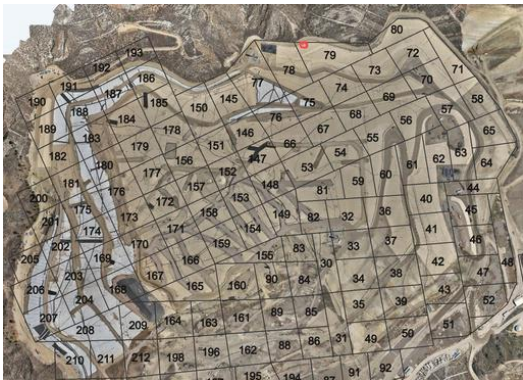
Indicate on the map the location

Which grid is the leachate seep/pooling located? 79

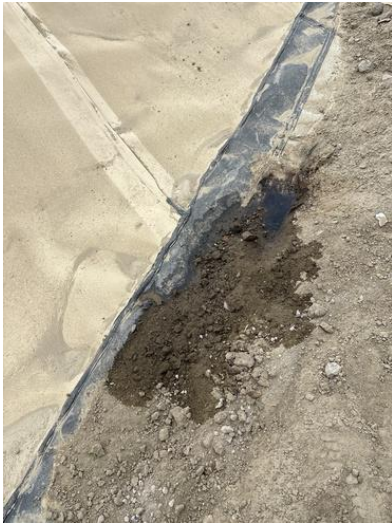
Photo 1

Has a leachate seep/pooling been located? Yes

Time seep/pooling was discovered 13 Jul 2026 9:52 AM PDT

Estimated duration of presence of leachate at such location 4 hours

Estimated quantity of leachate <1 gallons

Extent of area impacted (approximate sq ft impacted) 2 sq ft

Odor intensity 1 - Very Light Odor Detected

Surrounding soil saturation level Standing free liquid

Hole in liner was temporarily taped closed and later patched/extrusion welded to contain seep. Dirt added to cover the leachate was removed and properly disposed of.

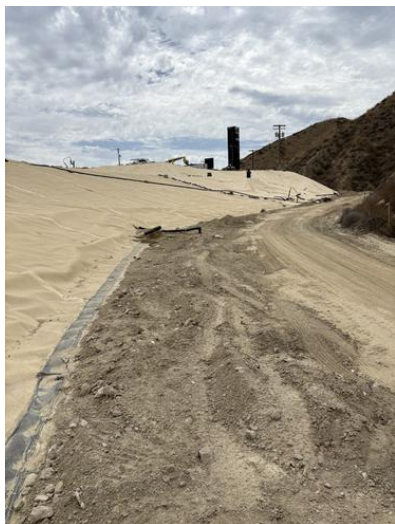
Photo 1

Grid 79. The seep observed in this grid as well as on the Westside and in grids 171/172 were not observed at the time of this inspection.

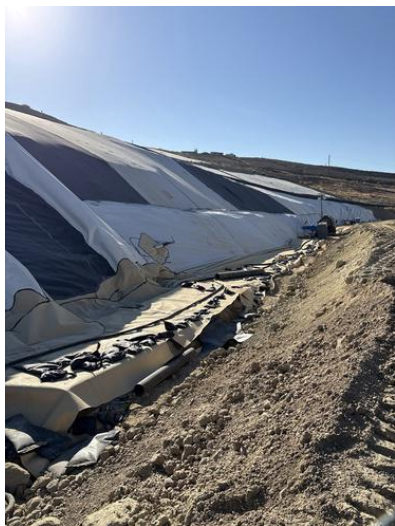
Photo 1

Westside perimeter road. None of the seepage previously observed in this area or 171/172 was observed at the time of this inspection.

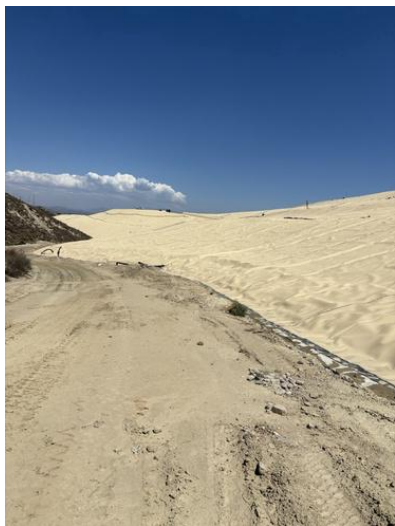
Photo 1

North perimeter road. None of the seepage previously observed in this area or 171/172 was observed at the time of this inspection.

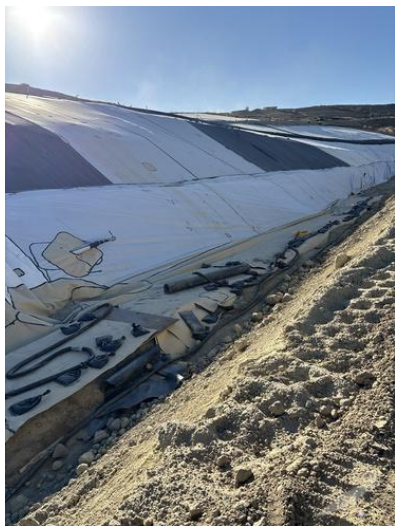
Photo 1

Westside perimeter road. None of the seepage previously observed in this area was observed at the time of this inspection. New sump was drilled and installed in grid 171/172.

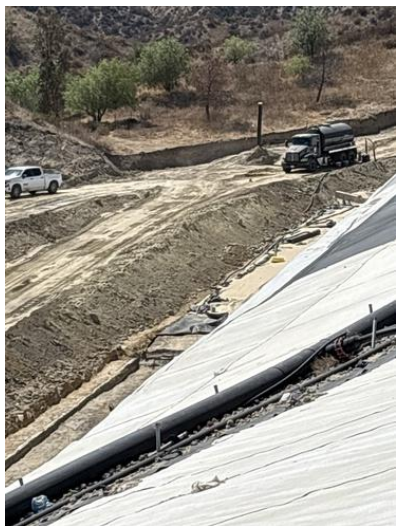
Photo 1

Westside perimeter road. None of the seepage previously observed in this area was observed at the time of this inspection.

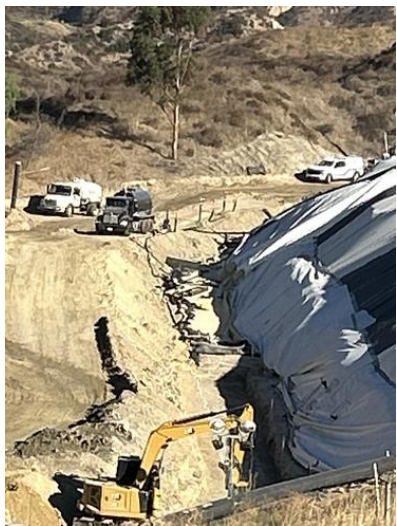
Photo 1

Westside perimeter road. None of the seepage previously observed in this area was observed at the time of this inspection.

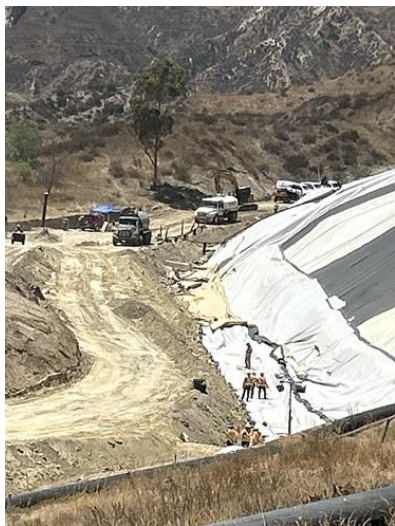
Photo 1

Westside perimeter road. None of the seepage previously observed in this area was observed at the time of this inspection.

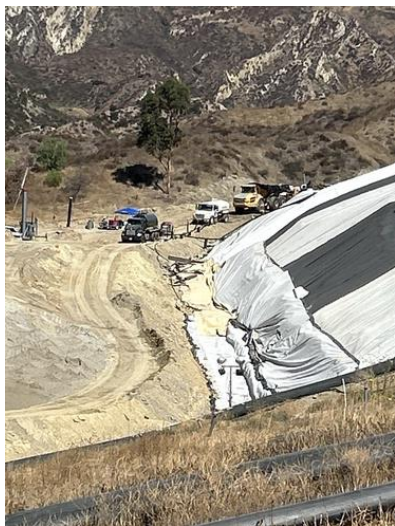
Photo 1

Westside perimeter road. None of the seepage previously observed in this area was observed at the time of this inspection.

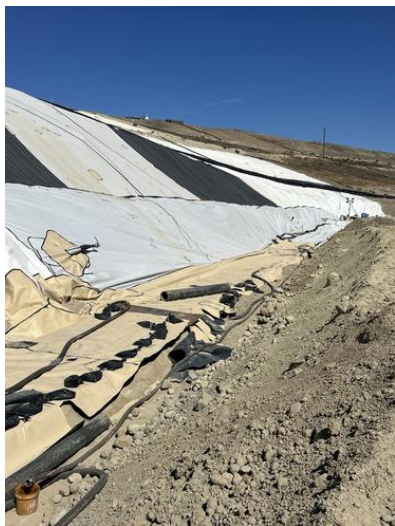
Photo 1

Westside perimeter road. None of the seepage previously observed in this area was observed at the time of this inspection.

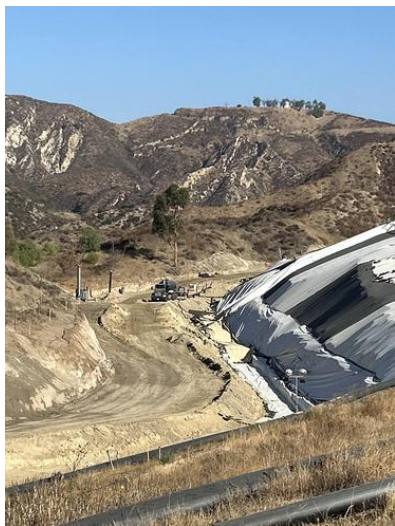
Photo 1

Westside perimeter road. None of the seepage previously observed in this area was observed at the time of this inspection.

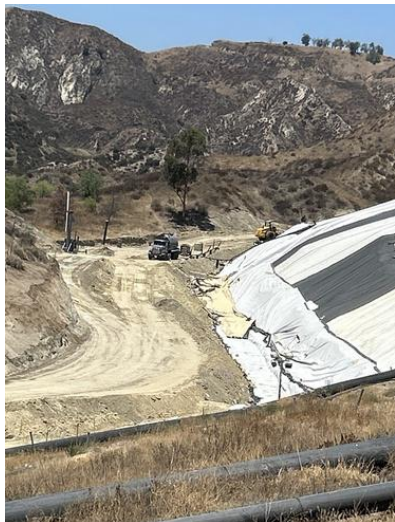
Photo 1

Westside perimeter road. None of the seepage previously observed in this area was observed at the time of this inspection.

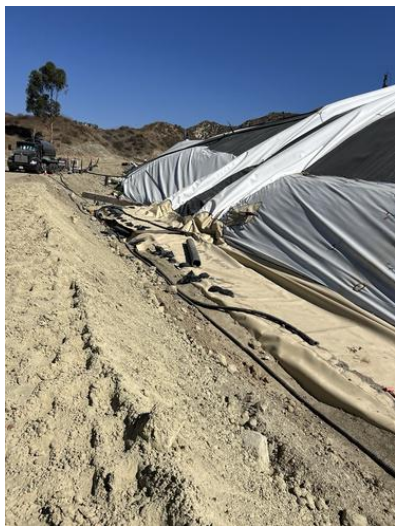
Photo 1

Westside perimeter road. None of the seepage previously observed in this area was observed at the time of this inspection.

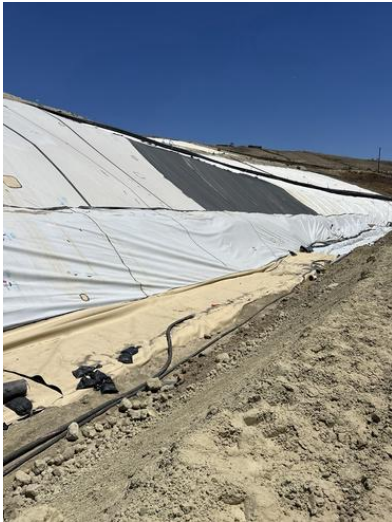
Photo 1

Westside perimeter road. None of the seepage previously observed in this area was observed at the time of this inspection.
