**CHIQUITA CANYON**  
*A Waste Connections Company*

**Re: Chiquita Canyon, LLC's Weekly Report on the Documentation and Tracking of Cover Issues**

# 4050 - Chiquita Reaction Area Tracking of Fissures and Tension Cracks

# 4050 - Geosynthetic Cover Inspection

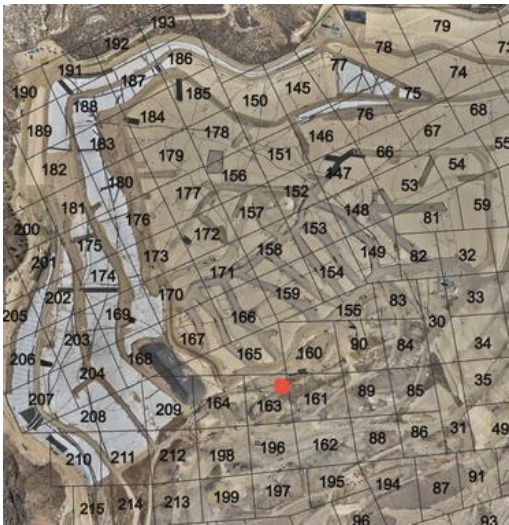
Using the attached image, annotate all areas where inspectors identified a fissure or tension crack.

163

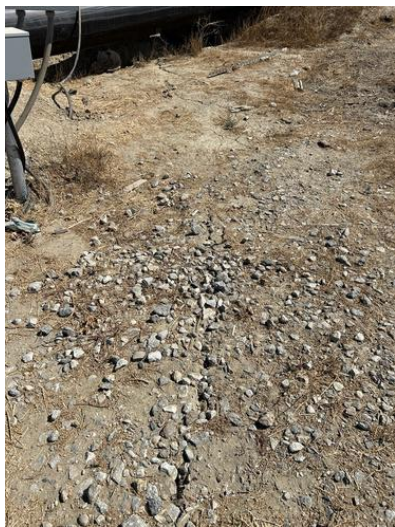
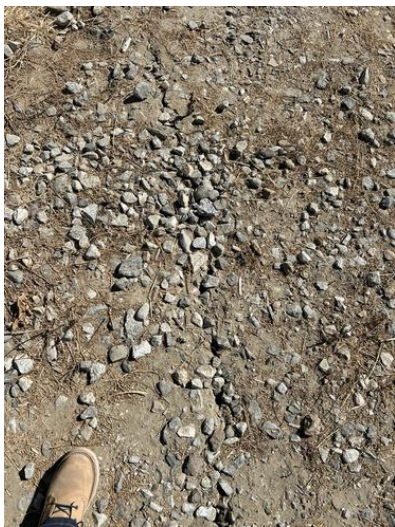
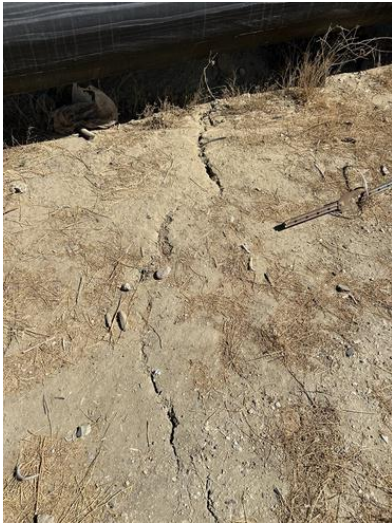
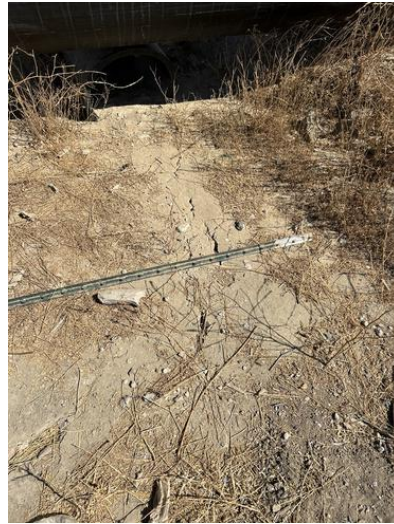
4ft x 20ft area

Small 0.5-2" in width

Extra small <0.5" in height

NE to SW

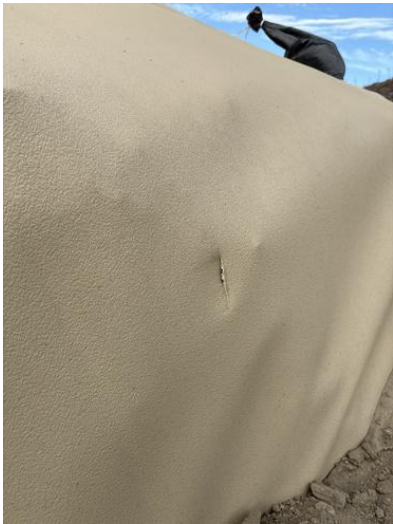
Photo 1

Tear in liner needs to be patched/extrusion welded

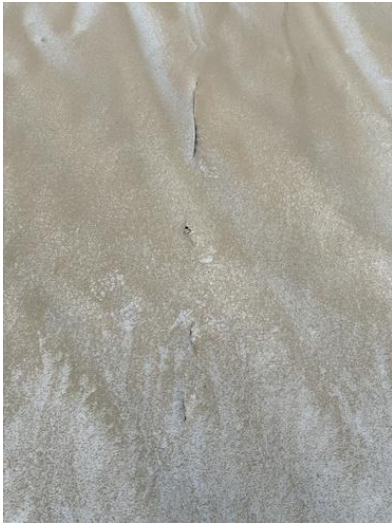
Photo 4

Tear in liner needs to be patched/extrusion welded
