**Re: Chiquita Canyon, LLC's Weekly Leachate Inspection Report for Stipulated Order for Abatement (Case No. 6177-4), Condition 27(c)**

Attachment: Leachate Inspection Logs from July 20 – July 26, 2026

# 4050 - Chiquita Leachate Seep/Pooling Inspection

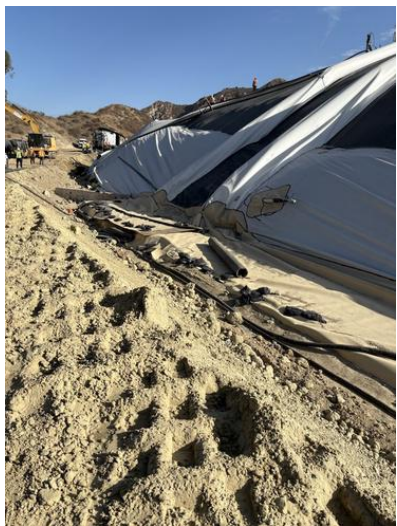
Photo 1

Westside perimeter road. None of the seepage previously observed in this area was observed at the time of this inspection

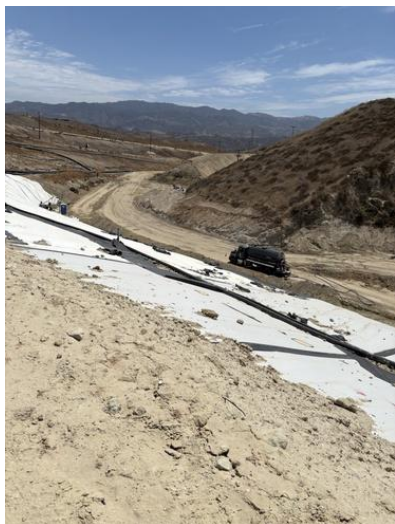
Photo 1

Westside perimeter road. None of the seepage previously observed in this area was observed at the time of this inspection

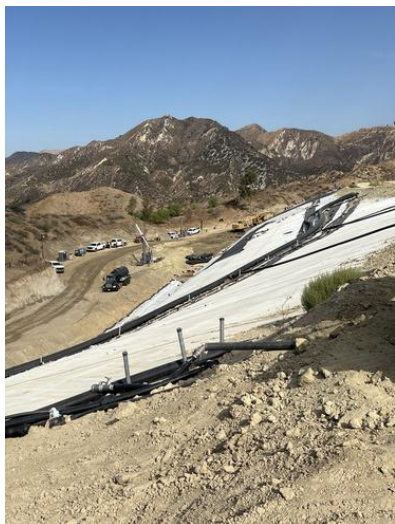
Photo 1

Westside perimeter road. None of the seepage previously observed in this area was observed at the time of this inspection

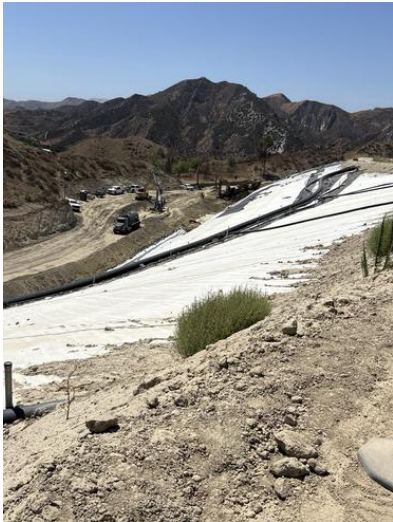
Photo 1

Westside perimeter road. None of the seepage previously observed in this area was observed at the time of this inspection

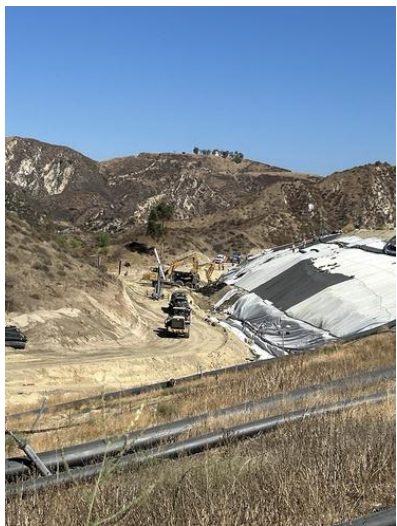
Photo 1

Westside perimeter road. None of the seepage previously observed in this area was observed at the time of this inspection. Permanent repairs are being conducted to contain seepage in this area as well.

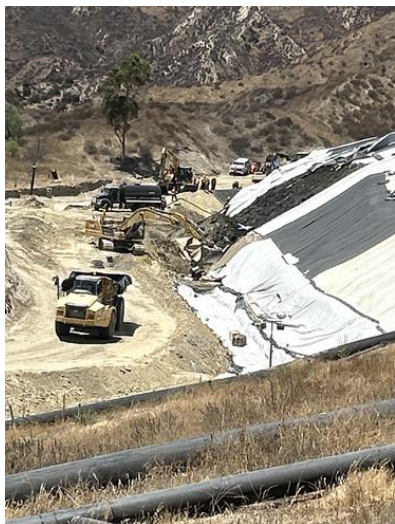
Photo 1

Westside perimeter road. None of the seepage previously observed in this area was observed at the time of this inspection. Permanent repairs are being conducted to contain seepage in this area as well.

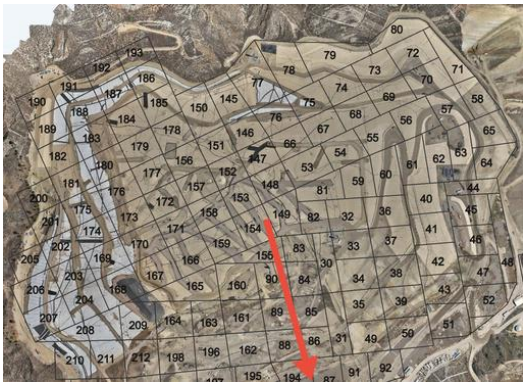
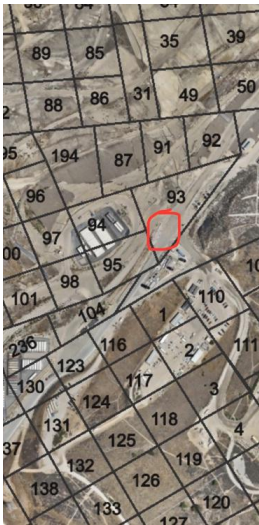
Photo 1

93

Castaic CA 91384  
United States  
(34.4303266466034,  
-118.6449536910166)

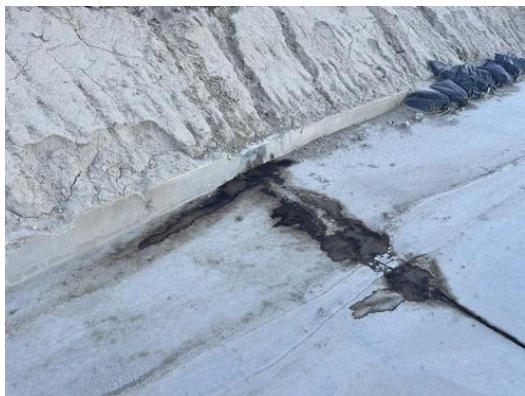
Photo 2

For the week of July 20 through July 26, 2026, leachate seepage was observed on July 23, 2026, at approximately 8:00 a.m., in Grid 93 at the Chiquita Canyon Landfill (the "Landfill"). The specific location of this seep is shown on the maps included in the attachment. The seepage originated from small cracks in the concrete of the stormwater channel. Liquid from the seepage reached the stormwater channel but did not reach either sedimentation basin. Upon discovery of the seep, Chiquita promptly initiated response and mitigation measures, including installing a check dam to contain the liquid and collecting the liquid using a vacuum truck. Chiquita also pressure-washed the stormwater channel and applied sealant to the affected cracks to prevent further seepage. The response work was completed by approximately 11:00 a.m. on July 23, 2026. Chiquita is planning to install a collection sump in the area to prevent future recurrence. The seepage was not observed during subsequent inspections conducted that week. The seepage is estimated to have been present for approximately four hours. The total volume of leachate associated with this seepage during that period is estimated to have been less than one gallon. The

observed area impacted by the seepage was approximately six square feet. The saturation of the soil was characterized as “Dry.” The odor was characterized as “Very Light.”

<1 gallons

6 sq ft

| Odor intensity | 1 - Very Light Odor Detected |
| Surrounding soil saturation level | Dry |

Check dam put in place, channel pressure washed and vacuumed using guzzler truck, cracks sealant applied to cracks in concrete

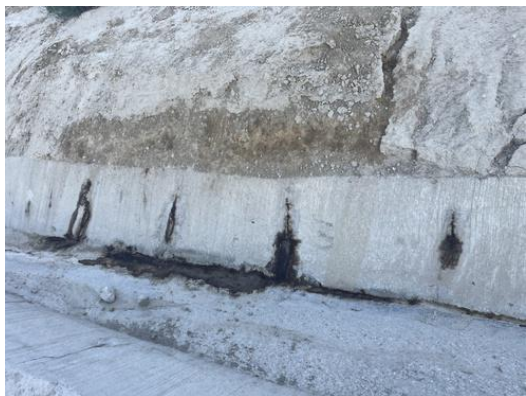
Photo 3

| Did the seep/pooling travel into the stormwater channel? | Yes |

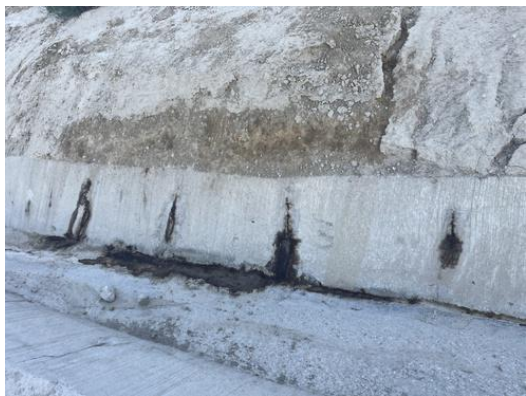
Photo 5

| Did the seep/pooling travel to the stormwater basin? | No |

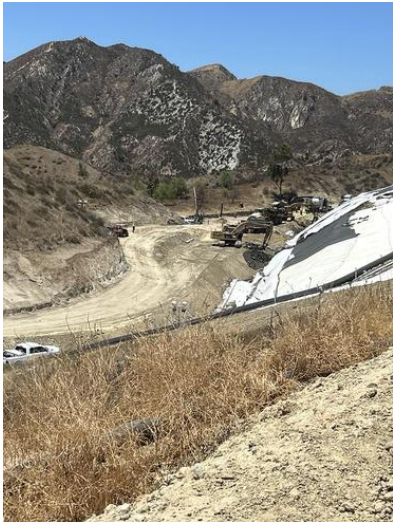
Photo 1

Westside perimeter road. None of the seepage previously observed in this area or the seep found during the AM inspection was observed at the time of this inspection. Permanent repairs are being conducted to contain seepage in this area as well.

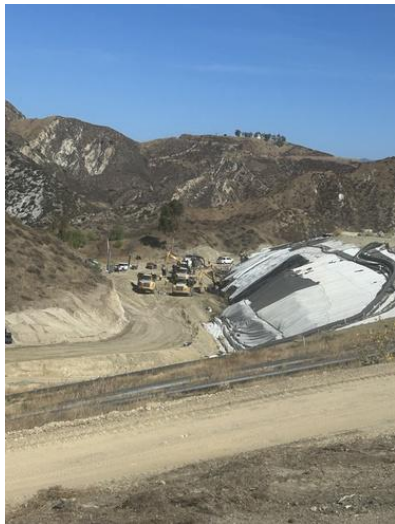
Photo 1

Westside perimeter road. None of the seepage previously observed in this area was observed at the time of this inspection. Permanent repairs are being conducted to contain seepage in this area as well.

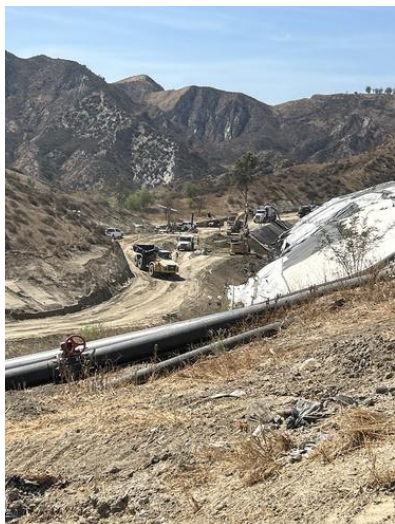
Photo 1

Westside perimeter road. None of the seepage previously observed in this area were observed at the time of this inspection. Permanent repairs are being conducted to contain seepage in this area as well.

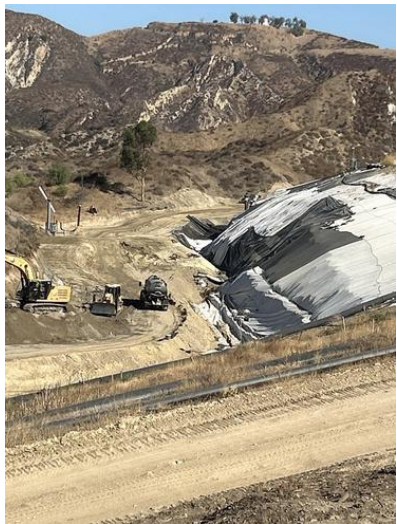
Photo 1

Westside perimeter road. None of the seepage previously observed in this area were observed at the time of this inspection. Permanent repairs are being conducted to contain seepage in this area as well.

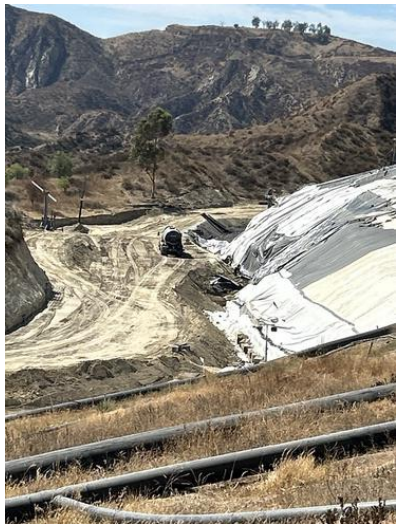
Photo 1

Westside perimeter road. None of the seepage previously observed in this area were observed at the time of this inspection. Permanent repairs are being conducted to contain seepage in this area as well.

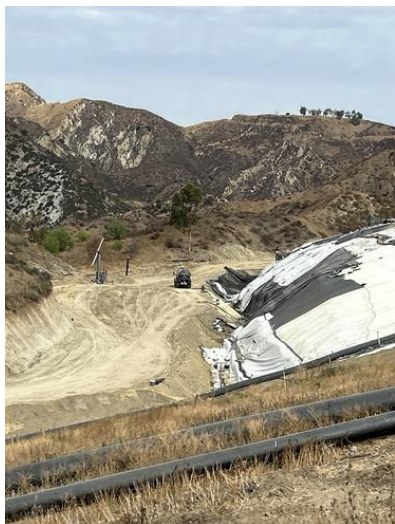
Photo 1

Westside perimeter road. None of the seepage previously observed in this area were observed at the time of this inspection. Permanent repairs are being conducted to contain seepage in this area as well.

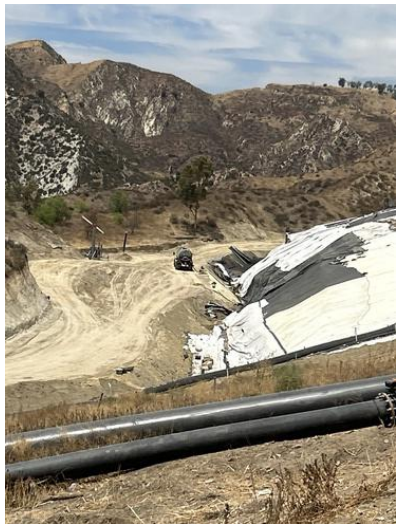
Photo 1

Westside perimeter road. None of the seepage previously observed in this area were observed at the time of this inspection. Permanent repairs are being conducted to contain seepage in this area as well.
