**CHIQUITA CANYON**  
*A Waste Connections Company*

**Re: Chiquita Canyon, LLC's Weekly Report on the Documentation and Tracking of Cover Issues**

Attachment: August 4, 2026 Weekly Cover Issues Report

# 4050 - Chiquita Reaction Area Tracking of Fissures and Tension Cracks

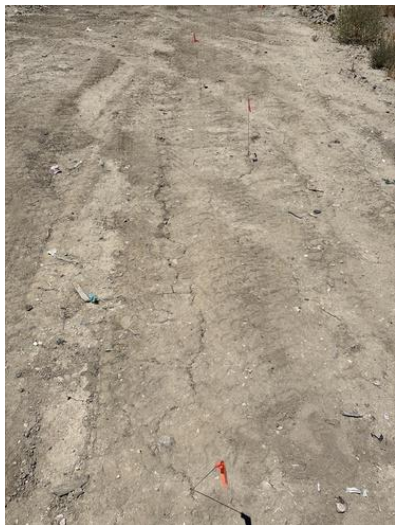
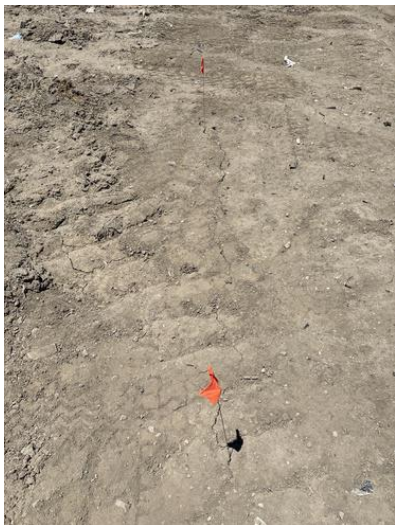
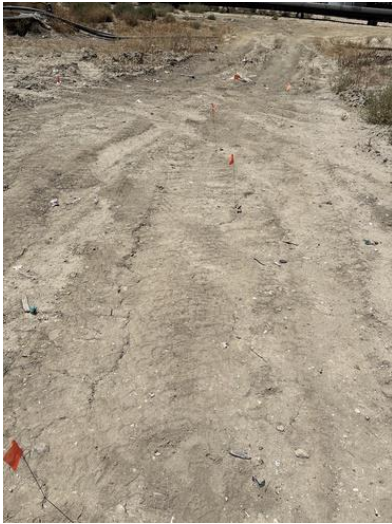
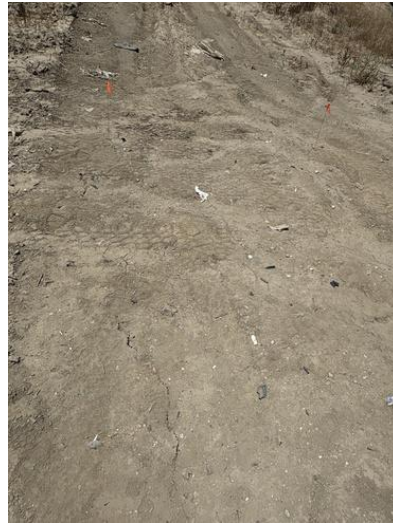
**Length of crack (ft) or area containing multiple cracks (ft x ft)**

20 ft x 10 ft

**Horizontal Offset (width)**

Extra Small <0.5 in width

**Vertical Offset (height)**

Extra small <0.5" in height

**Orientation (direction)**

NE to SW

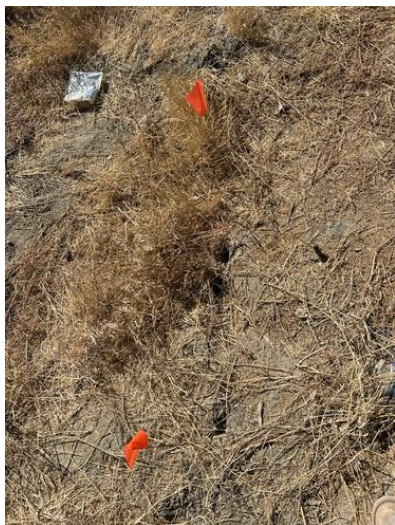
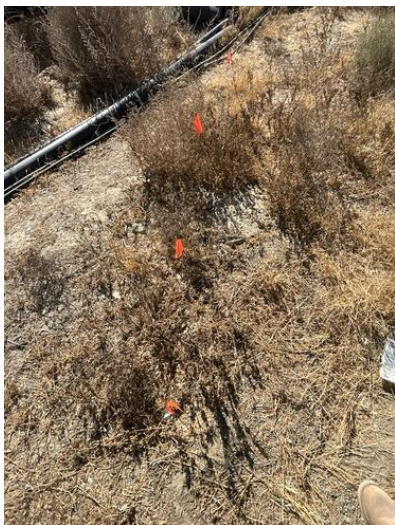
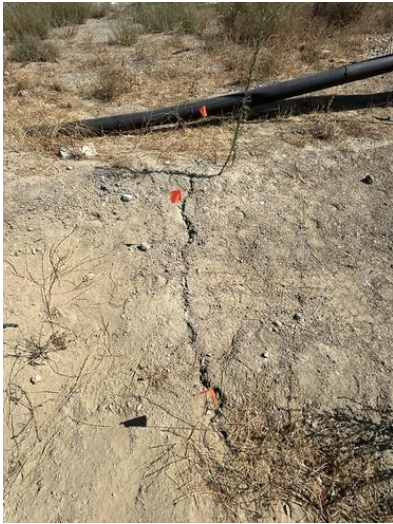
**Length of crack (ft) or area containing multiple cracks (ft x ft)** 13ft x 25 ft area

**Horizontal Offset (width)** Extra Small <0.5 in width

**Vertical Offset (height)** Extra small <0.5" in height

**Orientation (direction)** N to S

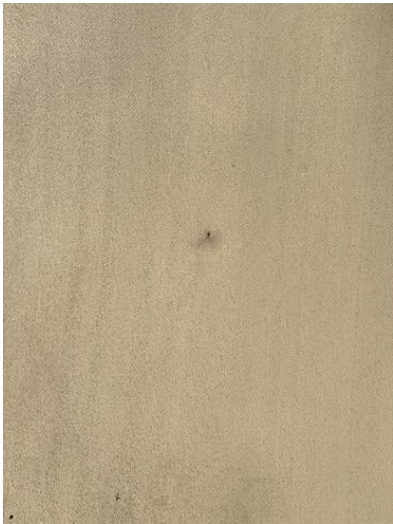
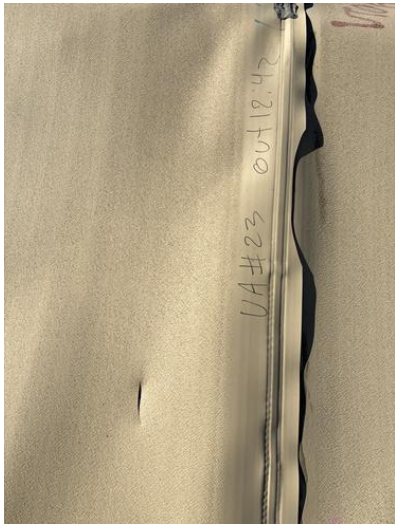
Liner needs to be patched/extrusion welded

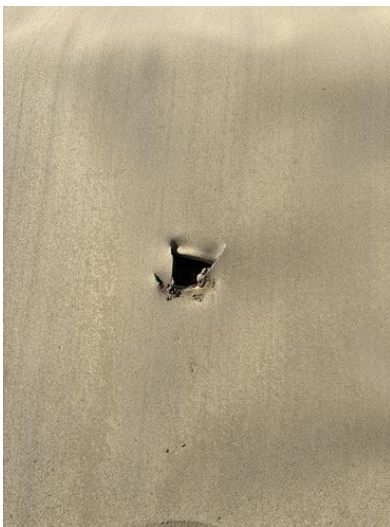
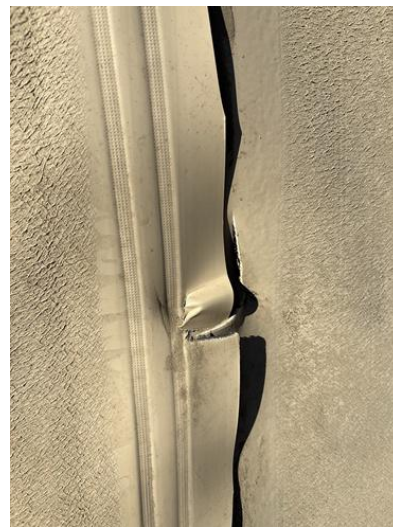
Liner needs to be patched/extrusion welded

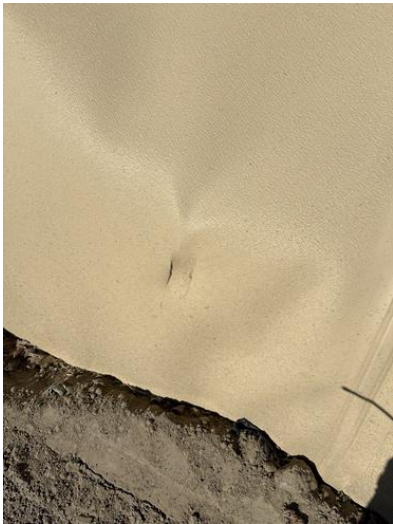
Photo 1

Tear in liner needs to be patched /  
extrusion welded

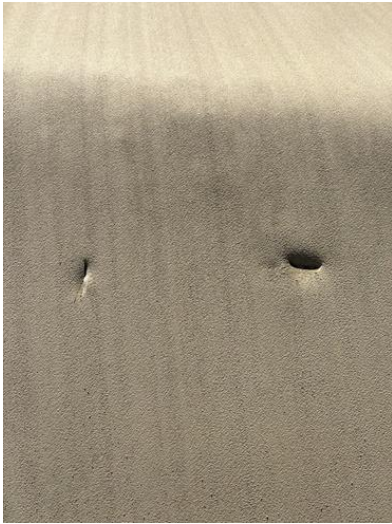
Photo 4

Tear in liner needs to be patched /  
extrusion welded

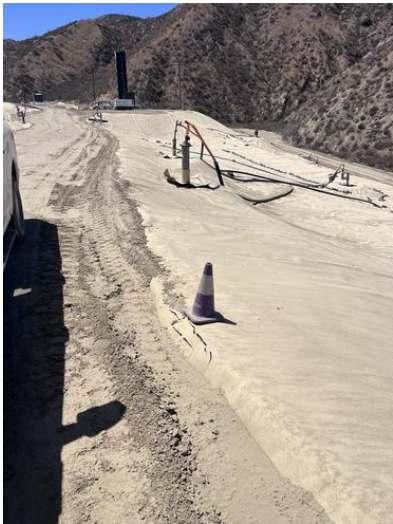
Photo 1

Liner torn. Needs to be patched and extrusion welded
