**Re: Chiquita Canyon, LLC's Weekly Leachate Inspection Report for Stipulated Order for Abatement (Case No. 6177-4), Condition 27(c)**

Attachment: Leachate Inspection Logs from July 27 – August 2, 2026

# 4050 - Chiquita Leachate Seep/Pooling Inspection

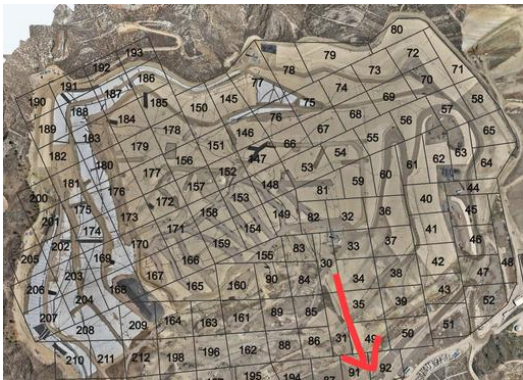
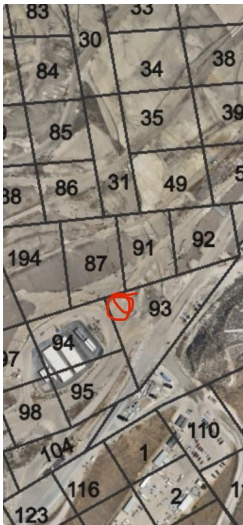
Photo 1

For the week of July 27 through August 2, 2026, leachate seepage was first observed on July 27, 2026, at approximately 8:05 a.m., in Grid 93 at the Chiquita Canyon Landfill (the "Landfill"). The specific location of this seep is shown on the maps included in the attachment. Liquid from the seepage did not reach the stormwater channel or either sedimentation basin. Upon discovery of the seep, Chiquita promptly initiated response and mitigation measures, including adding fresh soil to the affected area. This initial response work was completed by approximately 10:00 a.m. on July 27, 2026. The seepage is estimated to have been present for approximately two hours. The total volume of leachate associated with this seepage during that period is estimated to have been between one and five gallons. The observed area impacted by the seepage was approximately four square feet. The saturation of the soil was characterized as "Standing free liquid." The odor was characterized as "Very Light."

Which grid is the leachate seep/pooling located? 93

Castaic CA 91384  
United States  
(34.42990613925136,  
-118.64538107130188)

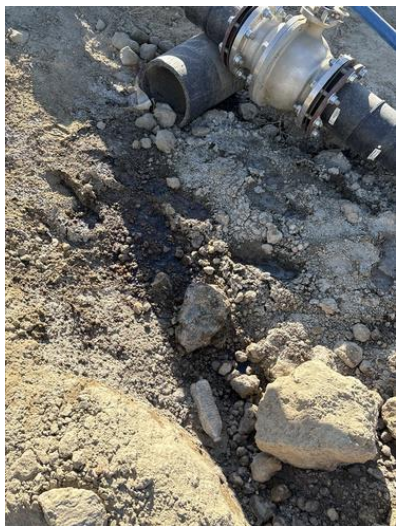
Photo 2

Time seep/pooling was discovered 27 Jul 2026 8:05 AM PDT

Estimated duration of presence of leachate at such location 2 hours

Estimated quantity of leachate 1-5 gallons

Extent of area impacted (approximate sq ft impacted) 4 sqft

| Odor intensity | 1 - Very Light Odor Detected |
| Surrounding soil saturation level | Standing free liquid |

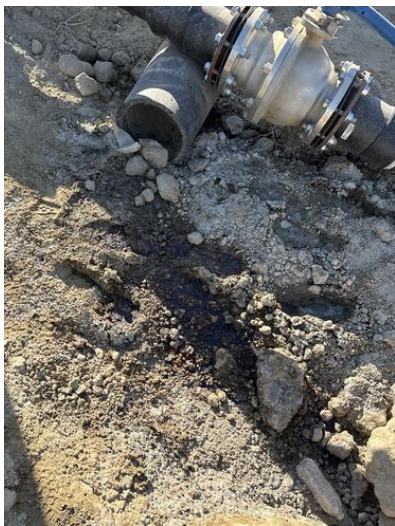
Photo 3

| Did the seep/pooling travel into the stormwater channel? | No |

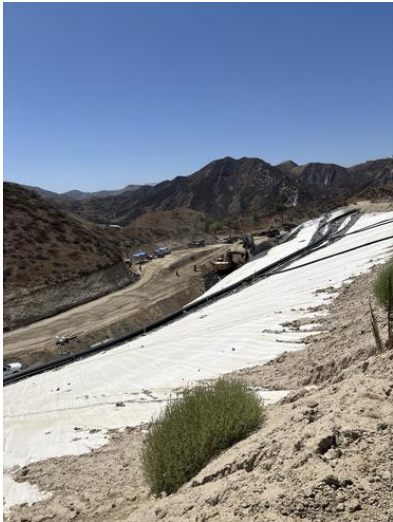
Photo 1

West side perimeter road. None of the seep found during the AM inspection was observed at the time of this inspection. Permanent repairs are being conducted to contain seepage in this area as well

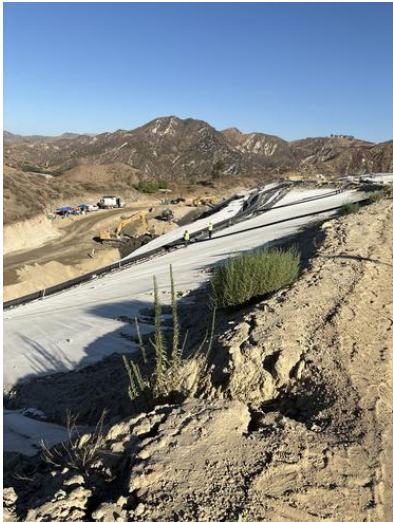
Photo 1

Westside perimeter road. None of the seepage previously observed in this area was observed at the time of this inspection. Permanent repairs are being conducted to contain seepage in this area as well

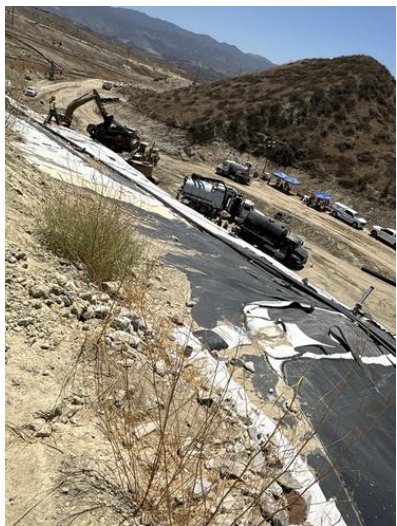
Photo 1

Westside perimeter road. None of the seepage previously observed in this area was observed at the time of this inspection. Permanent repairs are being conducted to contain seepage in this area as well

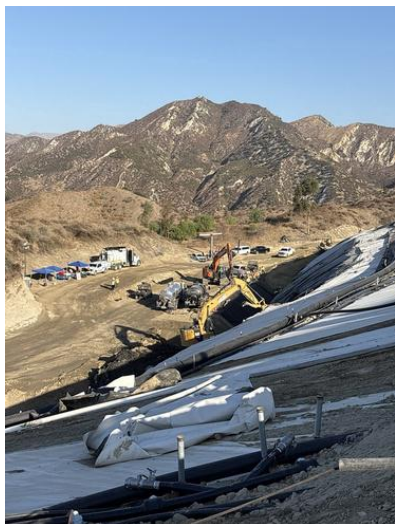
Photo 1

Westside perimeter road. None of the seepage previously observed in this area was observed at the time of this inspection. Permanent repairs are being conducted to contain seepage in this area as well

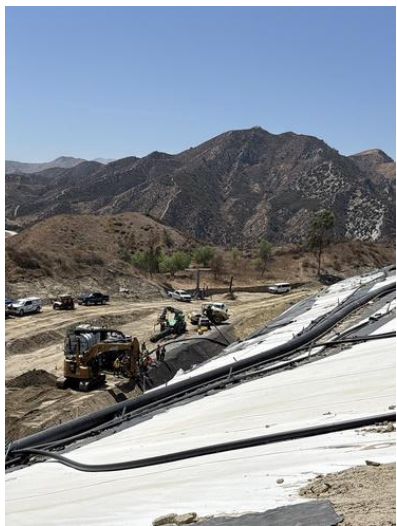
Photo 1

Westside perimeter road. None of the seepage previously observed in this area was observed at the time of this inspection. Permanent repairs are being conducted to contain seepage in this area as well

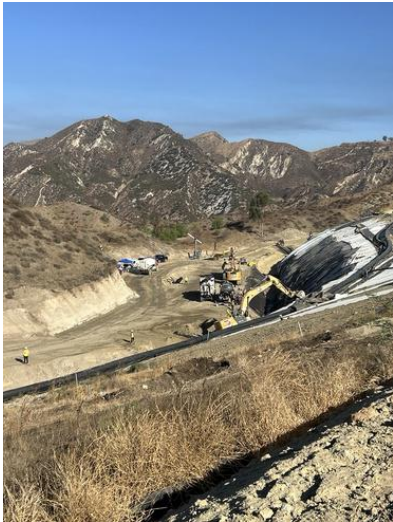
Photo 1

Westside perimeter road. None of the seepage previously observed in this area were observed at the time of this inspection. Permanent repairs are being conducted to contain seepage in this area as well.

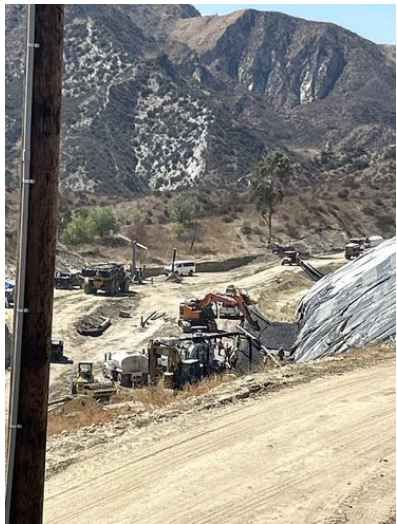
Photo 1

Westside perimeter road. None of the seepage previously observed in this area were observed at the time of this inspection. Permanent repairs are being conducted to contain seepage in this area as well.

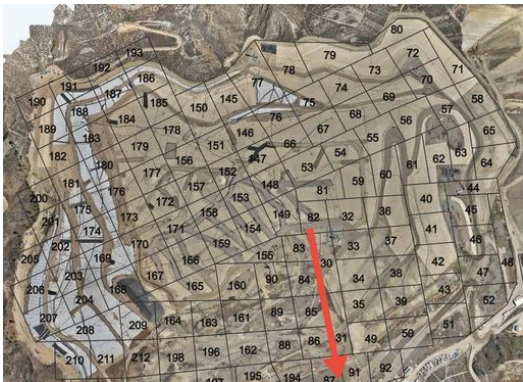
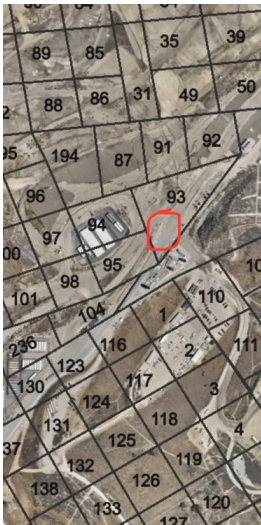
Photo 1

On July 31, 2026, at approximately 6:31 a.m., additional leachate seepage was observed in Grid 93. The specific location of this seep is shown on the maps included in the attachment. The seepage originated from an area immediately above the concrete-lined stormwater channel. Liquid from the seepage reached the stormwater channel but did not reach either sedimentation basin. Upon discovery of the seep, Chiquita promptly initiated response and mitigation measures, including installing a check dam to contain the liquid, removing impacted soil and placing it in a container for appropriate disposal. Chiquita then pressure-washed the stormwater channel and added fresh soil to the affected area. The response work was completed by approximately 8:30 a.m. on July 31, 2026. This seepage is related to the seepage that occurred in Grid 93 on July 23, 2026. Chiquita is planning to install a collection sump in the area to minimize the potential for future recurrence. The seepage was not observed during subsequent inspections conducted that week. The seepage is estimated to have been present for approximately five hours. The total volume of leachate associated with this seepage during that period is estimated to have been less than one gallon. The observed area impacted by the seepage was approximately four square feet. The saturation of the soil was characterized as "Semi-dry." The odor was characterized as "Very Light."

93

Castaic CA 91384  
United States  
(34.4306127145913,  
-118.644985681023)

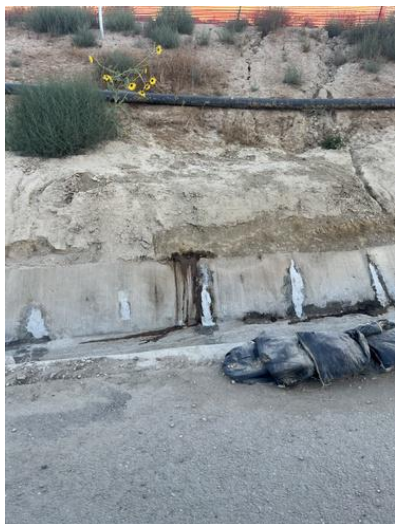
Photo 2

31 Jul 2026 6:31 AM PDT

5 hours

<1 gallons

4 sq ft

| Odor intensity | 1 - Very Light Odor Detected |
| Surrounding soil saturation level | Semi-dry |

| Did the seep/pooling travel into the stormwater channel? | Yes |

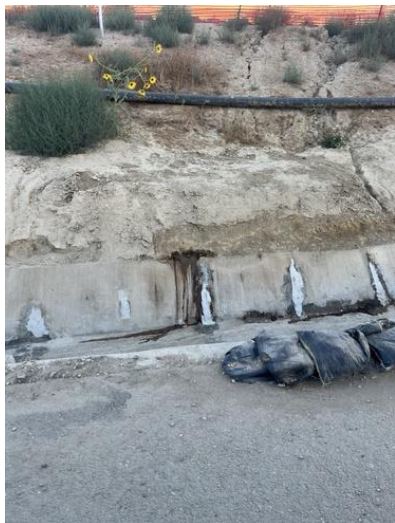
Photo 3

| Did the seep/pooling travel to the stormwater basin? | No |

Fresh soiled added and compacted, check dam in place, channel pressure washed under vacuum.

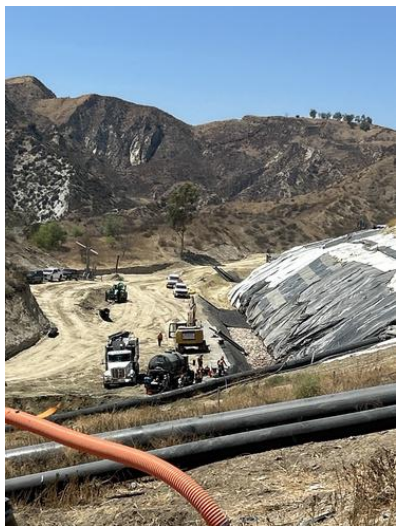
Photo 1

Westside perimeter road. None of the seepage previously observed in this area or the seep in grid 93 from the AM inspection were observed at the time of this inspection. Permanent repairs are being conducted to contain seepage in this area as well.

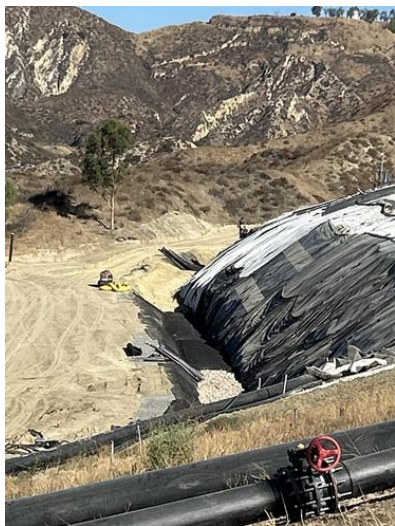
Photo 1

Westside perimeter road. None of the seepage previously observed in this area were observed at the time of this inspection. Permanent repairs are being conducted to contain seepage in this area as well.

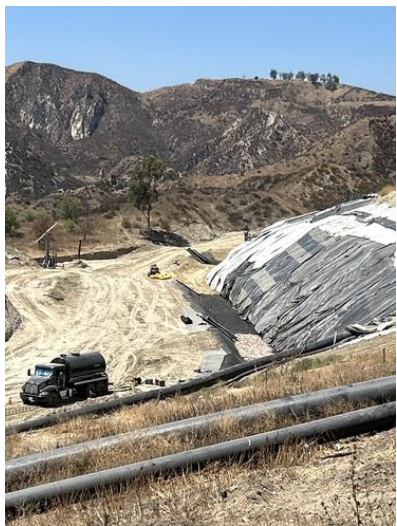
Photo 1

Westside perimeter road. None of the seepage previously observed in this area were observed at the time of this inspection. Permanent repairs are being conducted to contain seepage in this area as well.

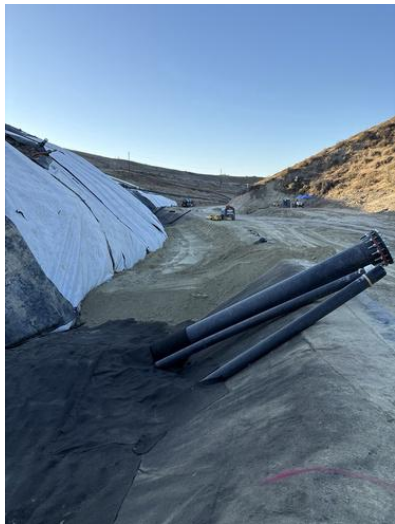
Photo 1

Westside perimeter road. None of the seepage previously observed in this area were observed at the time of this inspection. Permanent repairs are being conducted to contain seepage in this area as well.

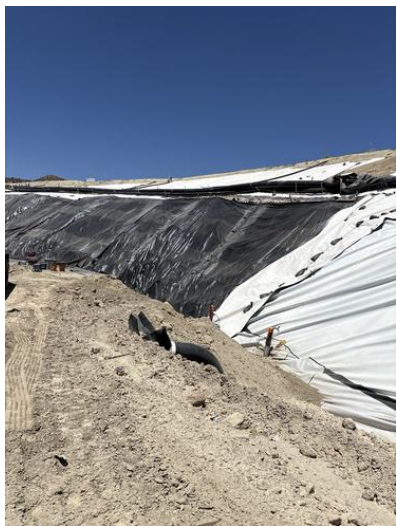
Photo 1

Westside perimeter road. None of the seepage previously observed in this area were observed at the time of this inspection. Permanent repairs are being conducted to contain seepage in this area as well.
