**Re: Chiquita Canyon, LLC's Weekly Leachate Inspection Report for Stipulated Order for Abatement (Case No. 6177-4), Condition 27(c)**

Attachment: Leachate Inspection Logs from August 3 – August 9, 2026

# 4050 - Chiquita Leachate Seep/Pooling Inspection

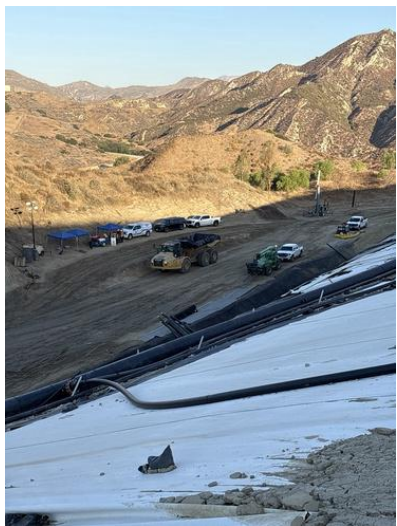
Photo 1

No

Westside perimeter road. None of the seepage previously observed in this area were observed at the time of this inspection. Permanent repairs are being conducted to contain seepage in this area as well.

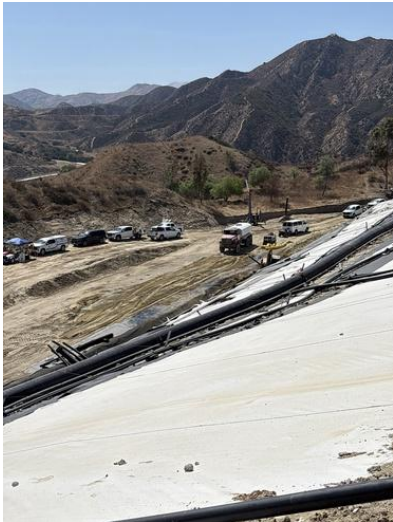
Photo 1

No

Westside perimeter road. None of the seepage previously observed in this area were observed at the time of this inspection. Permanent repairs are being conducted to contain seepage in this area as well.

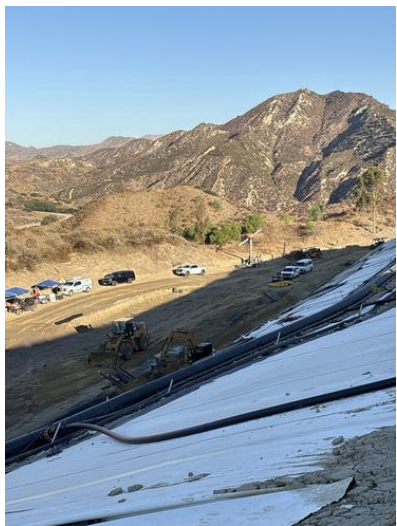
Photo 1

No

Westside perimeter road. None of the seepage previously observed in this area were observed at the time of this inspection. Permanent repairs are being conducted to contain seepage in this area as well.

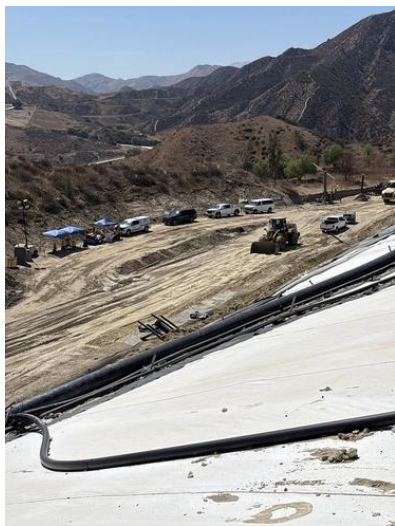
Photo 1

No

Westside perimeter road. None of the seepage previously observed in this area were observed at the time of this inspection. Permanent repairs are being conducted to contain seepage in this area as well.

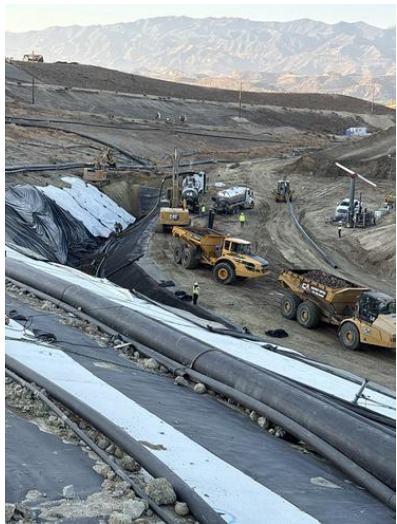
Photo 1

No

Westside perimeter road. None of the seepage previously observed in this area were observed at the time of this inspection. Permanent repairs are being conducted to contain seepage in this area as well.

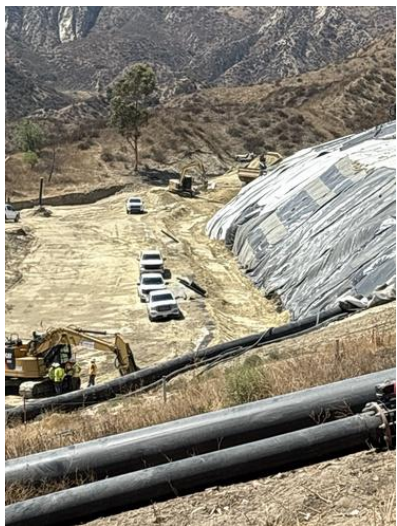
Photo 1

No

Westside perimeter road. None of the seepage previously observed in this area were observed at the time of this inspection. Permanent repairs are being conducted to contain seepage in this area as well.

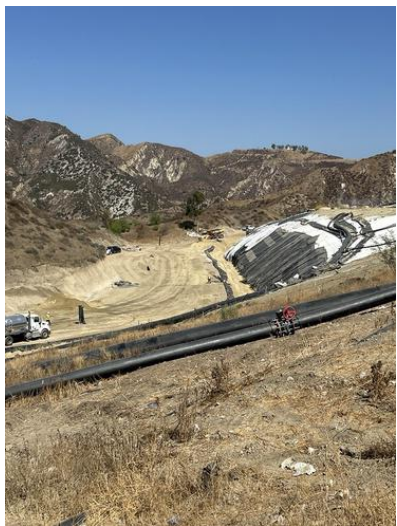
Photo 1

No

Westside perimeter road. None of the seepage previously observed in this area were observed at the time of this inspection. Permanent repairs are being conducted to contain seepage in this area as well.

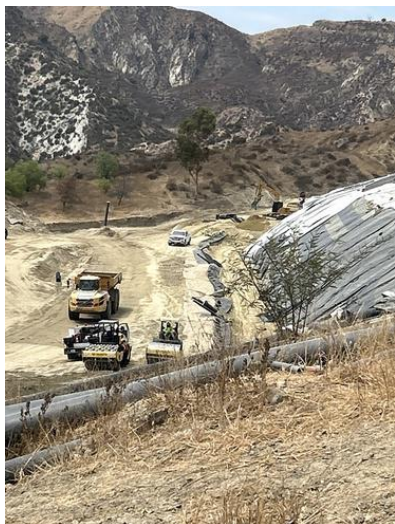
Photo 1

No

Westside perimeter road. None of the seepage previously observed in this area were observed at the time of this inspection. Permanent repairs are being conducted to contain seepage in this area as well.

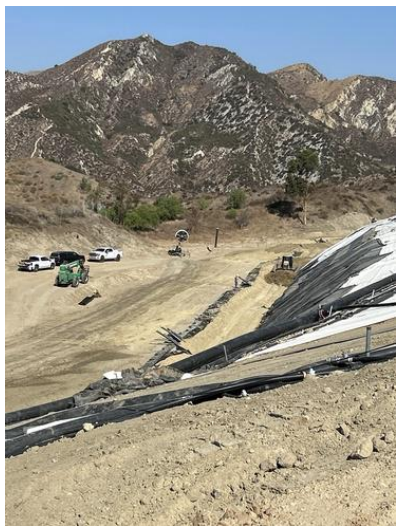
Photo 1

No

Westside perimeter road. None of the seepage previously observed in this area were observed at the time of this inspection. Permanent repairs are being conducted to contain seepage in this area as well.

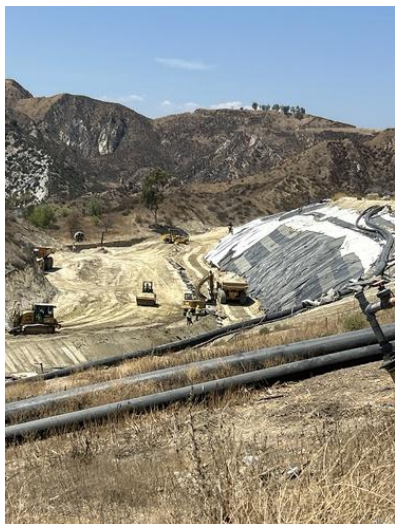
Photo 1

No

Westside perimeter road. None of the seepage previously observed in this area were observed at the time of this inspection. Permanent repairs are being conducted to contain seepage in this area as well.

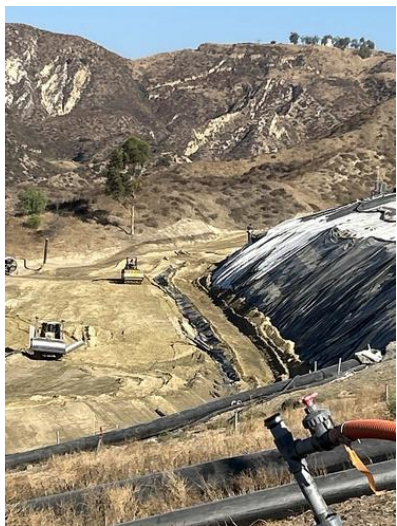
Photo 1

No

Westside perimeter road. None of the seepage previously observed in this area were observed at the time of this inspection. Permanent repairs are being conducted to contain seepage in this area as well.

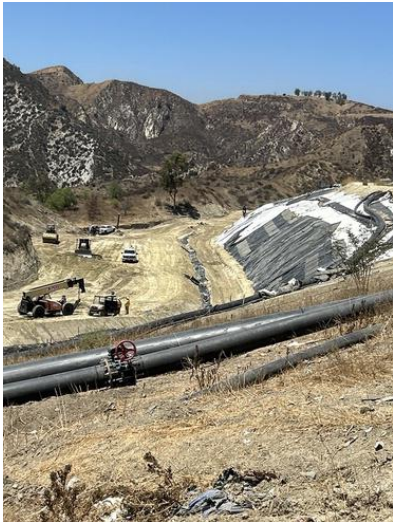
Photo 1

No

Westside perimeter road. None of the seepage previously observed in this area were observed at the time of this inspection. Permanent repairs are being conducted to contain seepage in this area as well.

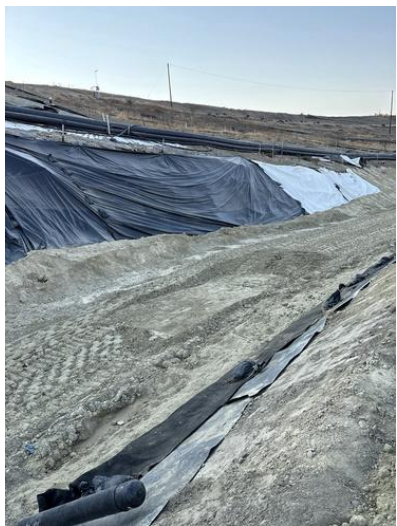
Photo 1

No

Westside perimeter road. None of the seepage previously observed in this area were observed at the time of this inspection. Permanent repairs are being conducted to contain seepage in this area as well.

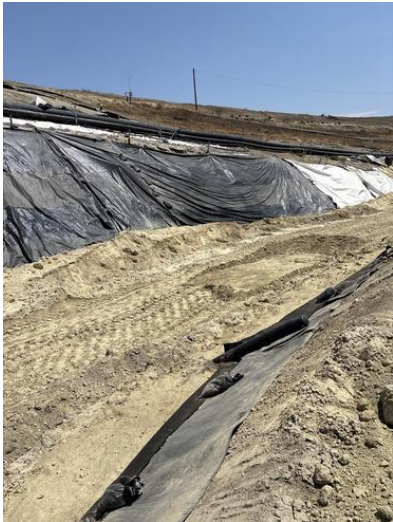
Photo 1

No

Westside perimeter road. None of the seepage previously observed in this area were observed at the time of this inspection. Permanent repairs are being conducted to contain seepage in this area as well.
