**CHIQUITA CANYON**  
*A Waste Connections Company*

**Re: Chiquita Canyon, LLC's Weekly Report on the Documentation and Tracking of Cover Issues, Monthly Summary, and Monthly Isopach Map**

# 4050 - Chiquita Reaction Area Tracking of Fissures and Tension Cracks

**JULY 2026 FISSURE AND TENSION CRACK MONITORING SUMMARY**  
**CHIQUITA CANYON LANDFILL**  
**CASTAIC, CALIFORNIA**

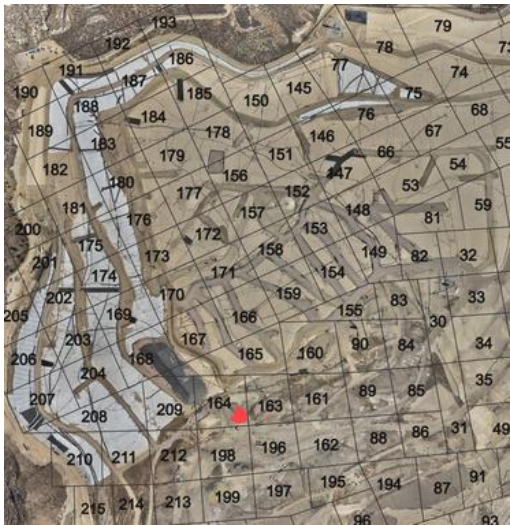
164

Using the attached image, annotate all areas where inspectors identified a fissure or tension crack.

65ft x 5ft

No individual crack 50ft or longer.

Medium 2-4" in width

Extra small <0.5" in height

E to W

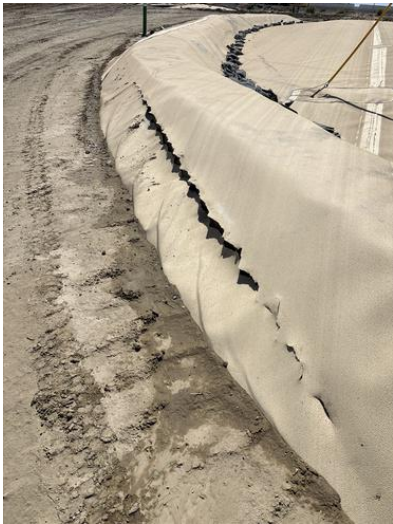
Photo 1

Tear in liner needs to be patched/extrusion welded.

Tear taped upon discovery, then patched and extrusion welded

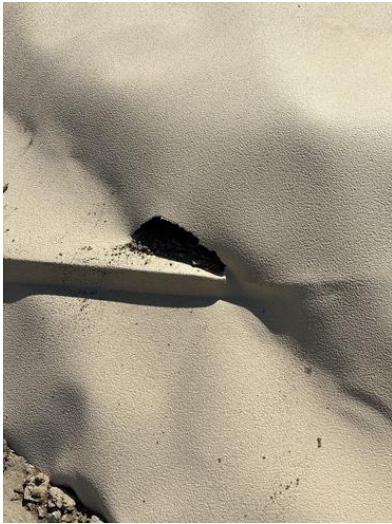
Photo 4

Tears in liner needs to be patched/extrusion welded.

| <b>Description of repair work</b> | Tears taped upon discovery, then patched and extrusion welded |

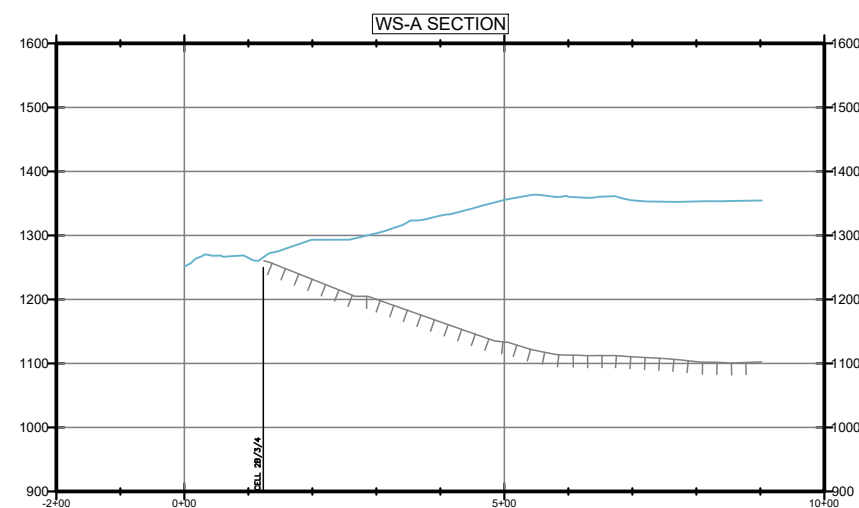
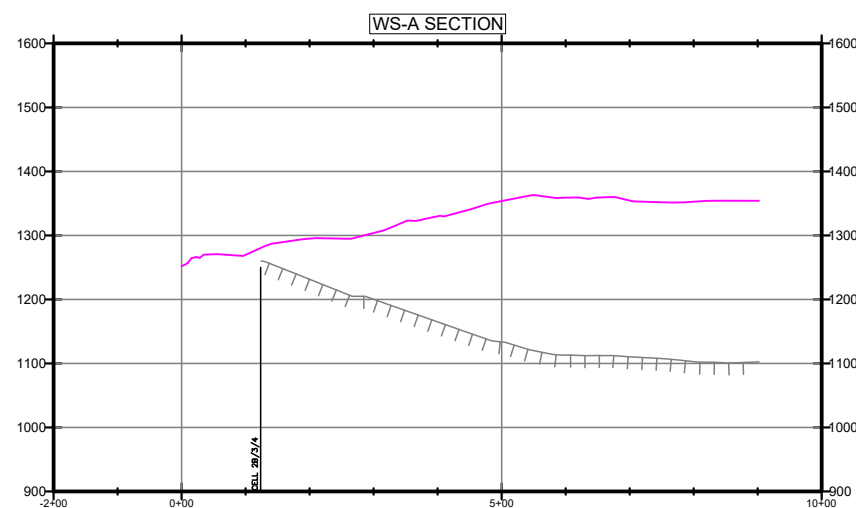
FIGURE 2A

All the cracks identified in Table 1 were repaired. Cross sections that compare June 24, 2026 and July 29, 2026 topography are shown in Figures 2A through 2E. The locations of these cross sections are shown in Figure 1. The sections show no significant difference in slope or evidence of instability between the June 2026 and July 2026 profiles, which is consistent with the observational records summarized in Tables 1 and 2. All the sections show changes in ground surface elevation at the toe of the western slope; however, these changes do not indicate slope movement or instability. Rather, these changes reflect the placement of soil in July as part of the western slope toe buttress project.
