**CHIQUITA CANYON**  
*A Waste Connections Company*

**Re: Chiquita Canyon, LLC's Weekly Report on the Documentation and Tracking of Cover Issues**

Attachment: August 18, 2026 Weekly Cover Issues Report

# 4050 - Chiquita Reaction Area Tracking of Fissures and Tension Cracks

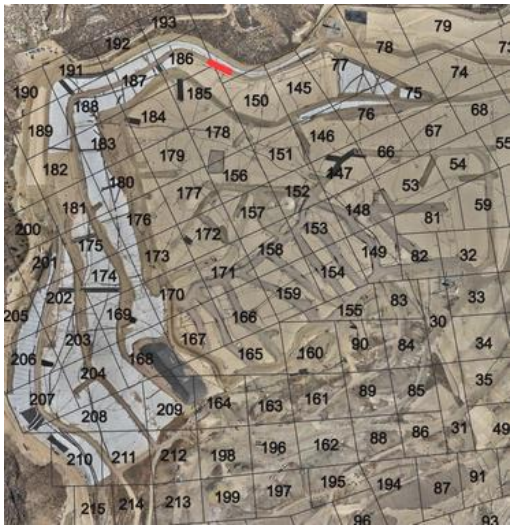
186

Yes

40 ft x 5 ft

Small 0.5-2" in width

Extra small <0.5" in height

E to W

Cracks were track walked.

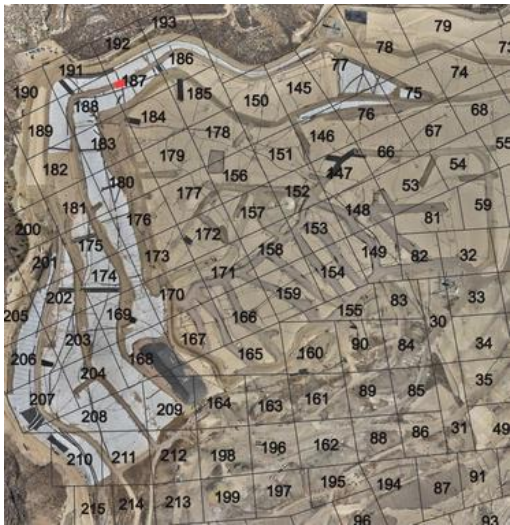
187

Yes

40ft x 6ft

Small 0.5-2" in width

Extra small <0.5" in height

NE to SW

Cracks were track walked.

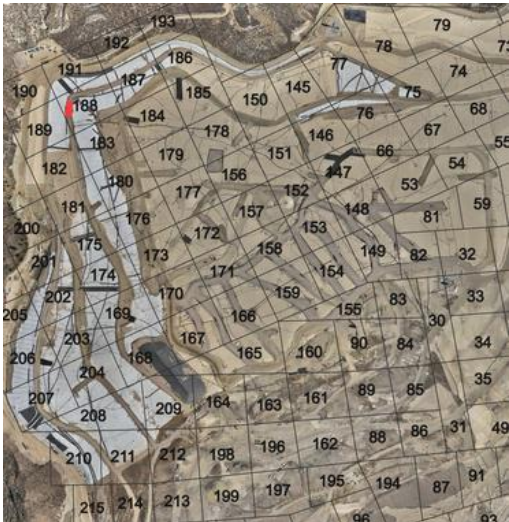
188

Yes

50ft x 6 ft

No individual crack 50ft or longer

Small 0.5-2" in width

Extra small <0.5" in height

NE to SW

Cracks were track walked.

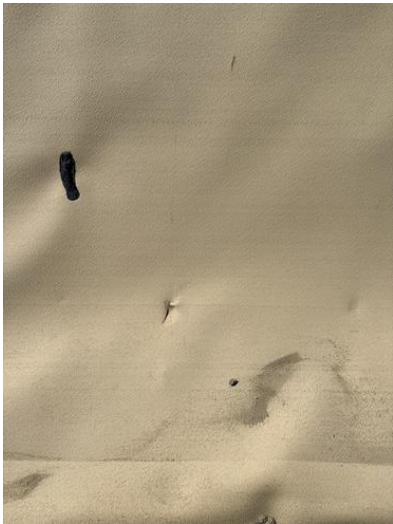
75

Liner needs to be patched /  
extrusion welded
