**Re: Chiquita Canyon, LLC's Weekly Leachate Inspection Report for Stipulated Order for Abatement (Case No. 6177-4), Condition 27(c)**

# 4050 - Chiquita Leachate Seep/Pooling Inspection

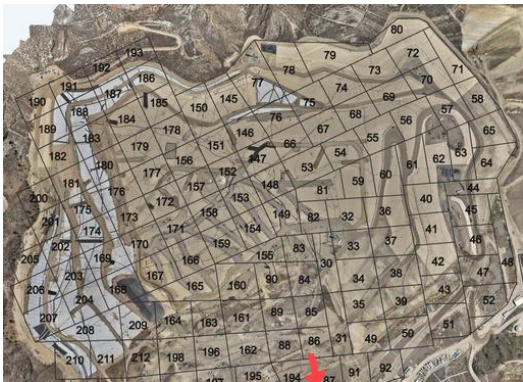
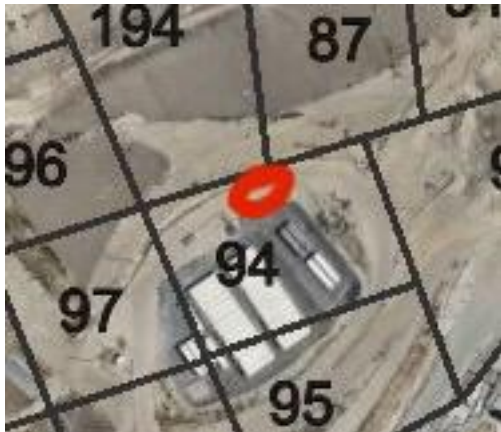
Photo 1

Which grid is the leachate seep/pooling located? 94

Extent of area impacted (approximate sq ft impacted) 30 sq ft

Standing free liquid

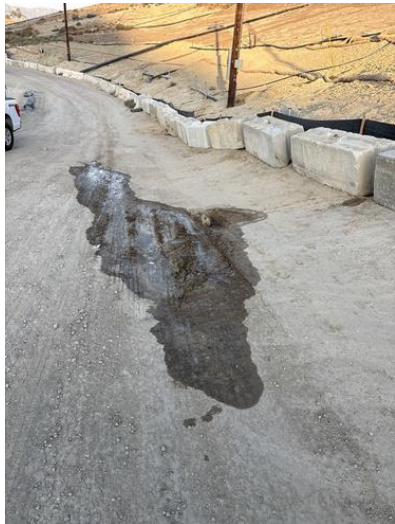
Photo 2

1 - Very Light Odor Detected

Seep was covered with fresh soil and compacted.

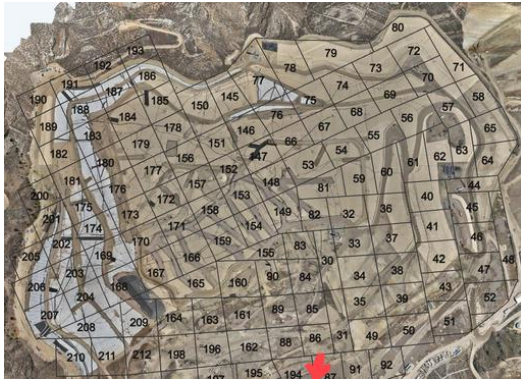
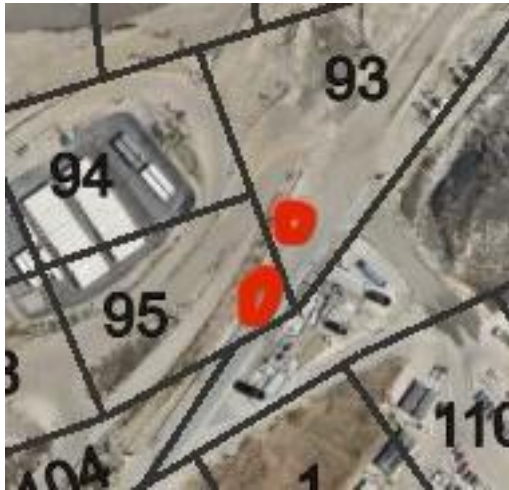
Photo 6

93 and 95

20 sq ft

Semi-dry

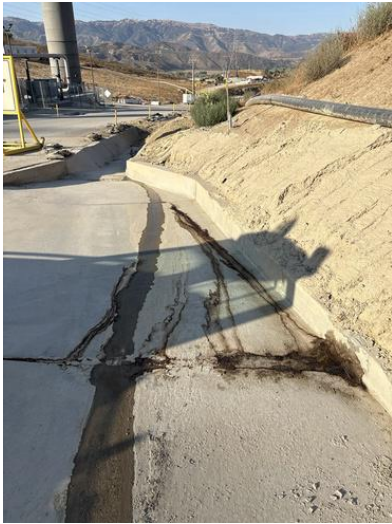
Photo 7

1-5 gallons

Chiquita installed a check dam to contain the liquid and collect it using a vacuum truck, The channel was also pressure washed while a vacuum truck collected the liquid. Sealant was then applied to prevent further seepage. Chiquita intends to install a collection sump in this area to minimize the potential for future seeps in the area.

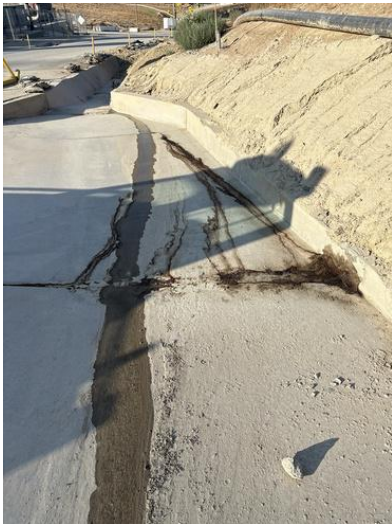
Photo 9

A seep of approximately 1.5 gallons of liquid originating from the joints in the concrete stormwater channel was observed in this area during the morning inspection. After cleanup activities were completed, a water line was struck while performing unrelated maintenance, causing non-potable water to flow through the prior seep area

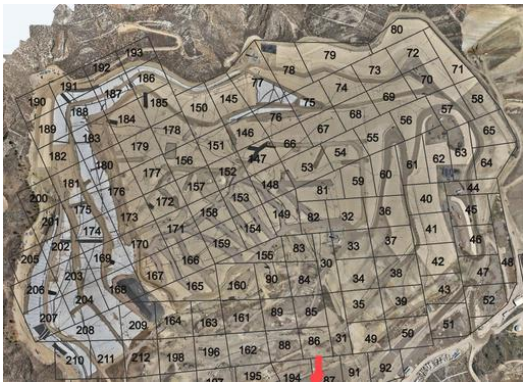
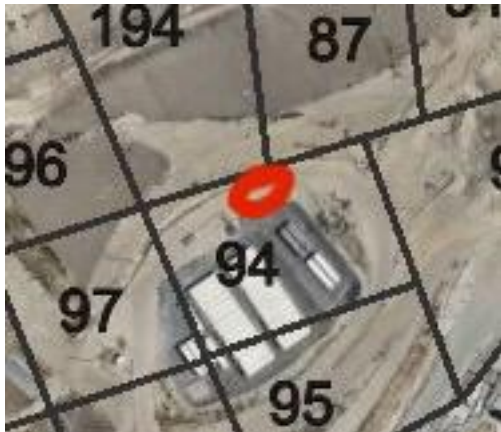
Photo 1

Which grid is the leachate seep/pooling located? 94

Extent of area impacted (approximate sq ft impacted) 12 sq ft

Standing free liquid

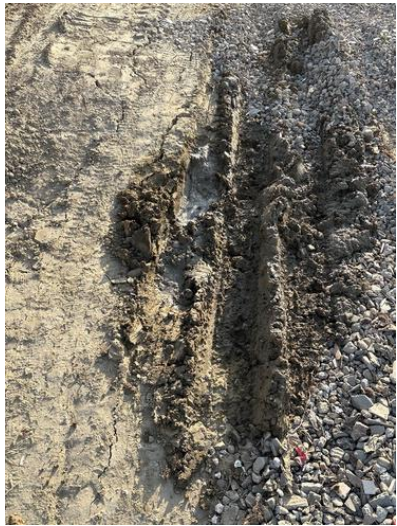
Photo 2

Estimated quantity of leachate 1-5 gallons

Soil was added and compacted.

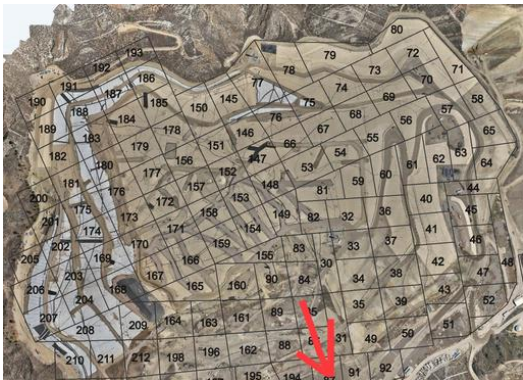
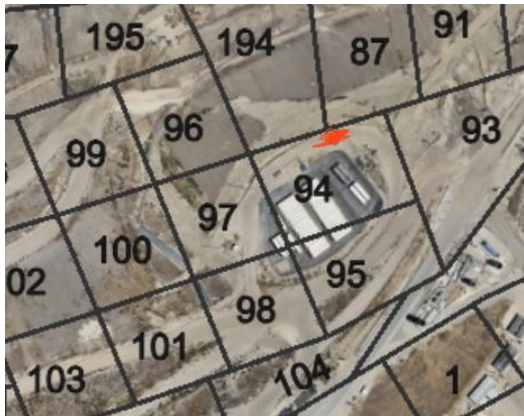
Photo 1

Grid 94

10 sqft

Standing free liquid

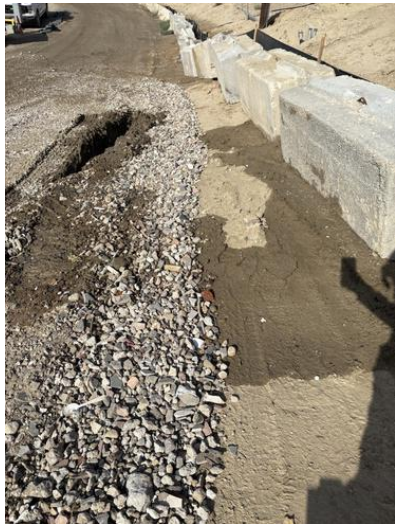
Photo 2

1-5 gallons

Seep was covered with clean soil and compacted

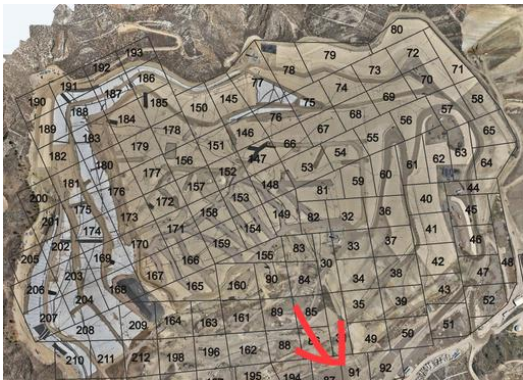
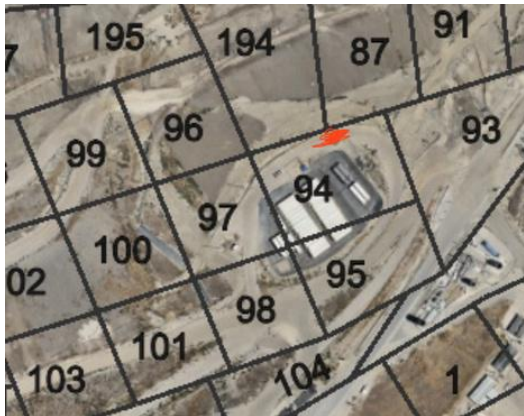
Photo 1

94

6 sqft

Standing free liquid

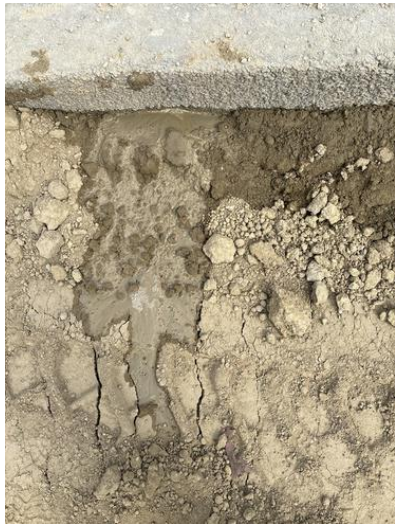
Photo 2

1-5 gallons

Clean soil was added and compacted
