August 18, 2026  
File No. 01204123.21, Task 22

## **MEMORANDUM**

SUBJECT: **SUMMARY REPORT - POST ELEVATED AIR CONCENTRATION EVENT  
INVESTIGATION: MS-08, AUGUST 13, 2026**

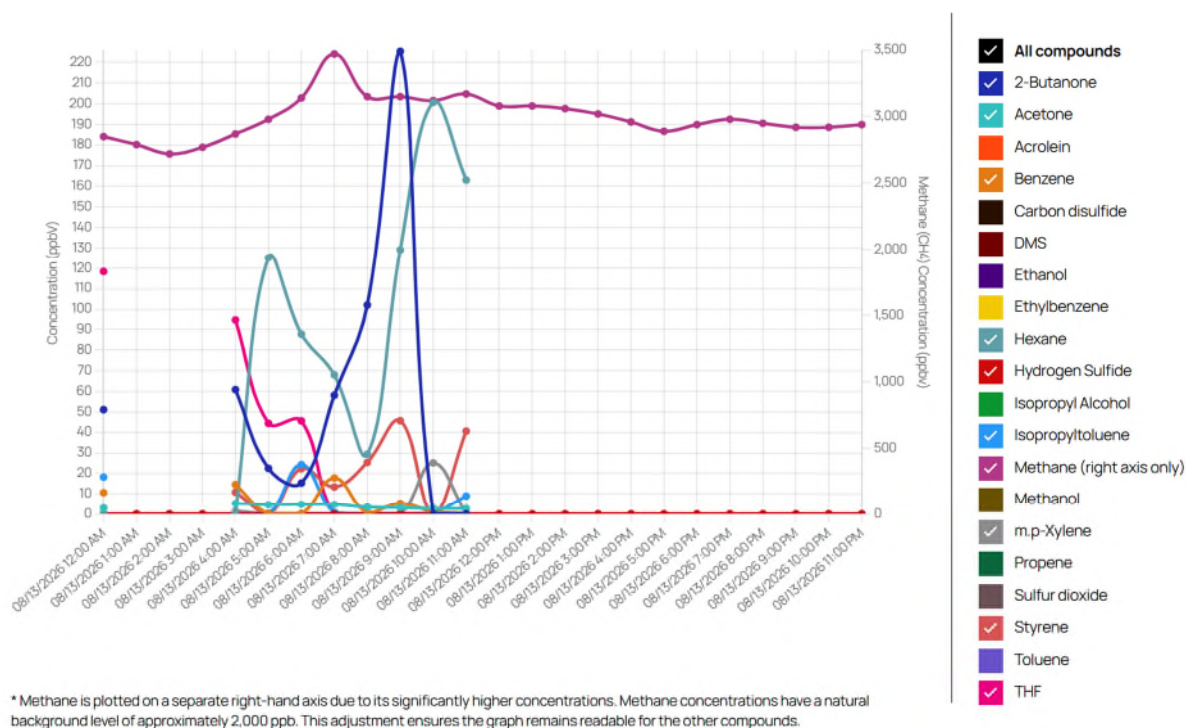
Figure 1. Graph of Selected Compounds at MS-08 on August 13, 2026

**Figure 1** presents MS-08's August 13 air monitoring data, as displayed on the Chiquita Community Air Monitoring program website. There is no data from the GC from 1:00 AM to 3:00 AM due to routine calibration. As discussed below, the GC was taken offline after 11:00 AM for further calibration. The data shows erratic readings across a multitude of compounds. These readings started at 8:00 PM August 12, 2026 but did not reach the threshold for an alert until August 13, 2026. The highest reading recorded was 225 ppb of 2-Butanone, which is significantly higher than what would be expected at any location. At the same time, the readings from the AQM air monitor (which measures methane, hydrogen sulfide, and sulfur dioxide) were comparatively very stable and low. A related increase in one of these 3 compounds would be expected if the landfill was the source of these readings.

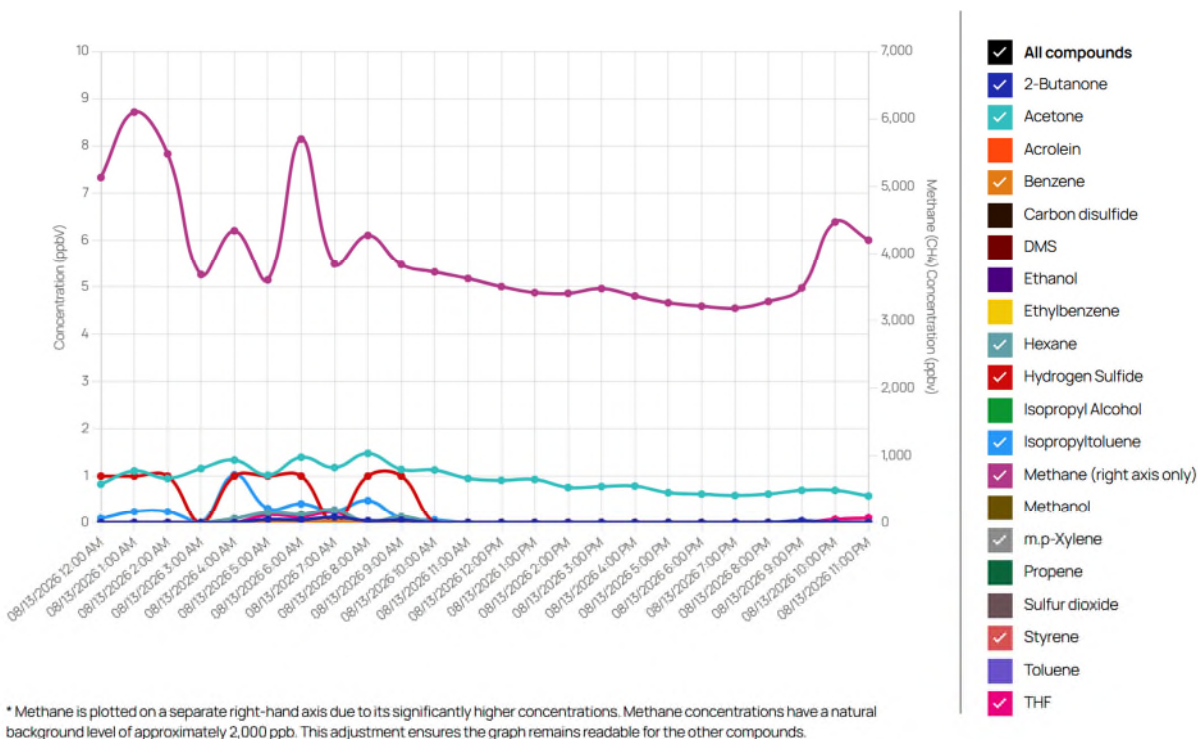
Figure 2. Graph of Selected Compounds at MS-04 on August 13, 2026

**Figure 2** presents MS-04's August 13 air monitoring data, as displayed on the Chiquita Community Air Monitoring program website. MS-04 is located along the northwestern boundary of the landfill, which is between the landfill and MS-08. Similar impacts would be expected at this location if the landfill were the source of the event, because MS-04 would be along the path that the gas would have to travel from the landfill to MS-08. Slightly elevated methane is the only noticeable impact at MS-04. None of the compounds monitored by the GC were above 2 ppb, which again suggests that the landfill is not the source of the readings.

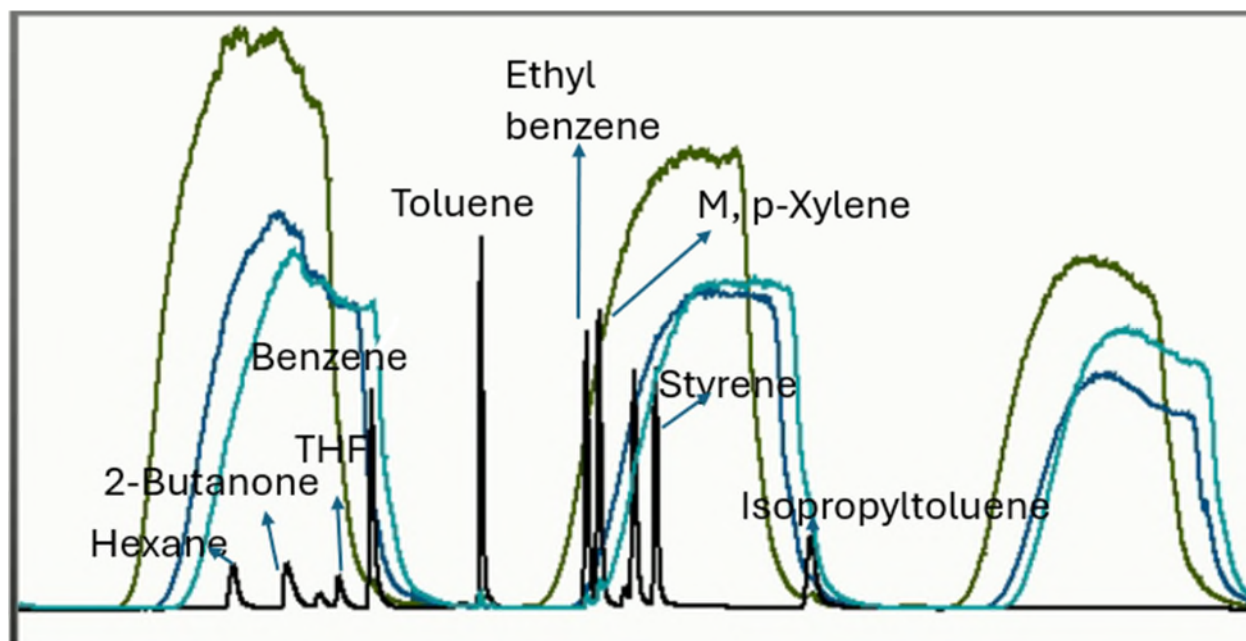
Figure 3. MS-08 Chromatogram – August 13, 2026

As part of the ongoing QA/QC procedures, Tricorn Tech (TCT) began an investigation of the event immediately on August 13. TCT's investigation included reviewing the gas chromatograms for MS-08 during the event. As shown in **Figure 3**, the black curve represents the calibration curve, while the other curves represent the ambient air samples. As shown, the sample curves do not match the expected pattern and are significantly elevated from expected levels. Following their review, TCT determined that the MS-08 GC sensor had failed completely and would need to be replaced.

Based on a review of on-site activities, wind direction, air monitoring data, and QA/QC analysis, SCS and TCT have concluded that the elevated benzene levels at MS-08 on August 13, 2026, were erroneous readings due to sensor failure in the GC.

The instrument was at the end of its lifecycle during the event. Sensor replacement had been scheduled but was delayed in order to maintain maximum coverage during site construction activities as previously discussed with SCAQMD. SCS and TCT were aware that sensor failure was a possibility with the aging sensor, so technicians responded quickly to the event. The instrument was taken offline once it was determined that the sensor had failed in order to prevent further erroneous readings. Maintenance began on the monitor to replace the sensor as soon as possible and it was completed on August 15, 2026. As of August 18, 2026 the monitor is functioning normally.
