**Re: Chiquita Canyon, LLC's Weekly Leachate Inspection Report for Stipulated Order for Abatement (Case No. 6177-4), Condition 27(c)**

Attachment: Leachate Seep/Pooling Inspection Logs from August 17 – August 23, 2026

# 4050 - Chiquita Leachate Seep/Pooling Inspection

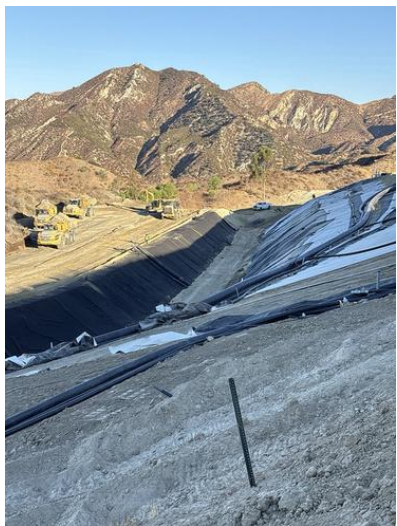
Photo 1

Westside perimeter road. None of the seepage previously observed in this area were observed at the time of this inspection, permanent repairs are being conducted to contain the seepage in this area. The seep observed in grid 94 was not observed at the time of this inspection either.

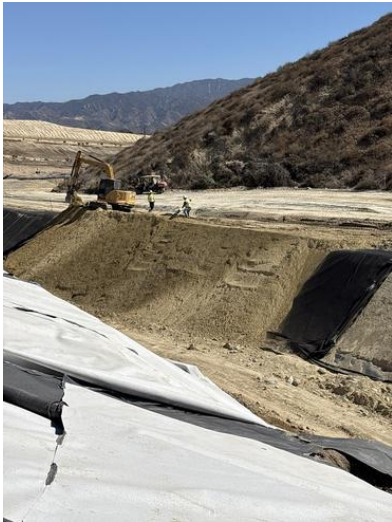
Photo 1

Westside perimeter road. None of the seepage previously observed in this area were observed at the time of this inspection, permanent repairs are being conducted to contain the seepage in this area. The seep observed in grid 94 was not observed at the time of this inspection either.

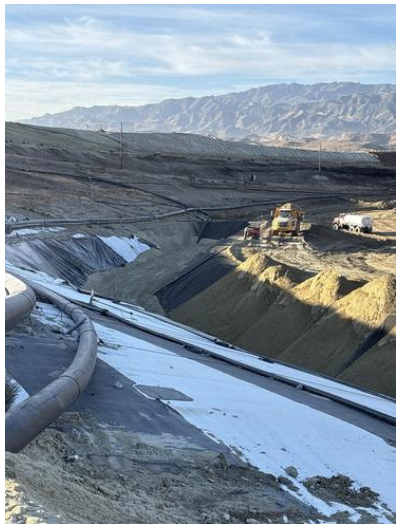
Photo 1

Westside perimeter road. None of the seepage previously observed in this area were observed at the time of this inspection, permanent repairs are being conducted to contain the seepage in this area. The seep observed in grid 94 was not observed at the time of this inspection either.

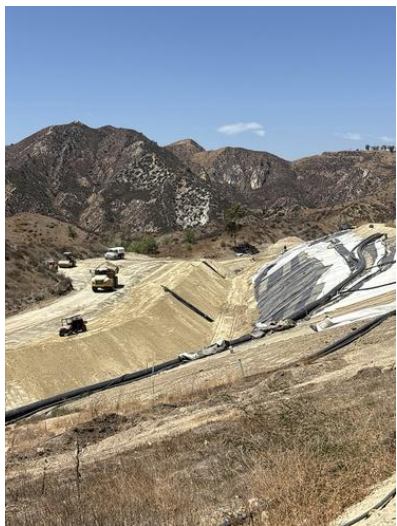
Photo 1

Westside perimeter road. None of the seepage previously observed in this area were observed at the time of this inspection, permanent repairs are being conducted to contain the seepage in this area. The seep observed in grid 94 was not observed at the time of this inspection either.

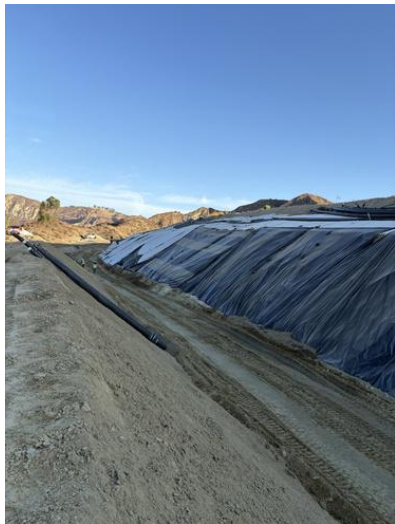
Photo 1

Westside perimeter road. None of the seepage previously observed in this area were observed at the time of this inspection. Permanent repairs are being conducted to contain seepage in this area as well.

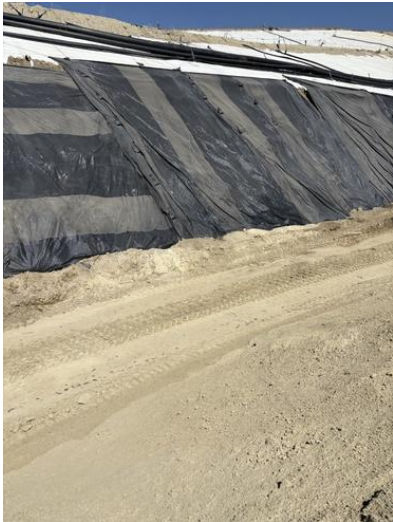
Photo 1

Westside perimeter road. None of the seepage previously observed in this area were observed at the time of this inspection. Permanent repairs are being conducted to contain seepage in this area as well.

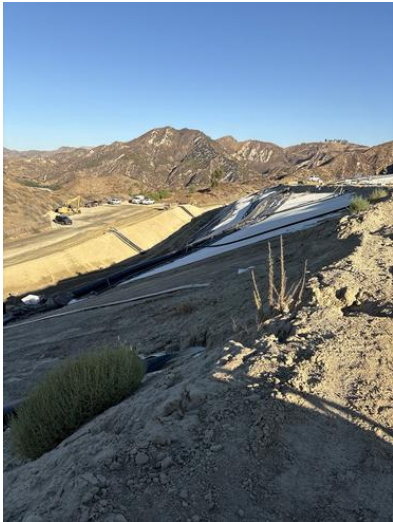
Photo 1

Westside perimeter road. None of the seepage previously observed in this area were observed at the time of this inspection. Permanent repairs are being conducted to contain seepage in this area as well.

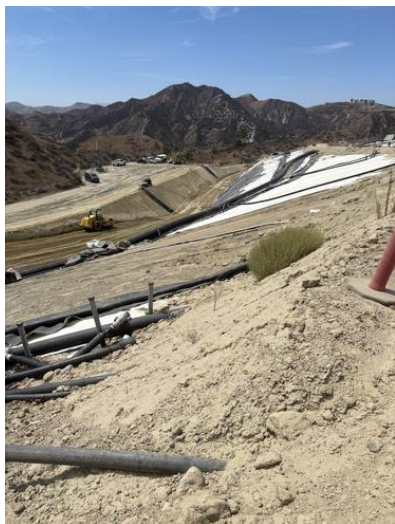
Photo 1

Westside perimeter road. None of the seepage previously observed in this area were observed at the time of this inspection. Permanent repairs are being conducted to contain seepage in this area as well.

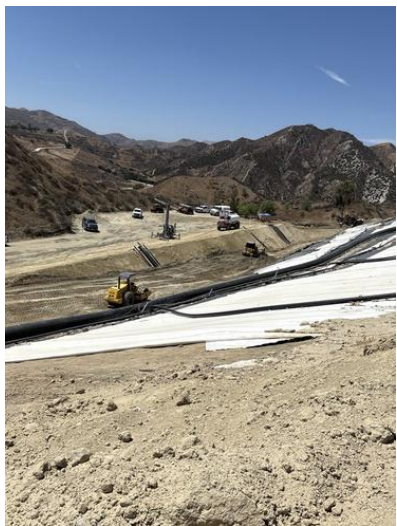
Photo 1

Westside perimeter road. None of the seepage previously observed in this area were observed at the time of this inspection. Permanent repairs are being conducted to contain seepage in this area as well.

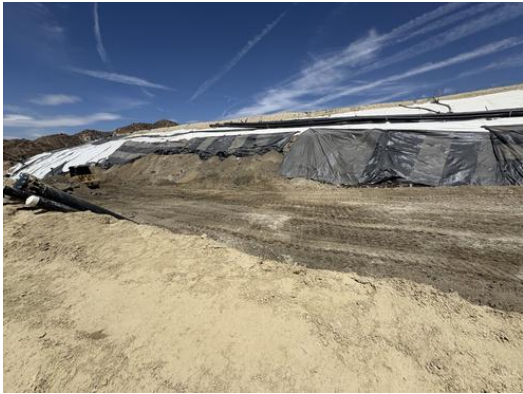
Photo 1

Westside perimeter road. None of the seepage previously observed in this area were observed at the time of this inspection. Permanent repairs are being conducted to contain seepage in this area as well.

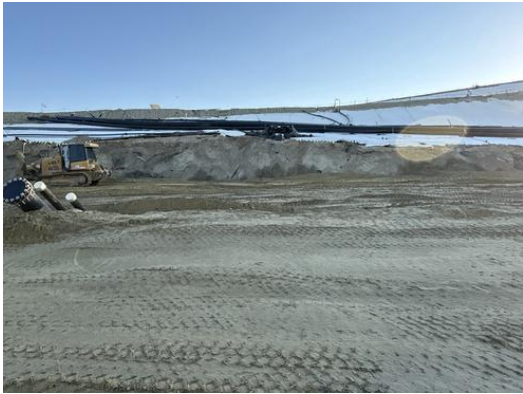
Photo 1

Westside perimeter road. None of the seepage previously observed in this area were observed at the time of this inspection. Permanent repairs are being conducted to contain seepage in this area as well.

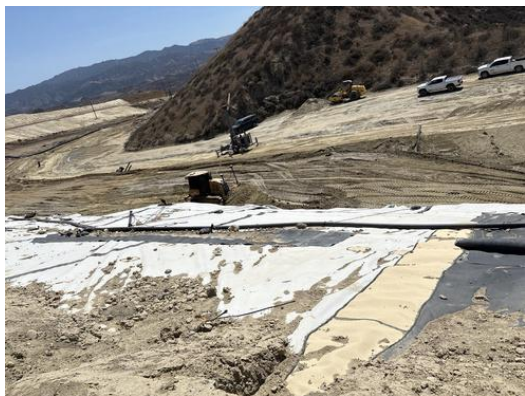
Photo 1

Westside perimeter road. None of the seepage previously observed in this area were observed at the time of this inspection. Permanent repairs are being conducted to contain seepage in this area as well.

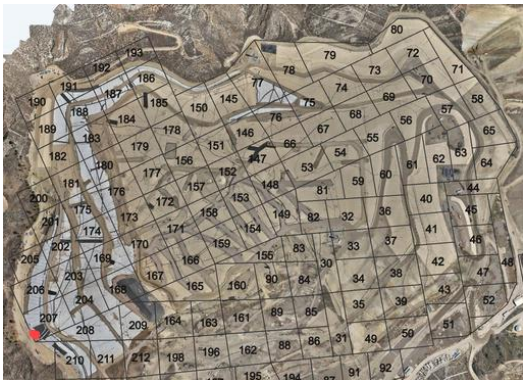
Indicate on the map the location

Which grid is the leachate seep/pooling located? 207

Drop Pin to record lat/long of seep/pooling location. (34.43263647195297, -118.65191836517434)

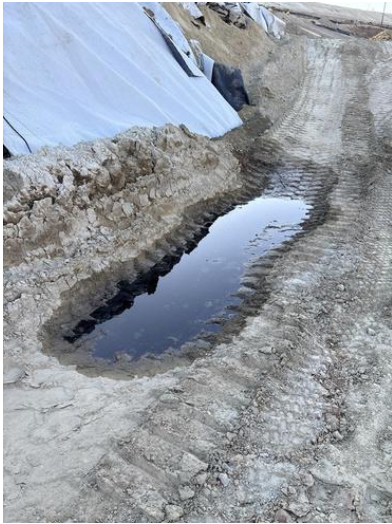
Photo 1

Time seep/pooling was discovered 23 Aug 2026 7:25 AM PDT

Estimated duration of presence of leachate at such location 6 hours

Estimated quantity of leachate 11-20 gallons

Extent of area impacted (approximate sq ft impacted) 30 sq ft

Odor type Leachate

Odor intensity 3 - Moderate Odor

Surrounding soil saturation level Standing free liquid

Soil added to existing berm to contain leachate, and soil added to cover pooling.

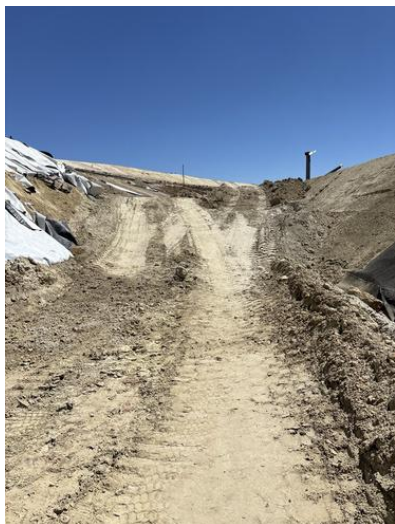
Photo 1

Westside perimeter road. The seep previously observed during the morning inspection was not observed at the time of this inspection. Permanent repairs are being conducted to contain seepage in this area as well.
