**CHIQUITA CANYON**  
*A Waste Connections Company*

**Re: Chiquita Canyon, LLC's Weekly Report on the Documentation and Tracking of Cover Issues**

Attachment: August 25, 2026 Weekly Cover Issues Report

# 4050 - Chiquita Reaction Area Tracking of Fissures and Tension Cracks

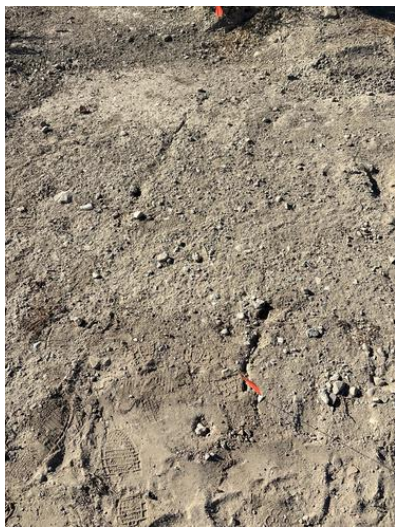
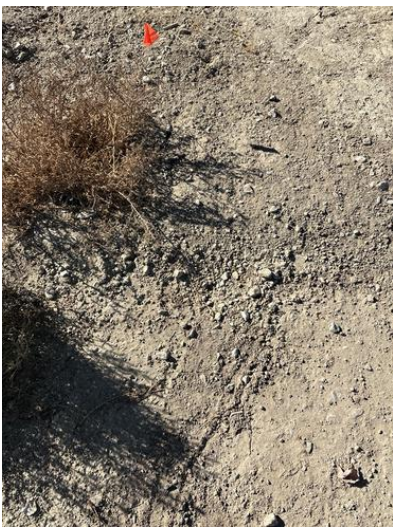
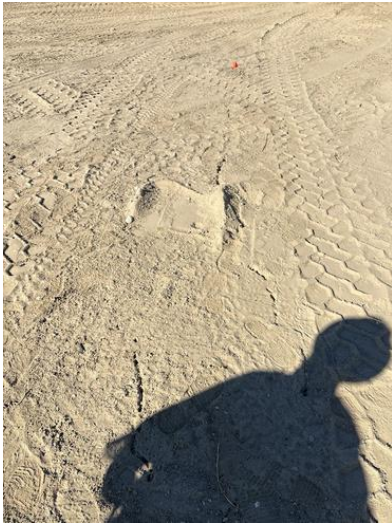
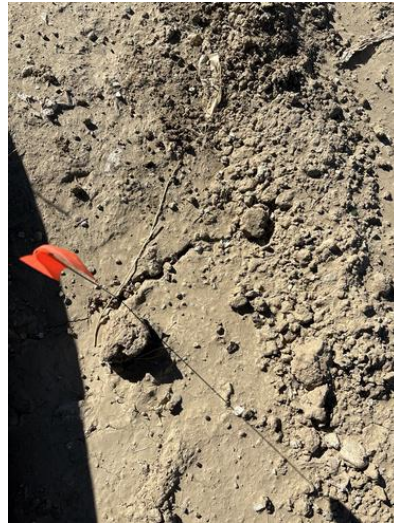
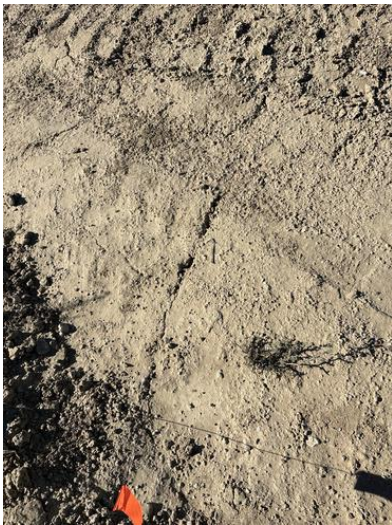
160

90ft x 45ft

No individual crack 50 ft or longer.

Small 0.5-2" in width

Extra small <0.5" in height

N to S

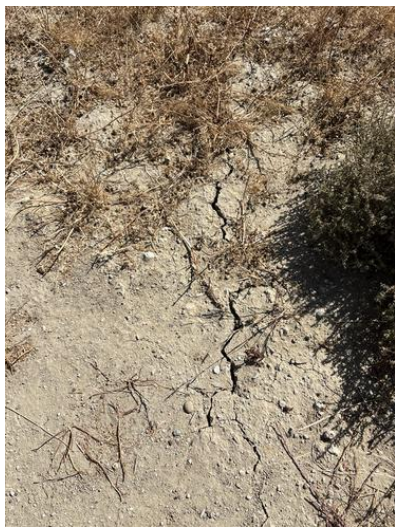
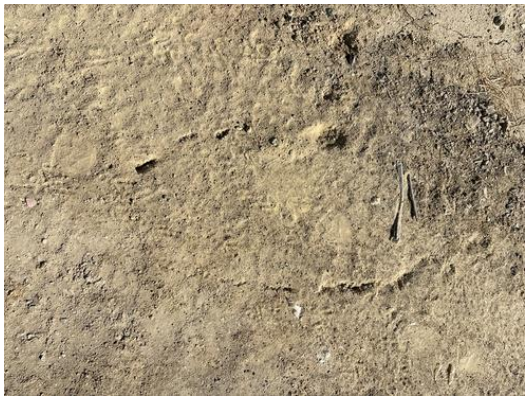
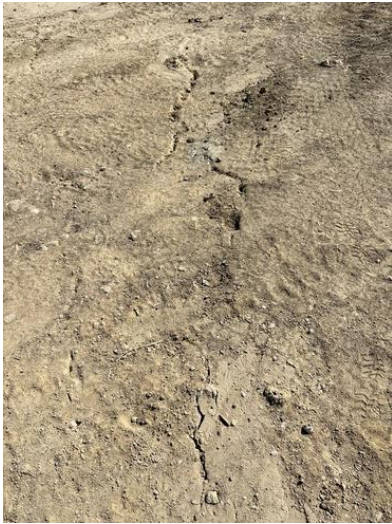
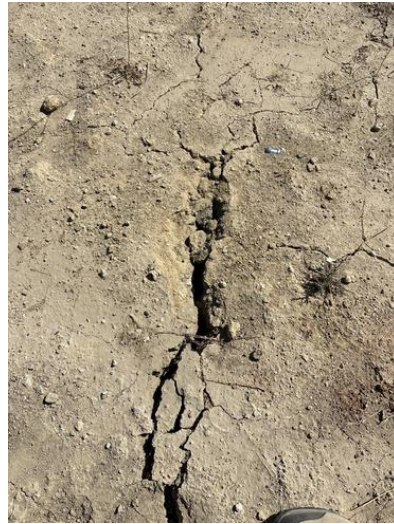
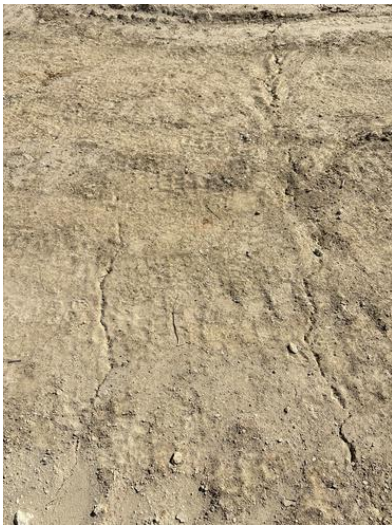
90

55 ft x 60 ft

No individual crack 50ft or longer.

Medium 2-4" in width

Extra small <0.5" in height

NE to SW

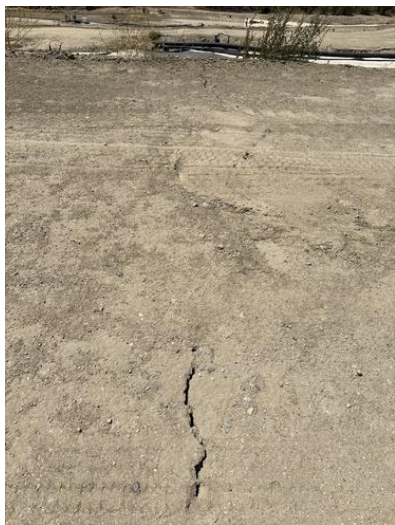
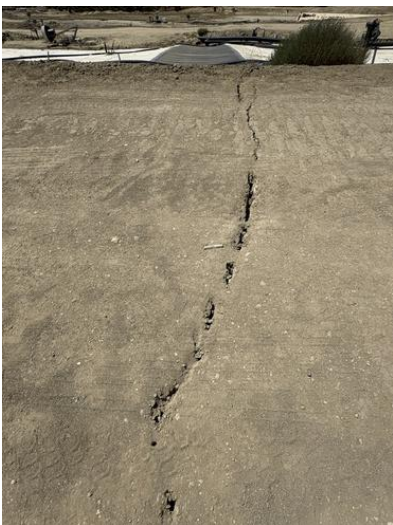
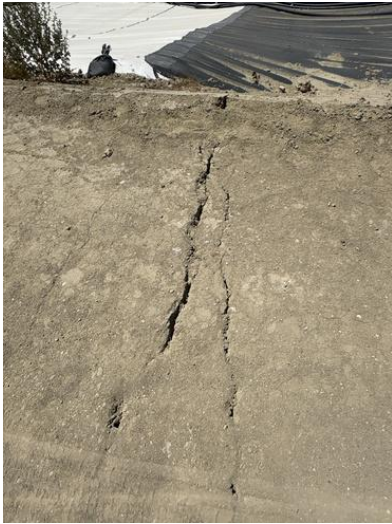
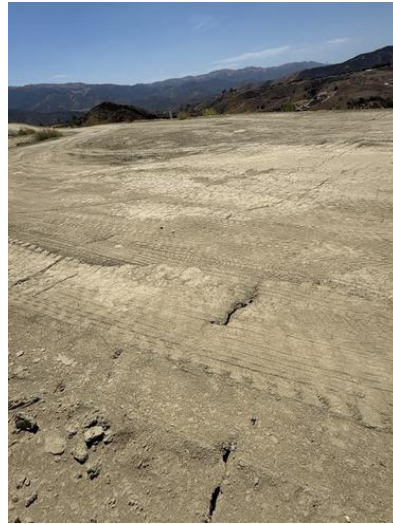
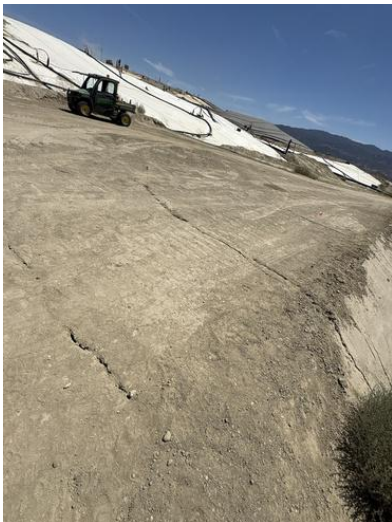
169

| <b>Length of crack (ft) or area containing multiple cracks (ft x ft)</b> | 40ft x 15 ft |
| <b>Horizontal Offset (width)</b> | Small 0.5-2" in width |
| <b>Vertical Offset (height)</b> | Small 0.5-2" in height |
| <b>Orientation (direction)</b> | NE to SW |

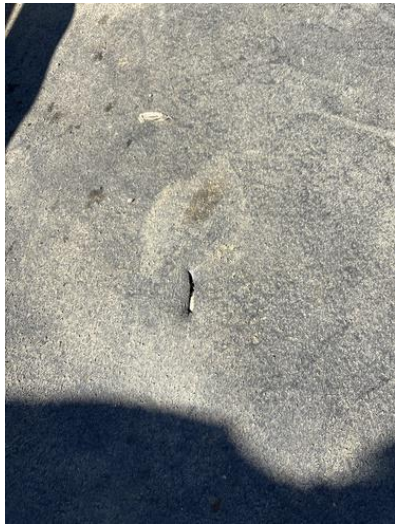
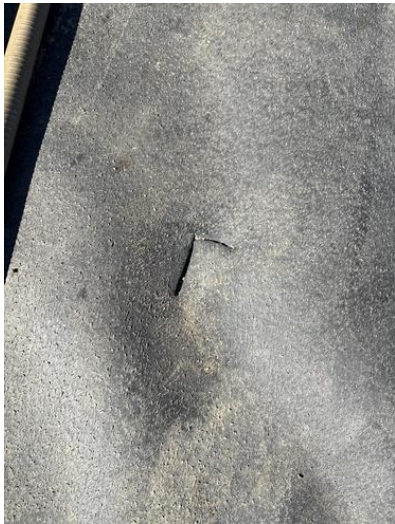
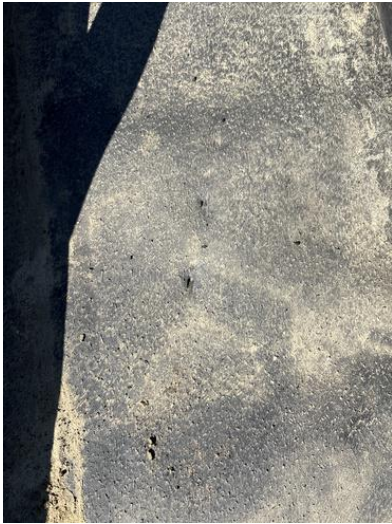
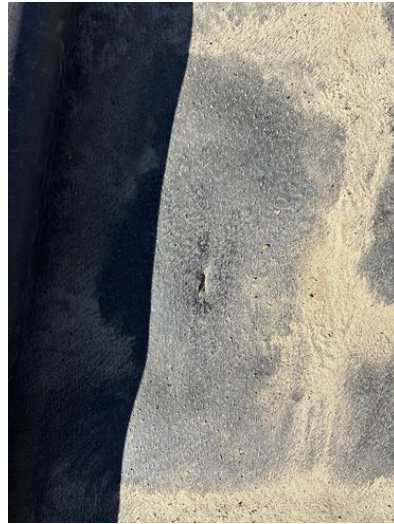
168

Multiple tears in close proximity to each other need to be patched/extrusion welded.

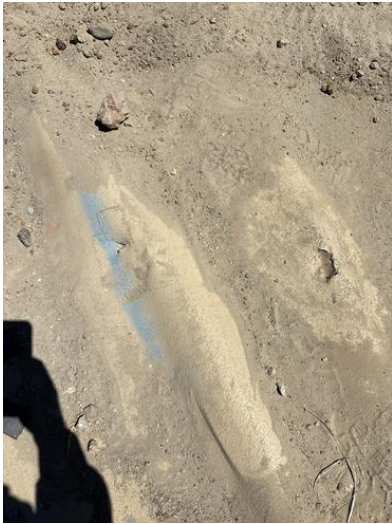
158

Two tears side by side need to be patched/extrusion welded.

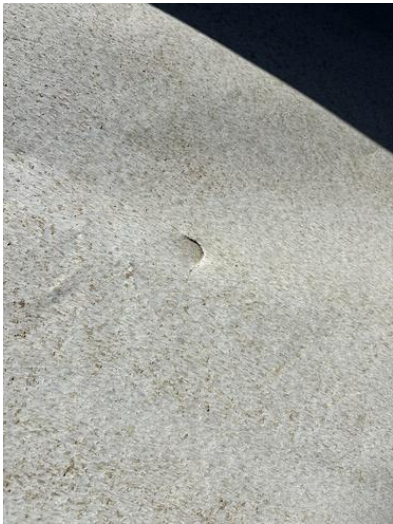
203

Tear in liner needs to be patched/extrusion welded.

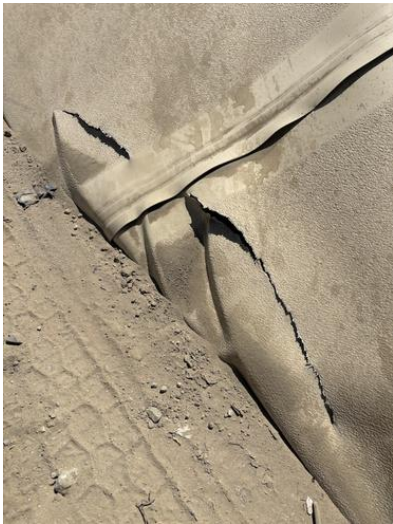
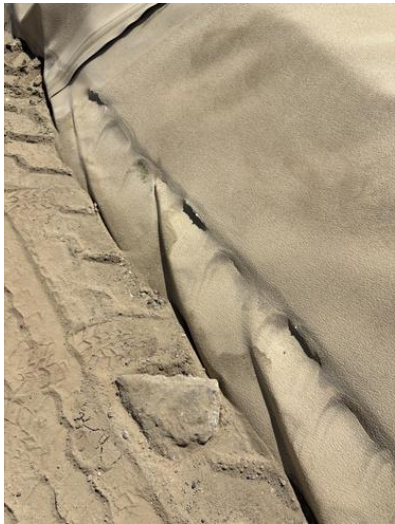
41

Multiple tears in liner need to be patched/extrusion welded.

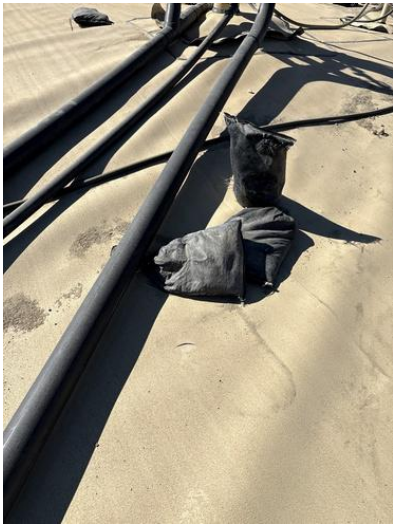
154

Tear in liner needs to be patched /  
extrusion welded

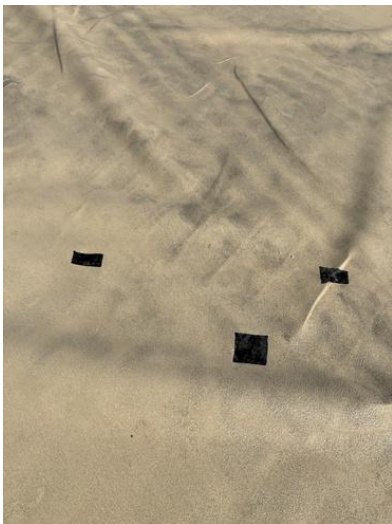
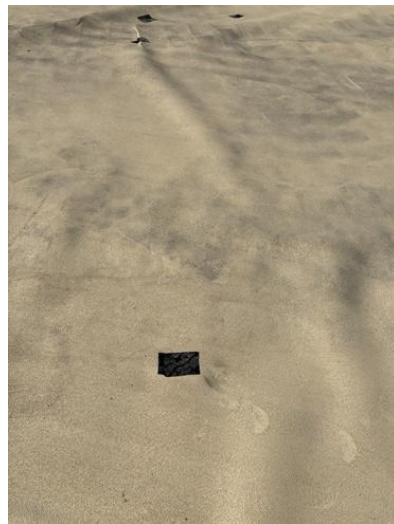
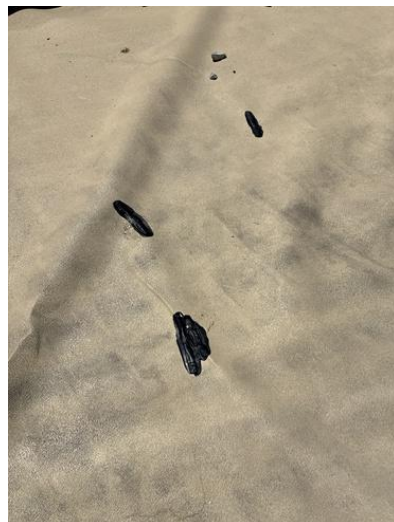
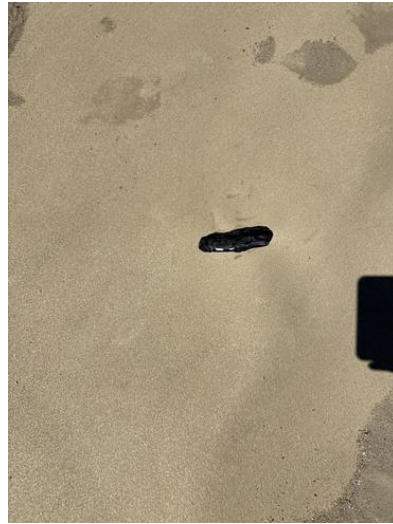
A few tears close to one another  
need to be patched / extrusion  
welded

| <b>Description of repair work</b> | Tears were taped upon discovery and later extrusion welded. |

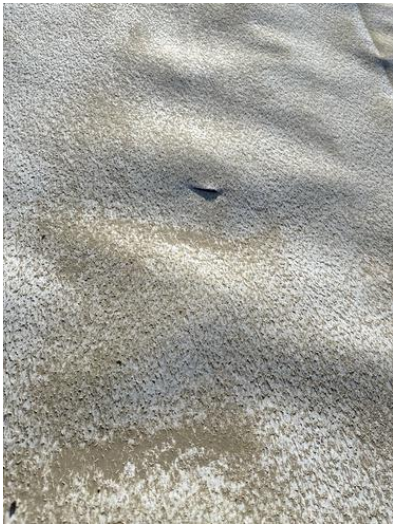
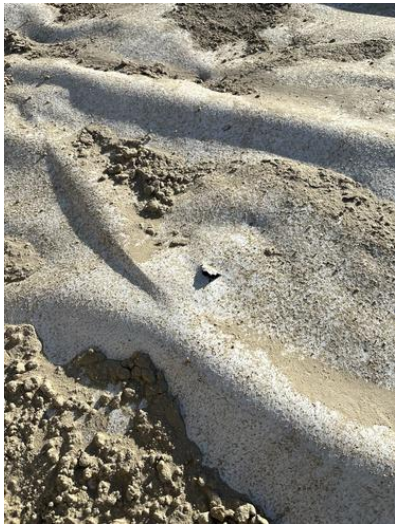
189

2 Tears close to one another.  
Liner needs to be patched  
extrusion welded

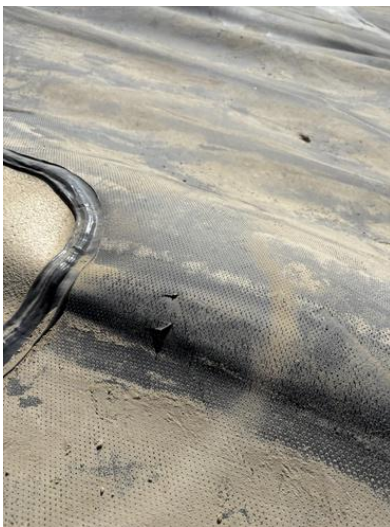
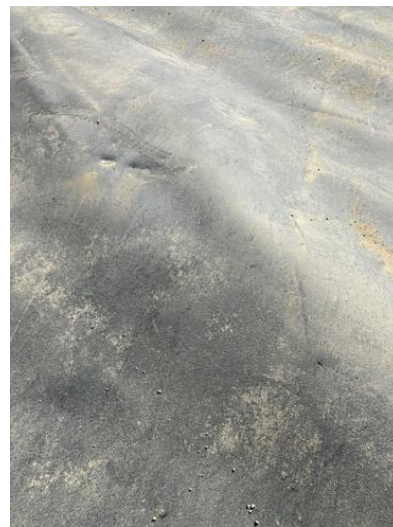
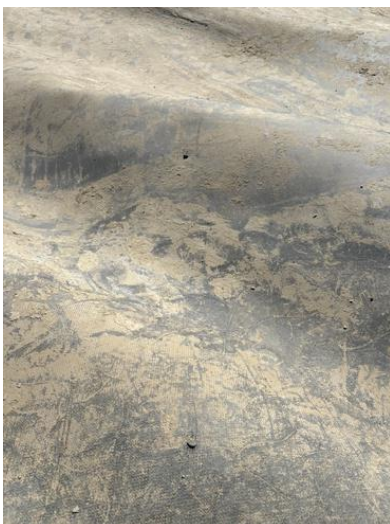
156

Tears close to one another. Liner needs to be patched/extrusion welded

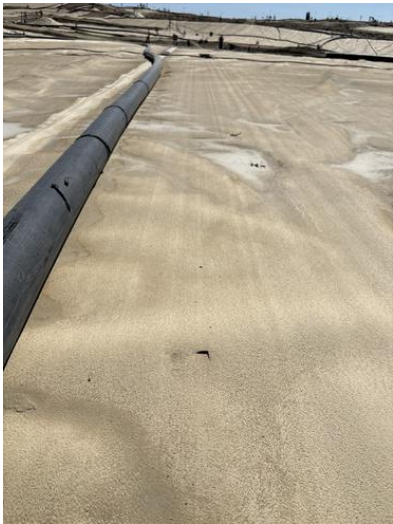
176

Tear in liner needs to be patched/extrusion welded

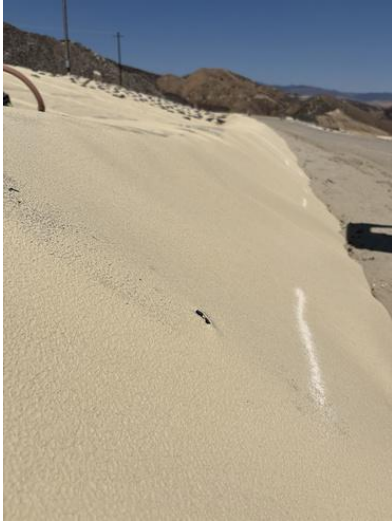
36

Tear in liner needs to be patched /  
extrusion welded
