**Re: Chiquita Canyon, LLC's Weekly Leachate Inspection Report for Stipulated Order for Abatement (Case No. 6177-4), Condition 27(c)**

Attachment: Leachate Seep/Pooling Inspection Logs from August 24 – August 30, 2026

# 4050 - Chiquita Leachate Seep/Pooling Inspection

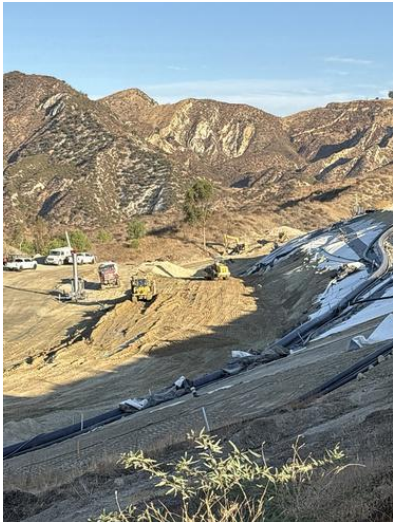
Photo 1

Westside perimeter road. None of the seepage previously observed in this area were observed at the time of this inspection. Permanent repairs are being conducted to contain seepage in this area as well.

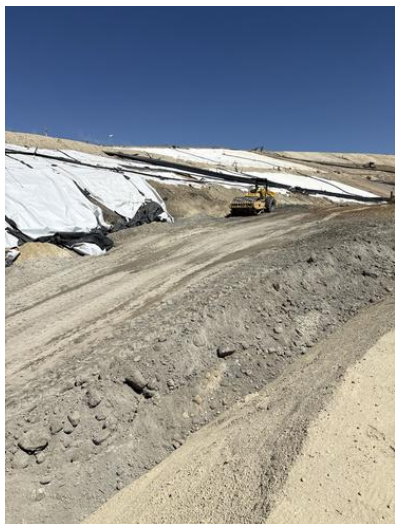
Photo 1

Westside perimeter road. None of the seepage previously observed in this area were observed at the time of this inspection. Permanent repairs are being conducted to contain seepage in this area as well.

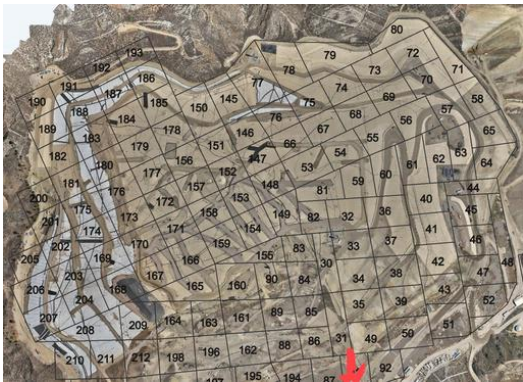
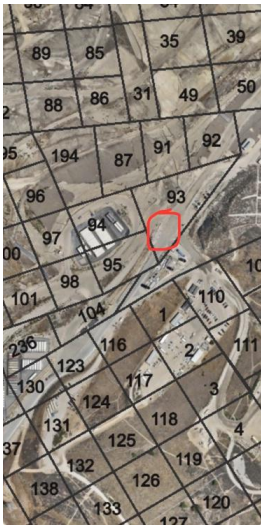
Photo 1

For the week of August 24 through August 30, 2026, leachate seepage was observed on August 25, 2026, in Grids 93 and 95 at the Landfill, at approximately 7:30 a.m. The specific location of this seep is shown on the maps included in the attachment. Liquid from this seepage traveled into the stormwater channel but did not reach either sedimentation basin; the liquid was contained by a soil check dam. Upon discovery of the seep, Chiquita promptly initiated response and mitigation measures, including pressure washing the channel while applying vacuum to ensure the proper collection of all wash water. This initial response work was completed by approximately 2:15 p.m. on August 25, 2026. The seepage is estimated to have been present for approximately 12 hours. The total volume of leachate associated with this seepage during that period is estimated to have been less than one gallon, of which approximately 0.25 gallons traveled into the stormwater channel. The observed area impacted by the seepage was approximately 35 square feet. The saturation of the soil was characterized as "Saturated." No odor associated with the seepage was detected. This seepage was not observed again during the twice daily inspections during the week.

93/95

Sealant was applied to the affected joints on August 27, 2026, as a protective measure to minimize the potential for recurrence. This seepage is related to the previously reported seepage that occurred in the area. Chiquita is planning to install a collection sump in the area to further minimize the potential for recurrence.

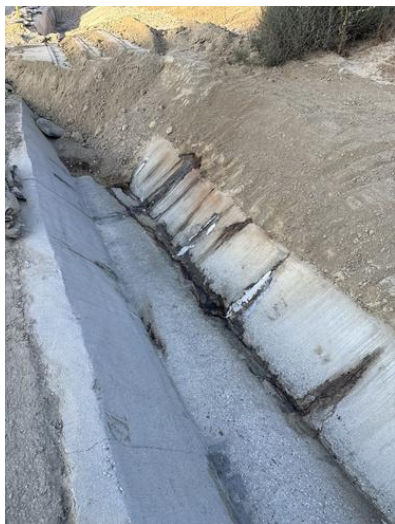
Photo 2

12 hours

<1 gallons

35sq ft

| Surrounding soil saturation level | Saturated |

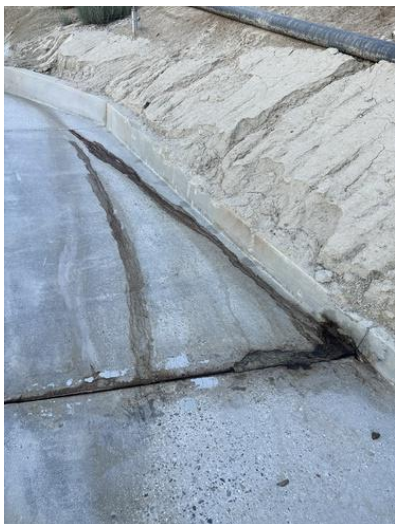
Photo 3

| Did the seep/pooling travel into the stormwater channel? | Yes |

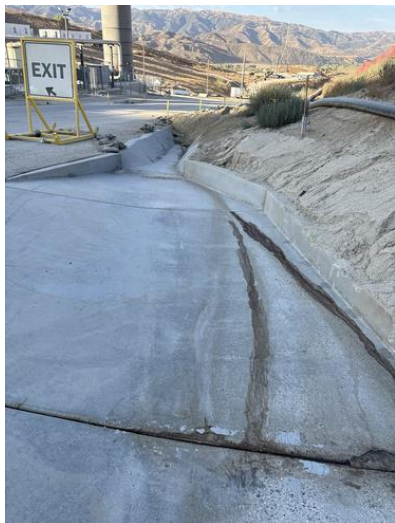
Photo 4

| Did the seep/pooling travel to the stormwater basin? | No |

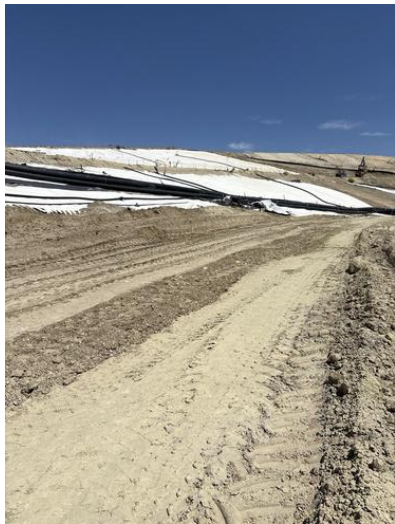
Photo 1

Westside perimeter road. None of the seepage previously observed in this area were observed at the time of this inspection. Permanent repairs are being conducted to contain seepage in this area as well. The seep observed in grids 93/95 was not observed during this inspection and was still pending the patching.

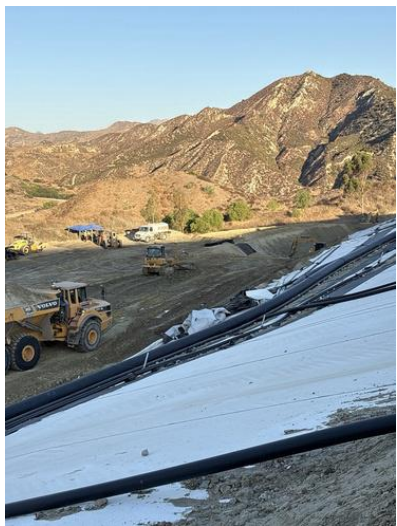
Photo 1

Westside perimeter road. None of the seepage previously observed in this area were observed at the time of this inspection. Permanent repairs are being conducted to contain seepage in this area as well.

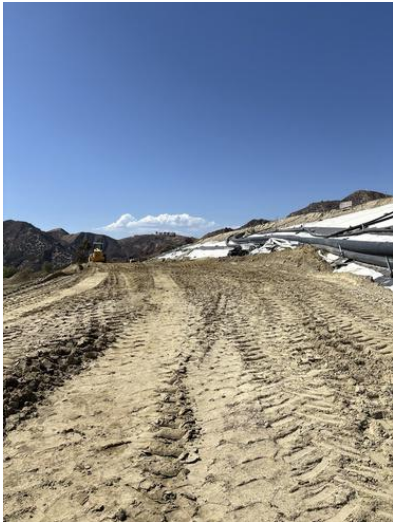
Photo 1

Westside perimeter road. None of the seepage previously observed in this area were observed at the time of this inspection. Permanent repairs are being conducted to contain seepage in this area as well.

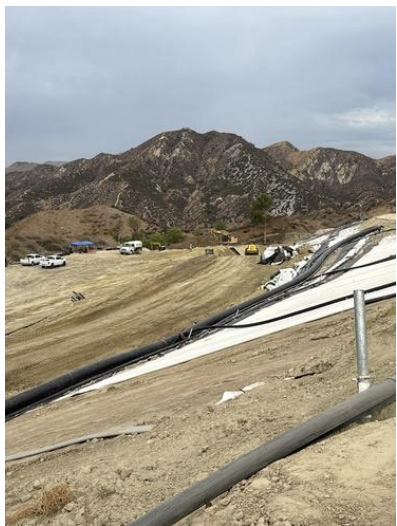
Photo 1

Westside perimeter road. None of the seepage previously observed in this area were observed at the time of this inspection. Permanent repairs are being conducted to contain seepage in this area as well.

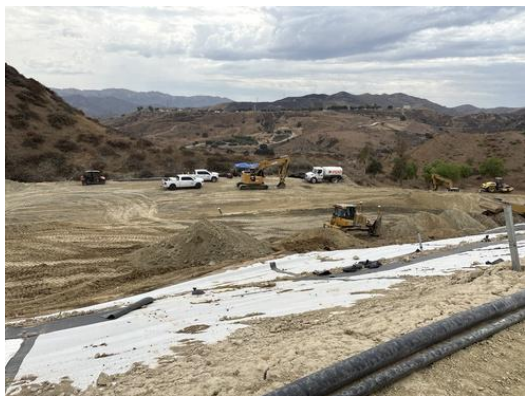
Photo 1

Westside perimeter road. None of the seepage previously observed in this area were observed at the time of this inspection. Permanent repairs are being conducted to contain seepage in this area as well.

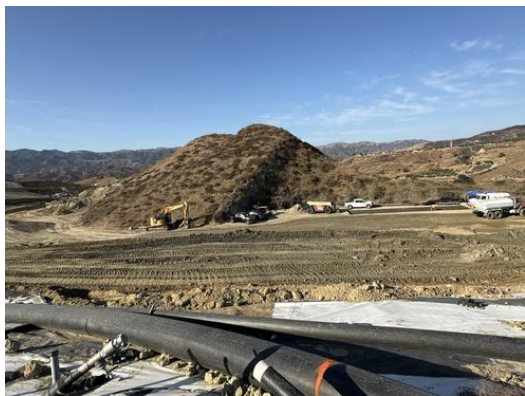
Photo 1

Westside perimeter road. None of the seepage previously observed in this area were observed at the time of this inspection. Permanent repairs are being conducted to contain seepage in this area as well.

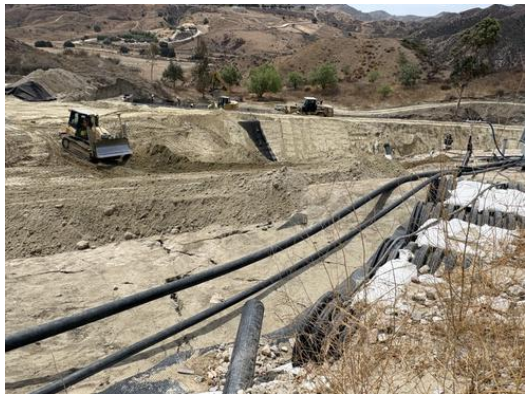
Photo 1

Westside perimeter road. None of the seepage previously observed in this area were observed at the time of this inspection. Permanent repairs are being conducted to contain seepage in this area as well.

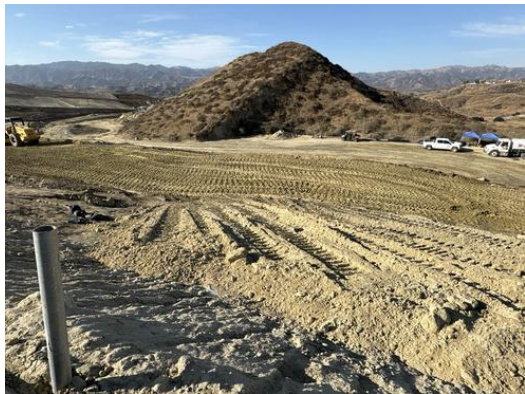
Photo 1

Westside perimeter road. None of the seepage previously observed in this area were observed at the time of this inspection. Permanent repairs are being conducted to contain seepage in this area as well.

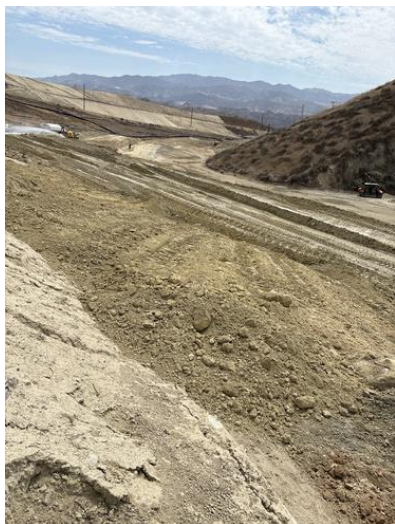
Photo 1

Westside perimeter road. None of the seepage previously observed in this area were observed at the time of this inspection. Permanent repairs are being conducted to contain seepage in this area as well.

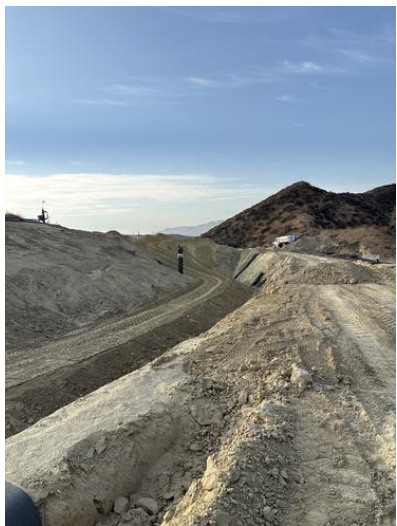
Photo 1

Westside perimeter road. None of the seepage previously observed in this area were observed at the time of this inspection. Permanent repairs are being conducted to contain seepage in this area as well.

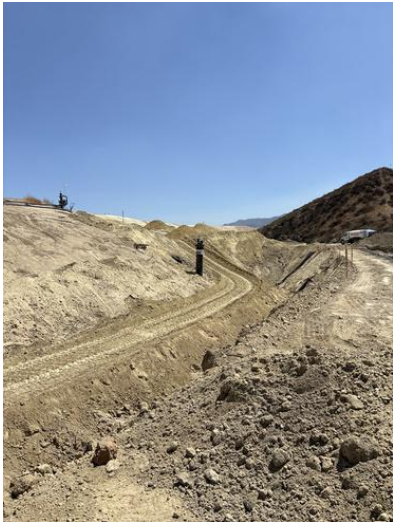
Photo 1

Westside perimeter road. None of the seepage previously observed in this area were observed at the time of this inspection. Permanent repairs are being conducted to contain seepage in this area as well.
