**CHIQUITA CANYON**  
*A Waste Connections Company*

**Re: Chiquita Canyon, LLC's Weekly Report on the Documentation and Tracking of Cover Issues**

Attachment: September 1, 2026 Weekly Cover Issues Report

# **Fissures and Tension Cracks**

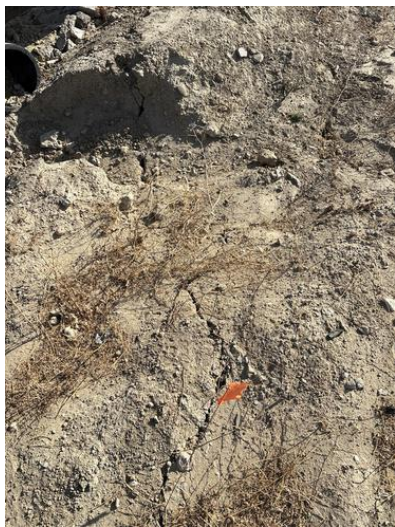
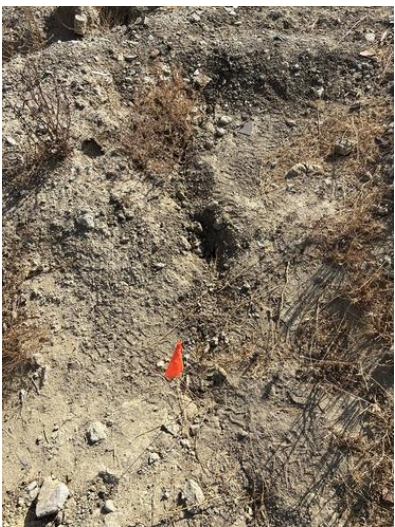
4ft x 12ft

Small 0.5-2" in width

Extra small <0.5" in height

NE to SW

Cracks were track walked.

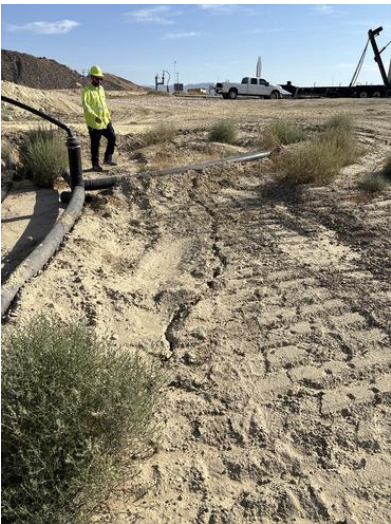
Photo 4

12ftx2ft

Medium 2-4" in width

Extra small <0.5" in height

NE to SW

Cracks were track walked.

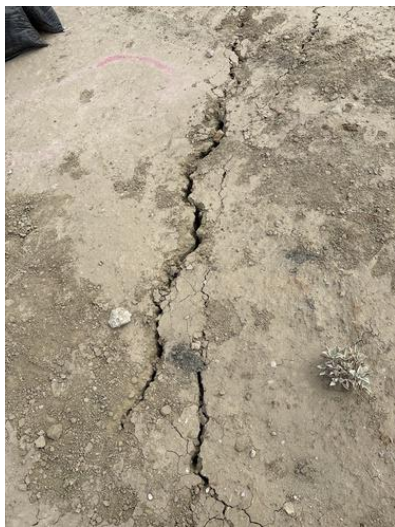
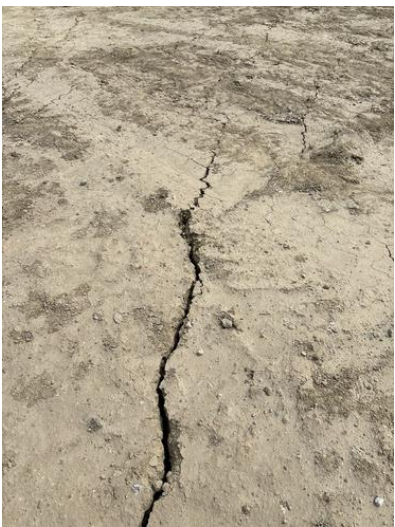
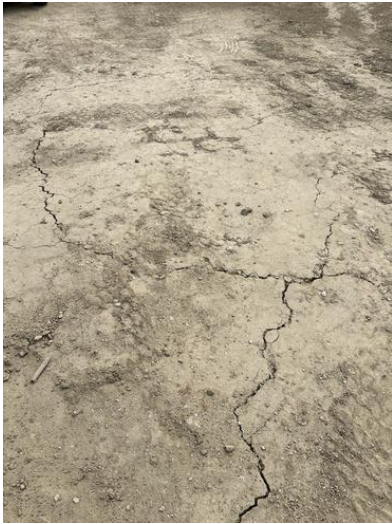
**Length of crack (ft) or area containing multiple cracks (ft x ft)** 40 ft x 30 ft

| <b>Horizontal Offset (width)</b> | Small 0.5-2" in width |
| <b>Vertical Offset (height)</b> | Small 0.5-2" in height |
| <b>Orientation (direction)</b> | E to W |

**Description of repairs** Cracks were track walked.

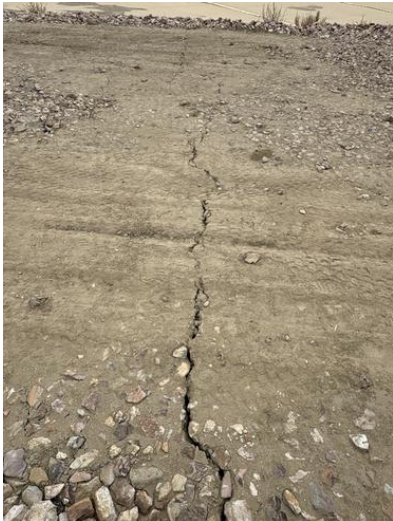
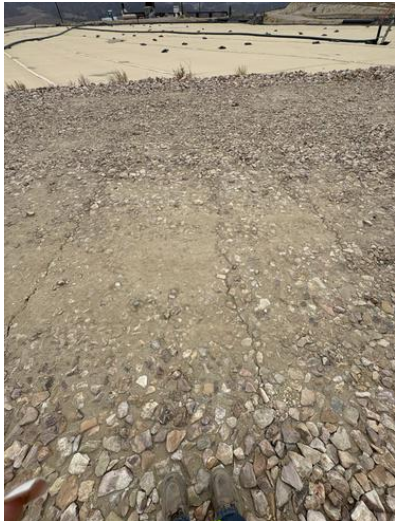
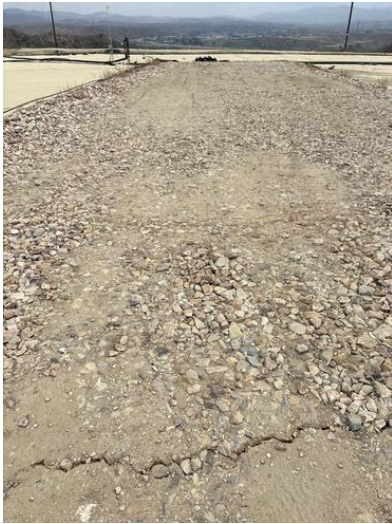
25 ft x 10 ft

Small 0.5-2" in width

Extra small <0.5" in height

N to S

Cracks were track walked.

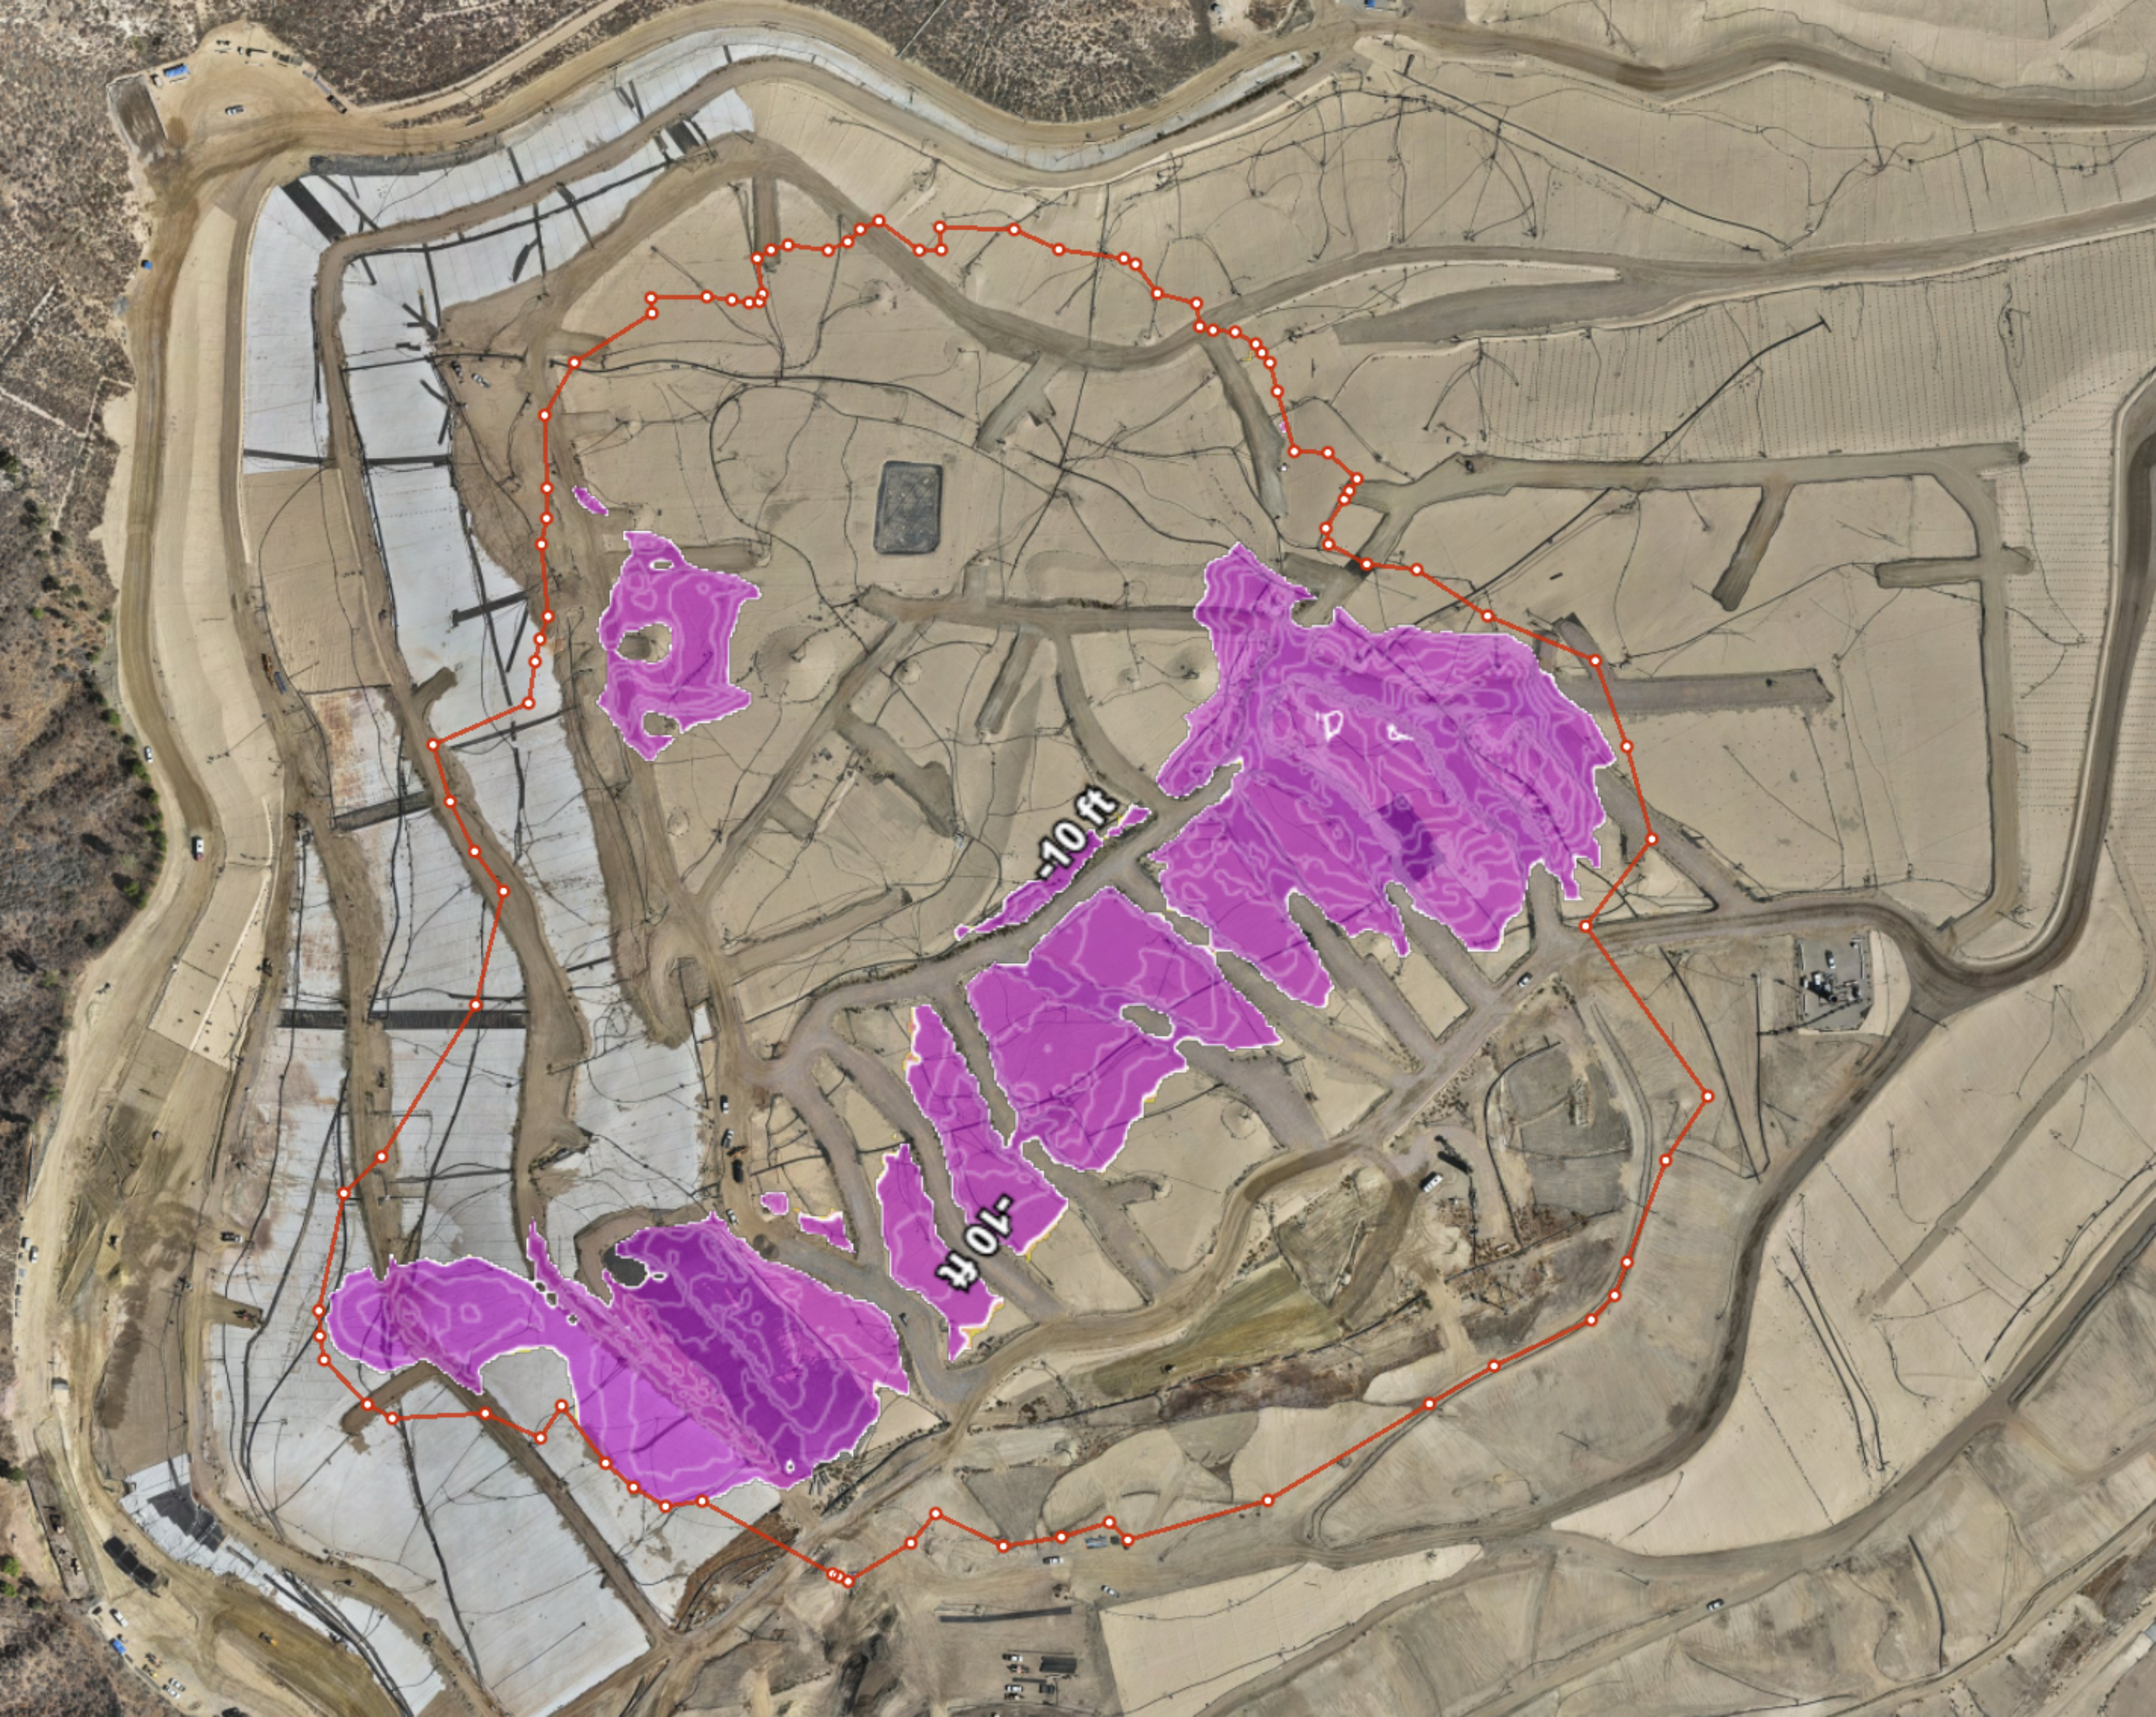
- The map shows the area between 8/27/2025 and 8/26/2026 where the grades have changed more than 10 feet. A typical MSW strain rate is 3% per year - for a landfill with a 300-foot waste column, this would be 9 feet per year.

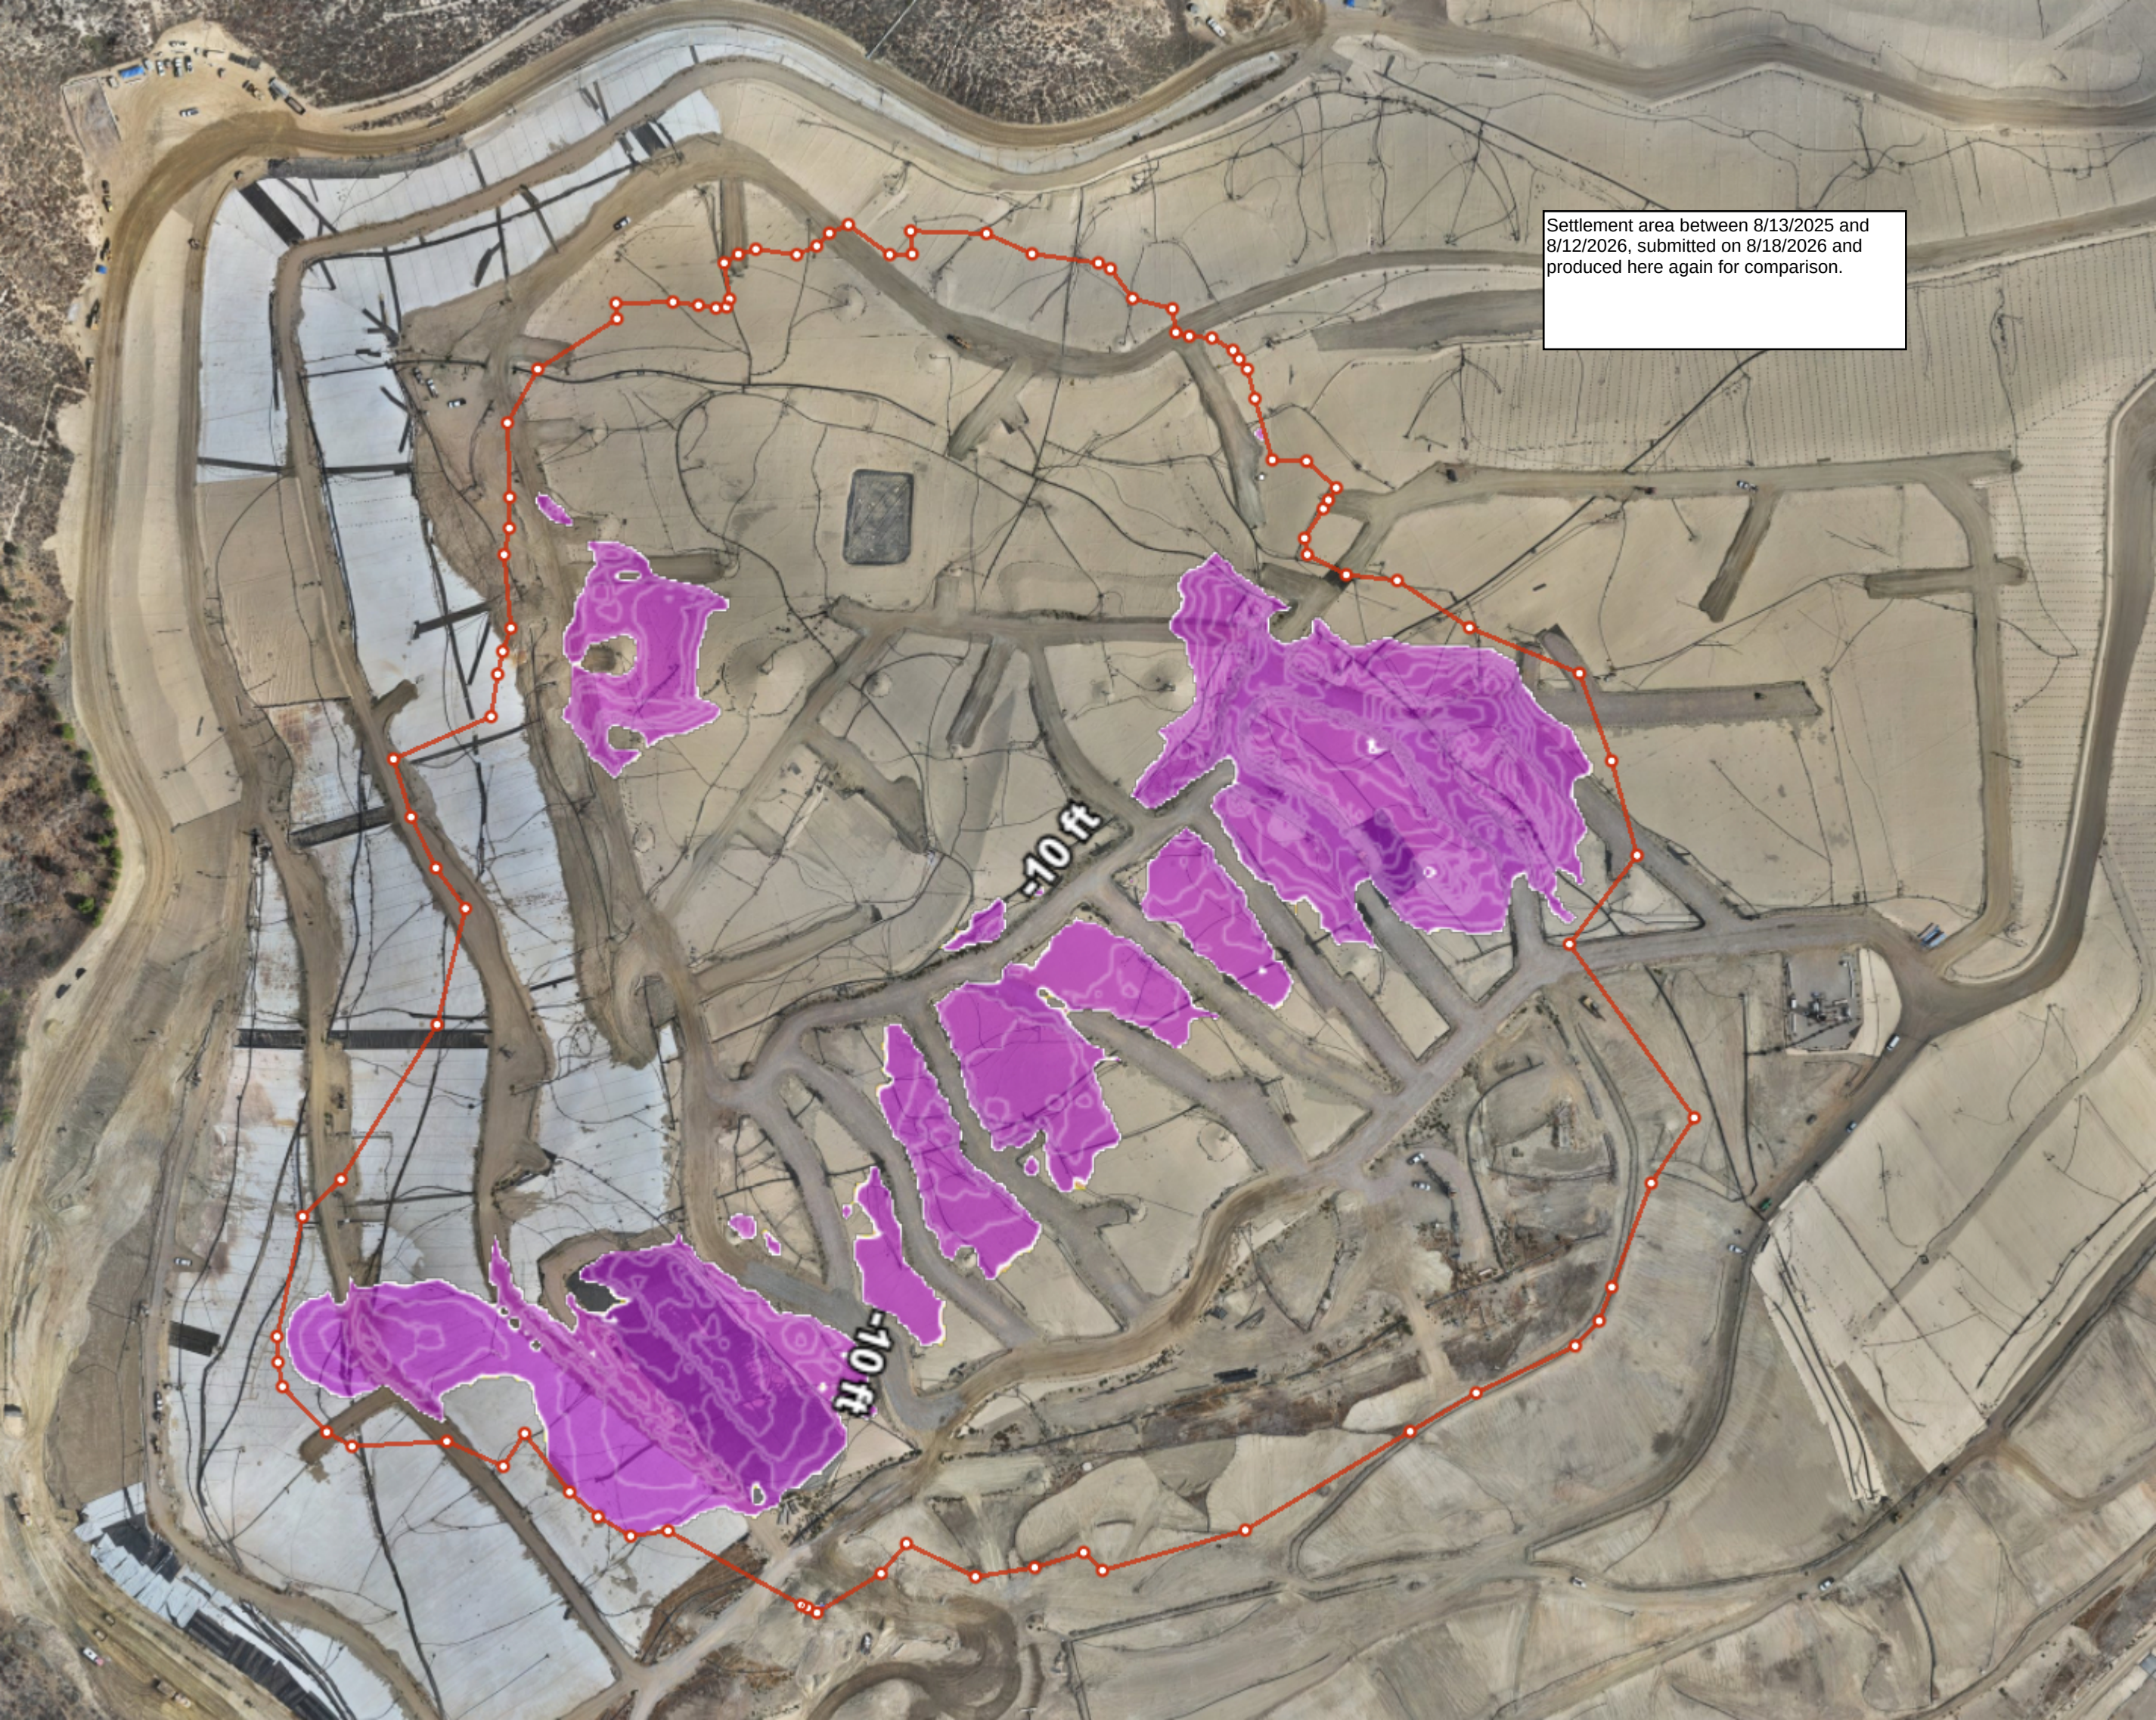
Settlement area between 8/13/2025 and 8/12/2026, submitted on 8/18/2026 and produced here again for comparison.

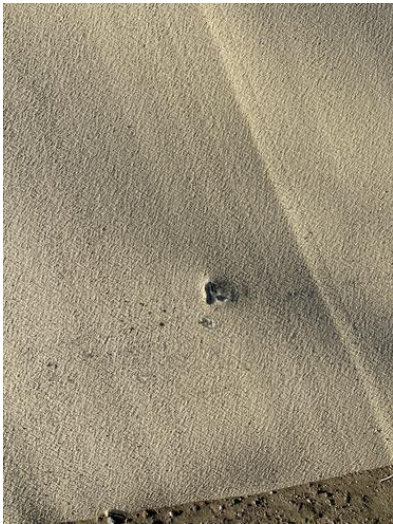
Photo 1

Tear in liner needs to be patched/extrusion welded.

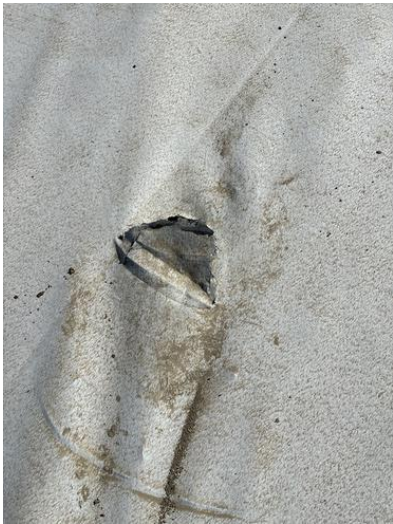
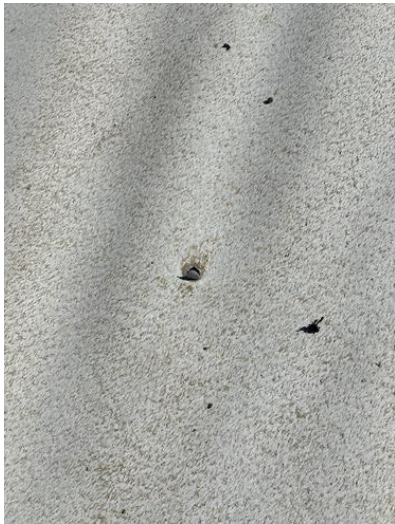
Two tears near each other need to be patched/extrusion welded.

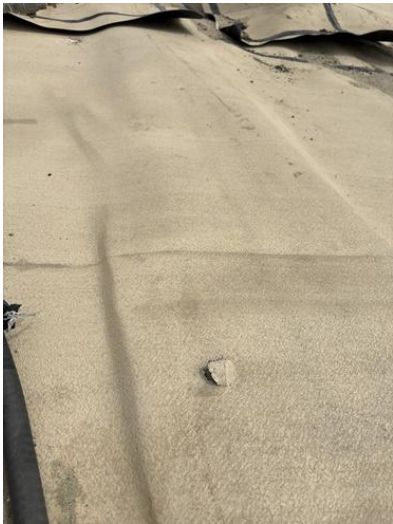
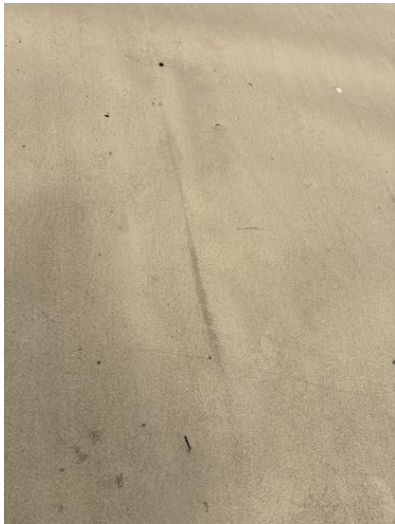
A few tears found near each other  
need to be patched / extrusion  
welded

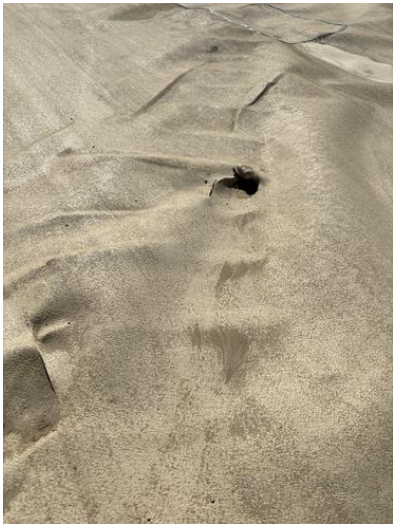
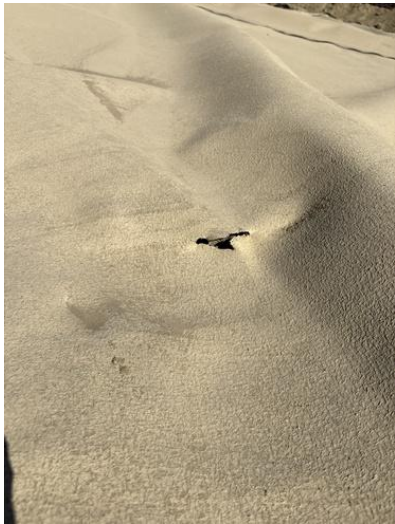
Tears near each other need to be patched/extrusion welded.

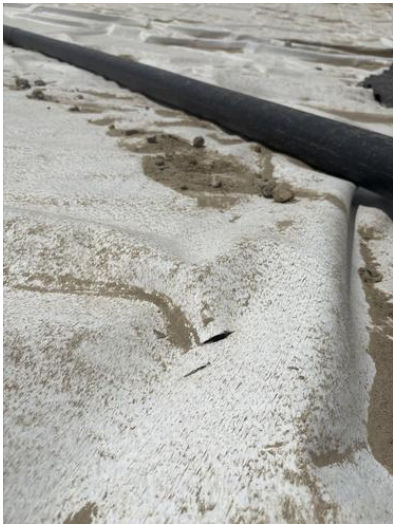
Photo 1

Two tears near each other need to be patched/extrusion welded
