**Re: Chiquita Canyon, LLC's Weekly Leachate Inspection Report for Stipulated Order for Abatement (Case No. 6177-4), Condition 27(c)**

Attachment: Leachate Seep/Pooling Inspection Logs from August 31 – September 6, 2026

# 4050 - Chiquita Leachate Seep/Pooling Inspection

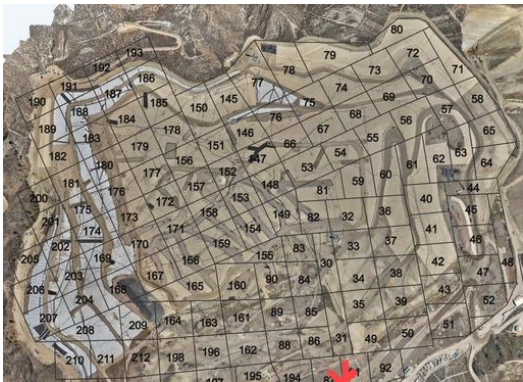
Photo 1

For the week of August 31 through September 6, 2026, leachate seepage was observed on August 31, 2026, in Grid 94 at the Landfill, at approximately 7:53 a.m. The specific location of this seep is shown on the maps included in the attachment. Upon discovery of the seep, Chiquita promptly initiated response and mitigation measures, including adding fresh soil to the affected area. This initial response work was completed by approximately 9:30 a.m. on August 31, 2026. The seepage is estimated to have been present for approximately eight hours. The total volume of leachate associated with this seepage during that period is estimated to have been between one and five gallons. The observed area impacted by the seepage was approximately 12 square feet. The saturation of the soil was characterized as "Saturated." The odor intensity was characterized as "Very Light." This seepage was not observed again during the twice daily inspections during the week. Chiquita is planning to install a collection sump in the area to further minimize the potential for recurrence.

Which grid is the leachate seep/pooling located?

94

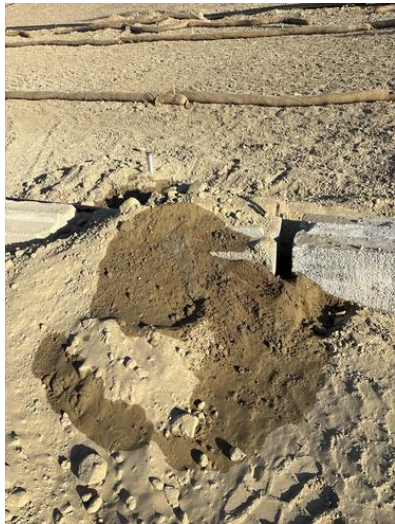
Photo 2

8 hours

1-5 gallons

12 sq ft

1 - Very Light Odor Detected

Saturated

Fresh soil added to contain seep.

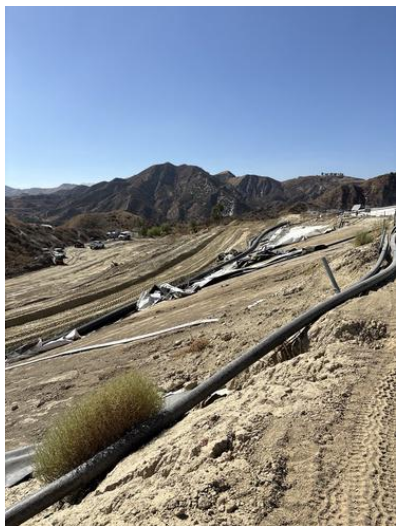
Photo 1

Westside perimeter road. None of the seepage previously observed in this area were observed at the time of this inspection, permanent repairs are being conducted to contain the seepage in this area. The seep observed in grid 94 was not observed at the time of this inspection.

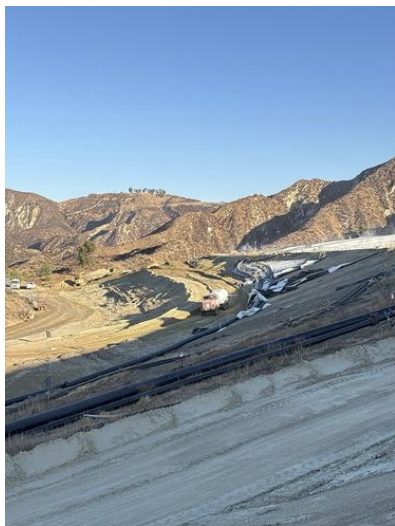
Photo 1

Westside perimeter road. None of the seepage previously observed in this area were observed at the time of this inspection. Permanent repairs are being conducted to contain seepage in this area as well.

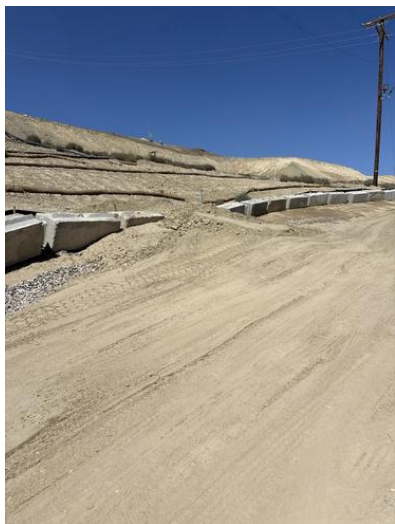
Photo 1

Grid 94. None of the seepage observed in this area or on the Westside was observed at the time of this inspection. Permanent repairs to the westside are currently underway.

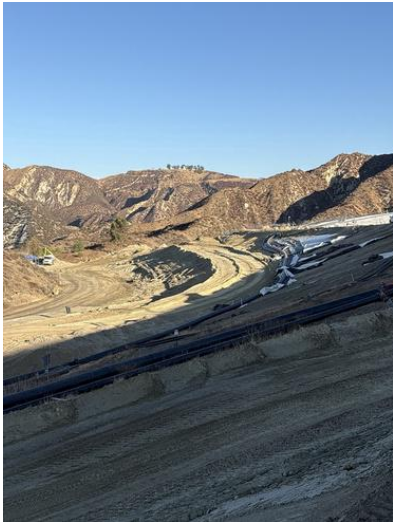
Photo 1

Westside perimeter road. None of the seepage previously observed in this area were observed at the time of this inspection. Permanent repairs are being conducted to contain seepage in this area as well.

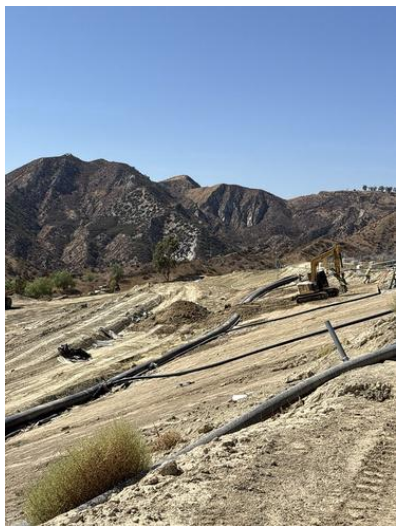
Photo 1

Westside perimeter road. None of the seepage previously observed in this area were observed at the time of this inspection. Permanent repairs are being conducted to contain seepage in this area as well.

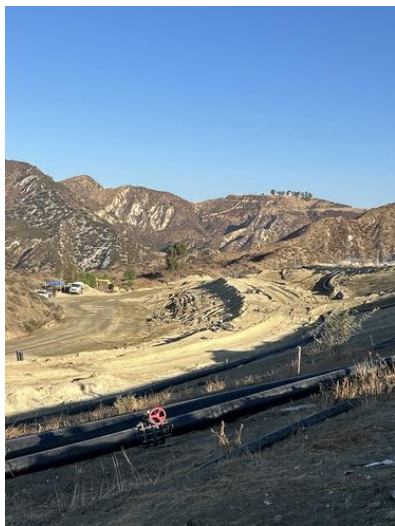
Photo 1

Westside perimeter road. None of the seepage previously observed in this area were observed at the time of this inspection. Permanent repairs are being conducted to contain seepage in this area as well.

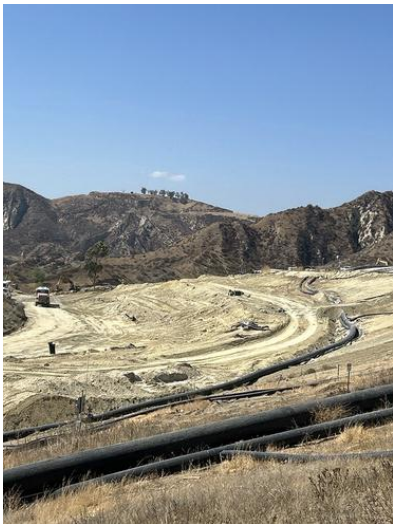
Photo 1

Westside perimeter road. None of the seepage previously observed in this area were observed at the time of this inspection. Permanent repairs are being conducted to contain seepage in this area as well.

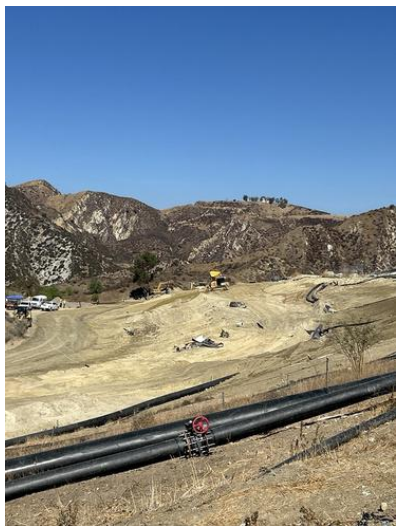
Photo 1

Westside perimeter road. None of the seepage previously observed in this area were observed at the time of this inspection. Permanent repairs are being conducted to contain seepage in this area as well.

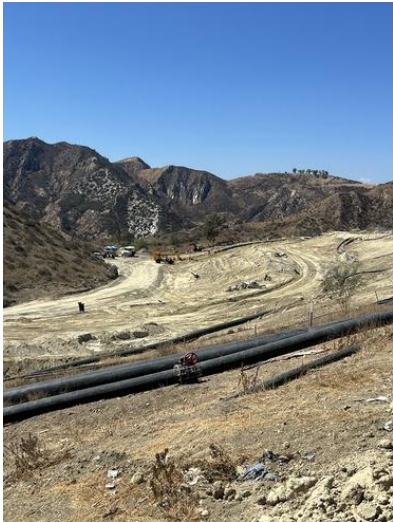
Photo 1

Westside perimeter road. None of the seepage previously observed in this area were observed at the time of this inspection. Permanent repairs are being conducted to contain seepage in this area as well.

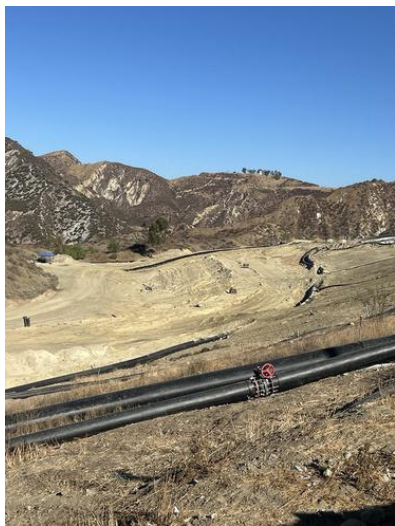
Photo 1

Westside perimeter road. None of the seepage previously observed in this area were observed at the time of this inspection. Permanent repairs are being conducted to contain seepage in this area as well.

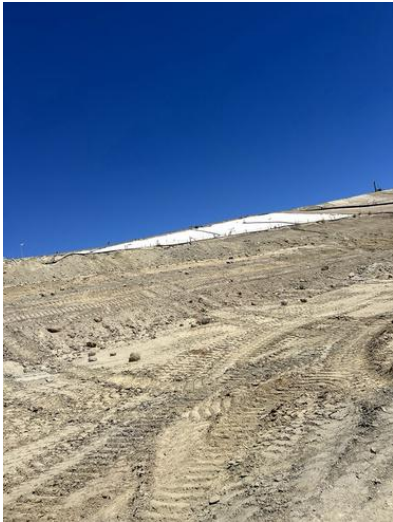
Photo 1

Westside perimeter road. None of the seepage previously observed in this area were observed at the time of this inspection. Permanent repairs are being conducted to contain seepage in this area as well.

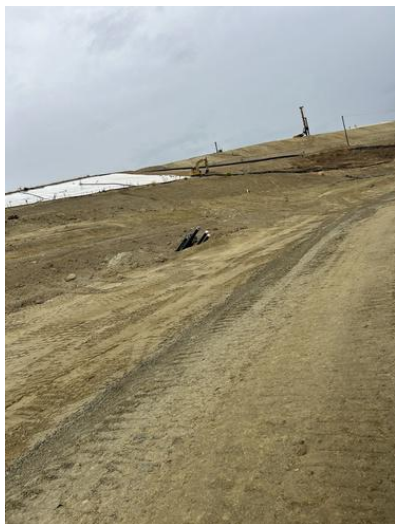
Photo 1

Westside perimeter road. None of the seepage previously observed in this area were observed at the time of this inspection. Permanent repairs are being conducted to contain seepage in this area as well.

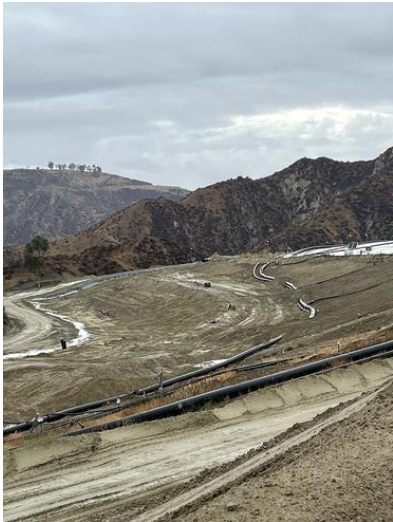
Photo 1

Westside perimeter road. None of the seepage previously observed in this area were observed at the time of this inspection. Permanent repairs are being conducted to contain seepage in this area as well.
