**CHIQUITA CANYON**  
*A Waste Connections Company*

**Re: Chiquita Canyon, LLC's Weekly Report on the Documentation and Tracking of Cover Issues, Monthly Summary, and Monthly Isopach Map**

# 4050 - Chiquita Reaction Area Tracking of Fissures and Tension Cracks

# 4050 - Geosynthetic Cover Inspection

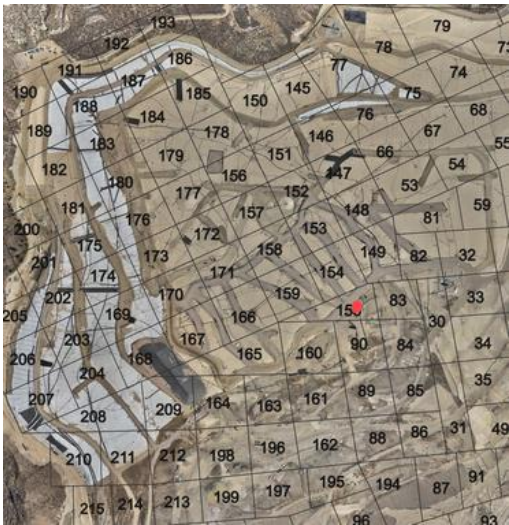
Grid Location

Using the attached image, annotate all areas where inspectors identified a fissure or tension crack.

155

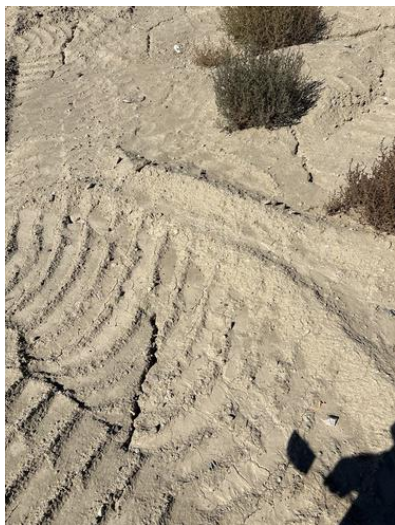
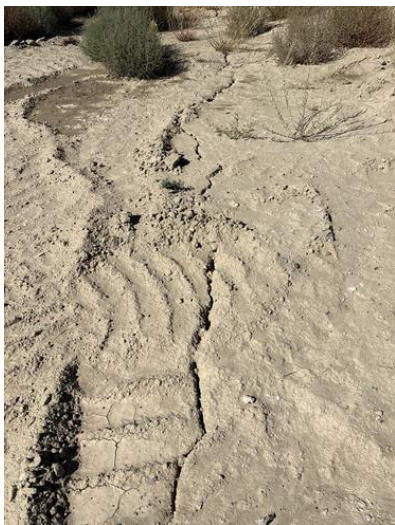
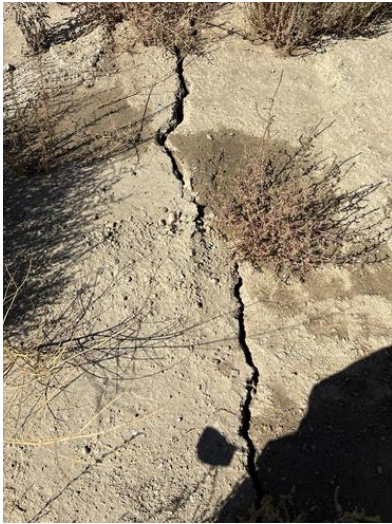
**Length of crack (ft) or area containing multiple cracks (ft x ft)** 75 ft x 35 ft

No individual crack 50ft or longer

**Horizontal Offset (width)** Medium 2-4" in width

**Vertical Offset (height)** Extra small <0.5" in height

**Orientation (direction)** N to S

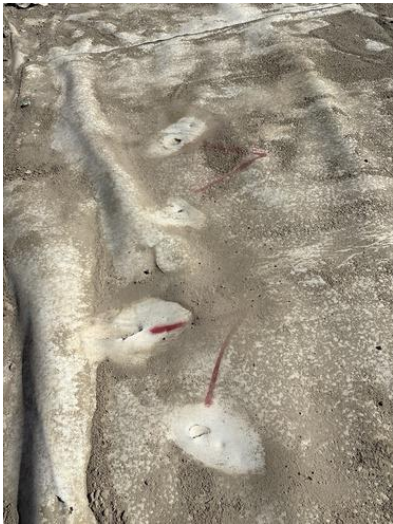
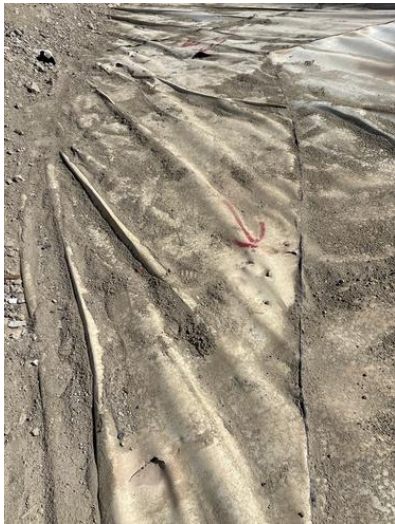
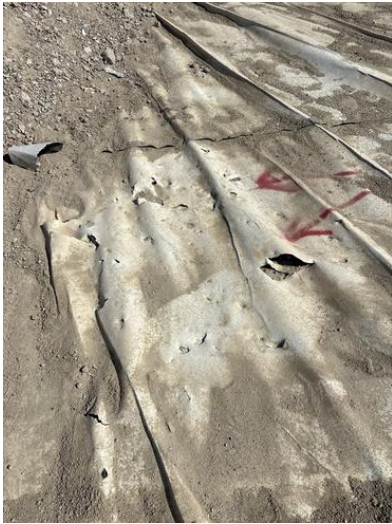
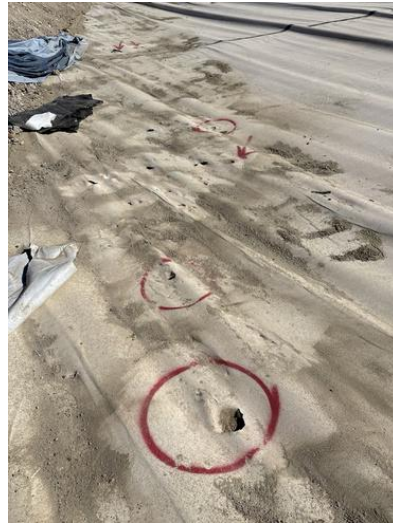
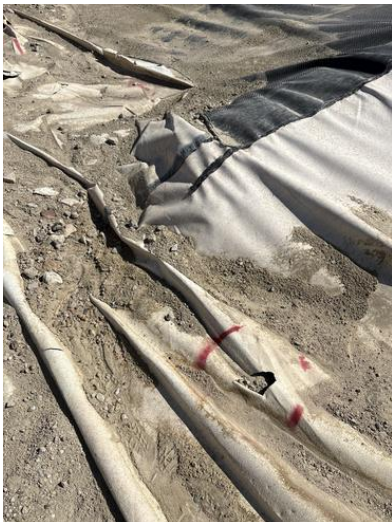
Multiple tears need to be patched/extrusion welded.

19. Multiple tears in Grid 202 need to be patched/extrusion welded. Tears taped on discovery and then patched on extrusion welded.

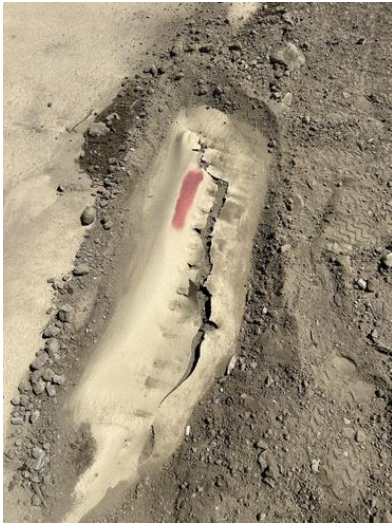
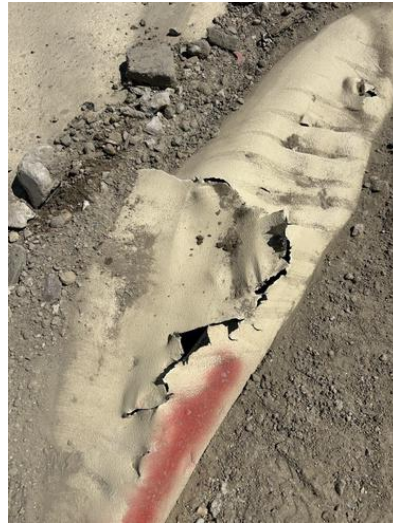
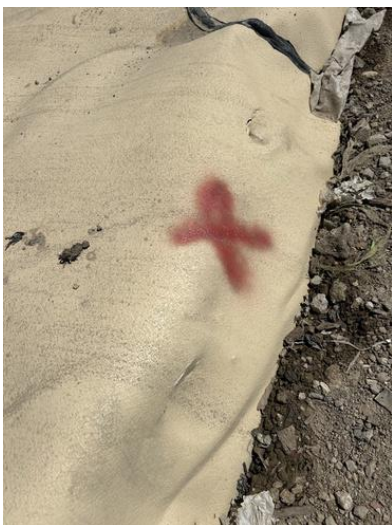
Liner torn. Needs to be patched  
and extrusion welded
