**Re: Chiquita Canyon, LLC's Weekly Leachate Inspection Report for Stipulated Order for Abatement (Case No. 6177-4), Condition 27(c)**

# 4050 - Chiquita Leachate Seep/Pooling Inspection

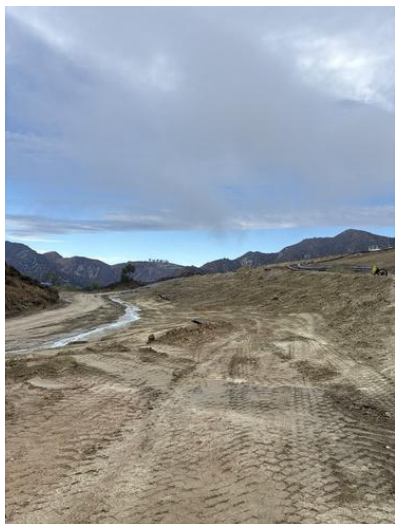
Photo 1

Westside perimeter road. None of the seepage previously observed in this area were observed at the time of this inspection. Permanent repairs are being conducted to contain seepage in this area as well.

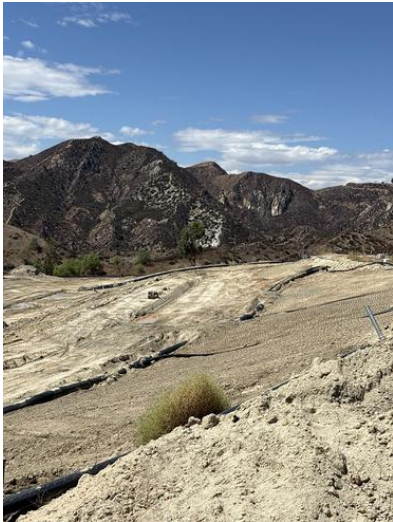
Photo 1

Westside perimeter road. None of the seepage previously observed in this area were observed at the time of this inspection. Permanent repairs are being conducted to contain seepage in this area as well.

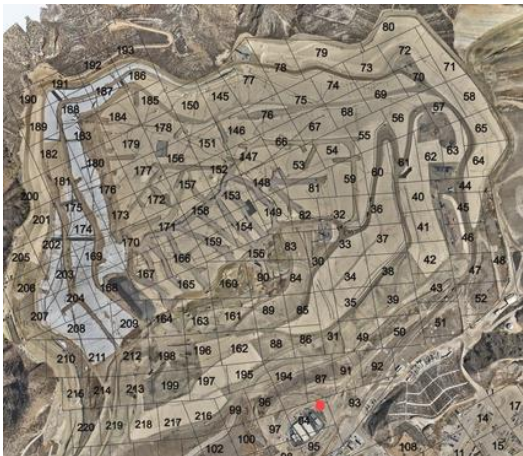
94

Castaic CA 91384  
United States  
(34.43109548536677,  
-118.64515220812355)

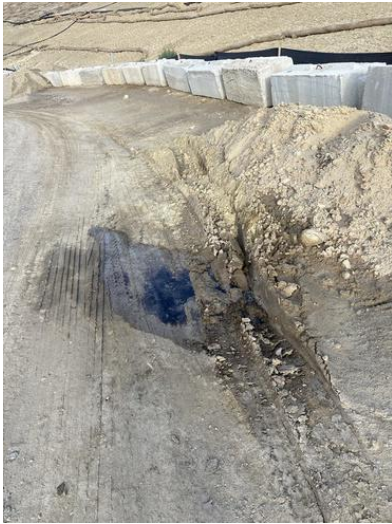
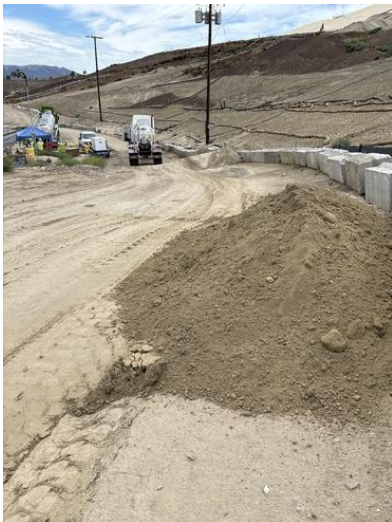
Photo 1

For the week of September 7 through September 13, 2026, leachate seepage was observed on September 8, 2026, in Grid 94 at the Chiquita Canyon Landfill (the "Landfill"), at approximately 8:05 a.m. The specific location of this seep is shown on the maps included in the attachment. Upon discovery of the seep, Chiquita promptly initiated response and mitigation measures, including adding fresh soil to the affected area. This initial response work was completed by approximately 9:30 a.m. on September 8, 2026. The seepage is estimated to have been present for approximately five hours. The total volume of leachate associated with this seepage during that period is estimated to have been between one and five gallons. The observed area impacted by the seepage was approximately 16 square feet. The saturation of the soil was characterized as "Standing free liquid." The odor intensity was characterized as "Very Light." This seepage was not observed again during the twice daily inspections during the week. Chiquita is planning to install a collection sump in the area to further minimize the potential for recurrence.

8 Sep 2026 8:05 AM PDT

5 hours

1-5 gallons

16 sq ft

1 - Very Light Odor Detected

Standing free liquid

Fresh soil added. Seep collector planned to be installed later this month.

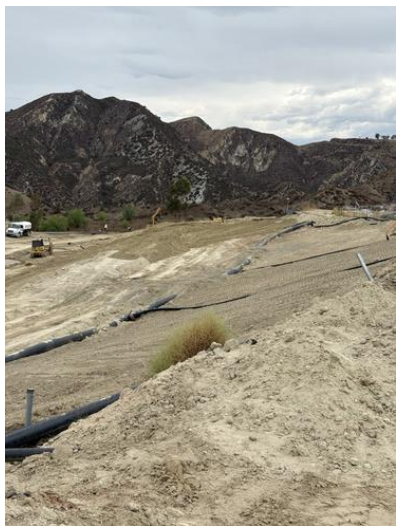
Photo 1

Westside perimeter road. None of the seepage previously observed in this area were observed at the time of this inspection, permanent repairs are being conducted to contain the seepage in this area. The seep observed in grid 94 was not observed at the time of this inspection.

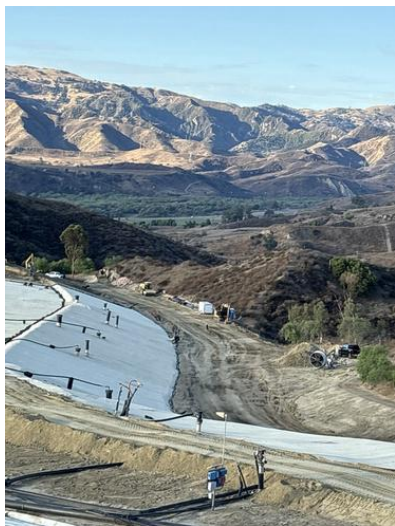
Photo 1

Westside perimeter road. None of the seepage previously observed in this area were observed at the time of this inspection. Permanent repairs are being conducted to contain seepage in this area as well.

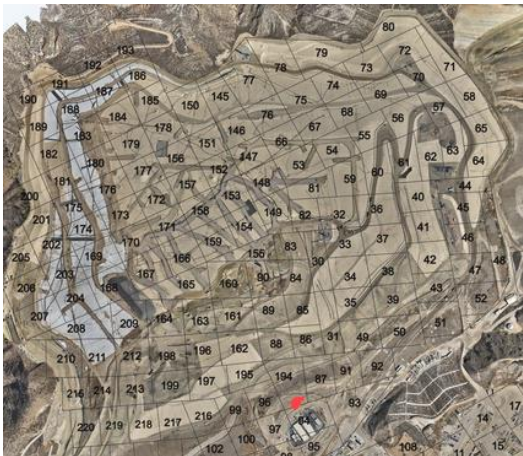
Which grid is the leachate seep/pooling located? 194

Drop Pin to record lat/long of seep/pooling location. Castaic CA 91384 United States (34.429721642482185, -118.64545066355299)

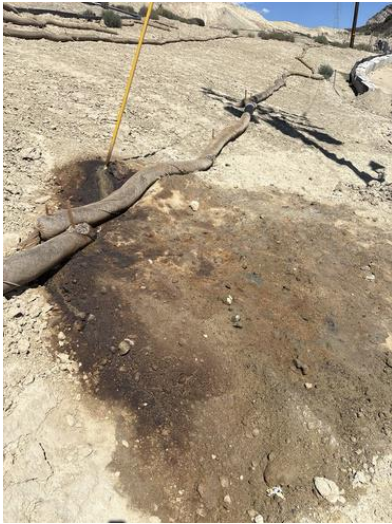
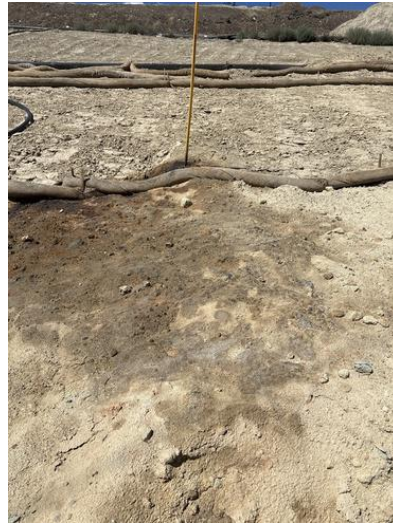
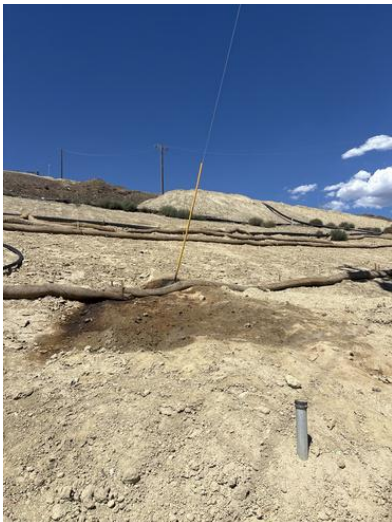
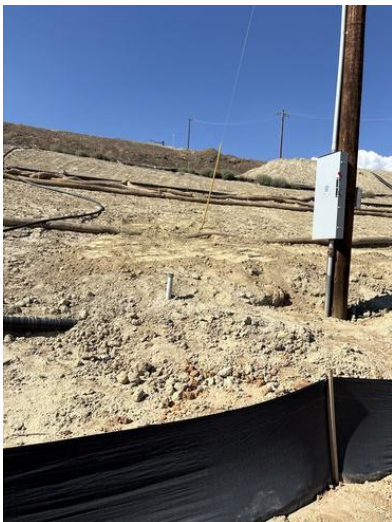
discovery of the seep, Chiquita promptly initiated response and mitigation measures, including adding fresh soil to the affected area. This initial response work was completed by approximately 3:00 p.m. on September 9, 2026. The seepage is estimated to have been present for approximately five hours. The total volume of leachate associated with this seepage is estimated to have been between 11 and 20 gallons. The observed area impacted by the seepage was approximately 35 square feet. The saturation of the soil was characterized as “Standing free liquid.” The odor intensity was characterized as “Light.”

Time seep/pooling was discovered 9 Sep 2026 1:06 PM PDT

Estimated duration of presence of leachate at such location 5 hours

Estimated quantity of leachate 11-20 gallons

Extent of area impacted (approximate sq ft impacted) 35 sq ft

Odor intensity 2 - Light Odor Detected

Surrounding soil saturation level Standing free liquid

Soil added and compacted

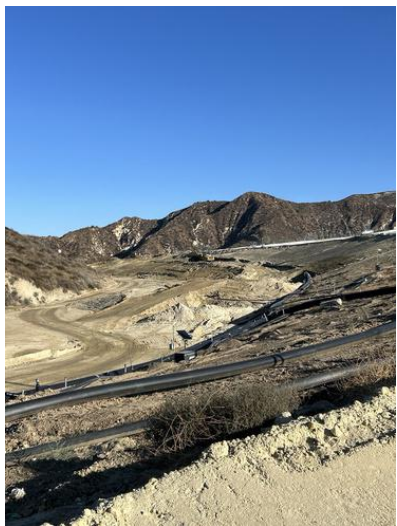
Photo 1

Westside perimeter road. None of the seepage previously observed in this area were observed at the time of this inspection. Permanent repairs are being conducted to contain seepage in this area as well.

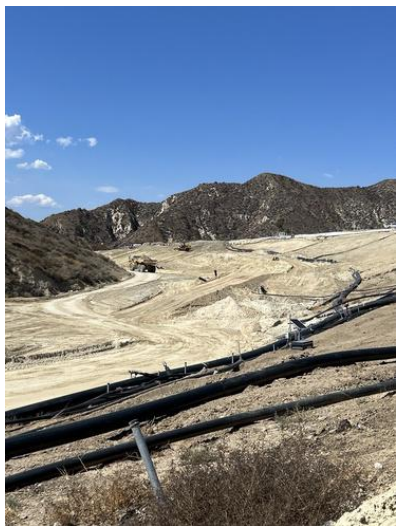
Photo 1

Westside perimeter road. None of the seepage previously observed in this area were observed at the time of this inspection. Permanent repairs are being conducted to contain seepage in this area as well.

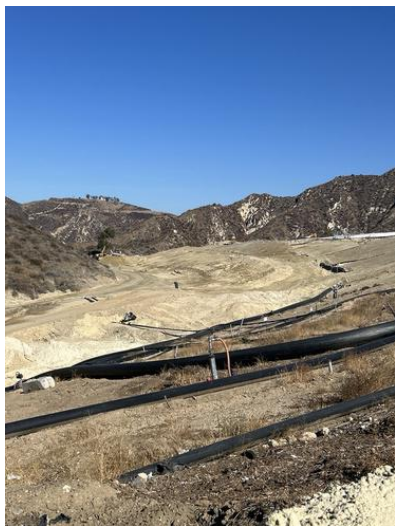
Photo 1

Westside perimeter road. None of the seepage previously observed in this area were observed at the time of this inspection. Permanent repairs are being conducted to contain seepage in this area as well.

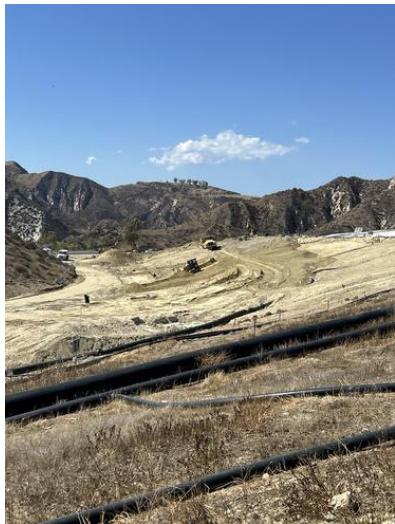
Photo 1

Westside perimeter road. None of the seepage previously observed in this area were observed at the time of this inspection. Permanent repairs are being conducted to contain seepage in this area as well.

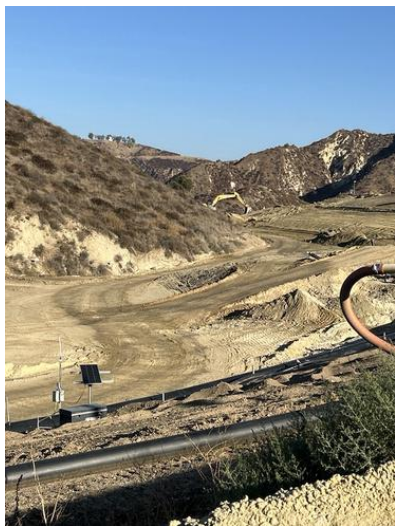
Photo 1

Westside perimeter road. None of the seepage previously observed in this area were observed at the time of this inspection. Permanent repairs are being conducted to contain seepage in this area as well.

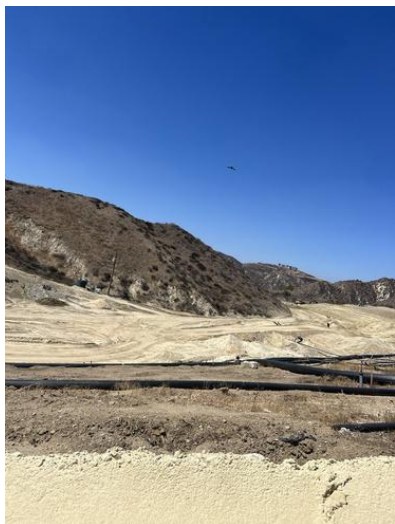
Photo 1

Westside perimeter road. None of the seepage previously observed in this area were observed at the time of this inspection. Permanent repairs are being conducted to contain seepage in this area as well.

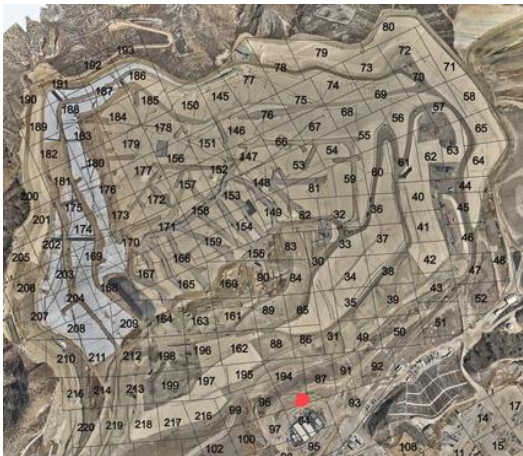
194

Castaic CA 91384  
United States  
(34.43099405154067,  
-118.6455685739579)

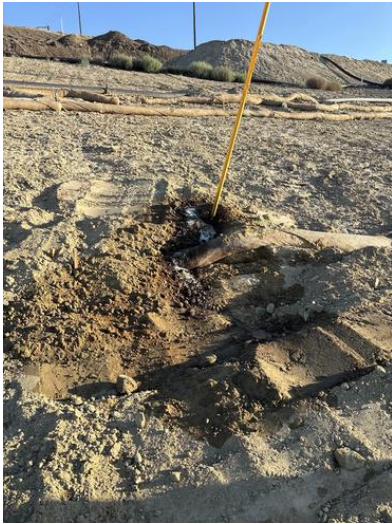
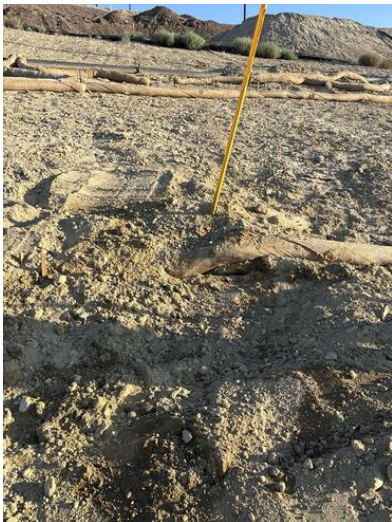
Photo 1

Seepage was again observed in Grid 194 on September 13, at approximately 7:27 a.m. Chiquita continued to implement response measures, including adding fresh soil to the affected area. The seepage was estimated to have been present for approximately four hours. The total volume of leachate associated with this seepage is estimated to have been between six and ten gallons. The observed area impacted by the seepage was approximately 16 square feet. The saturation of the soil was characterized as “Standing free liquid.” The odor was characterized as “Light.” The seepage was not observed during the afternoon inspection conducted that same day.

13 Sep 2026 7:27 AM PDT

4 hours

6-10 gallons

16 sqft

2 - Light Odor Detected

Standing free liquid

Soil added

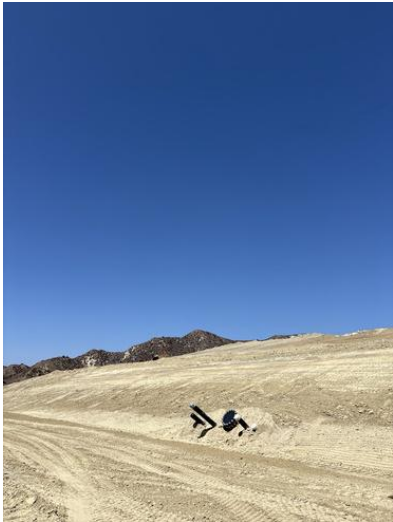
Photo 1

Westside perimeter road. None of the seepage previously observed in this area were observed at the time of this inspection. Permanent repairs are being conducted to contain seepage in this area as well. The seep observed this morning in grid 194 was not observed during this inspection.
