**Re: Chiquita Canyon, LLC's Weekly Leachate Inspection Report for Stipulated Order for Abatement (Case No. 6177-4), Condition 27(c)**

Attachment: Leachate Seep/Pooling Inspection Logs from September 14 – September 20, 2026

# 4050 - Chiquita Leachate Seep/Pooling Inspection

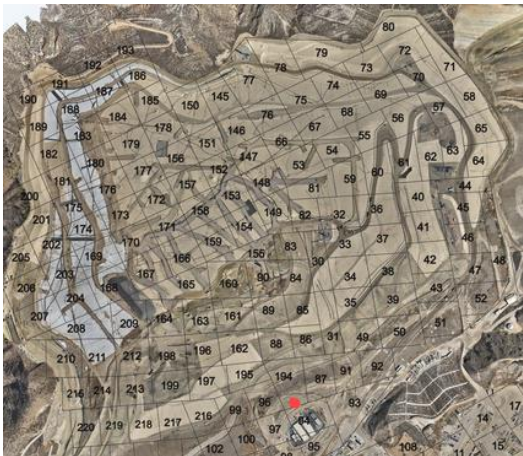
194

Indicate on the map the location

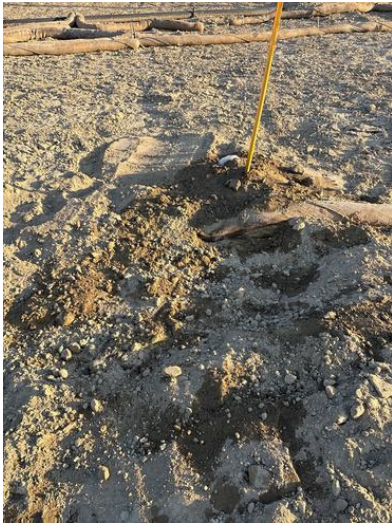
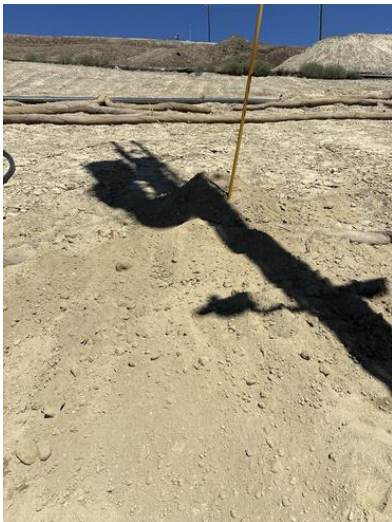
Photo 1

3 hours

1-5 gallons

16 sq ft

1 - Very Light Odor Detected

Saturated

Soil added to contain seep.

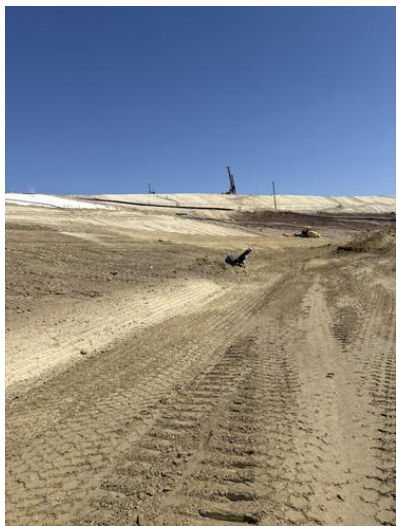
Photo 1

Westside perimeter road. None of the seepage previously observed in this area were observed at the time of this inspection. Permanent repairs are being conducted to contain seepage in this area as well. The seep observed in grid 194 was not observed at the time of this inspection.

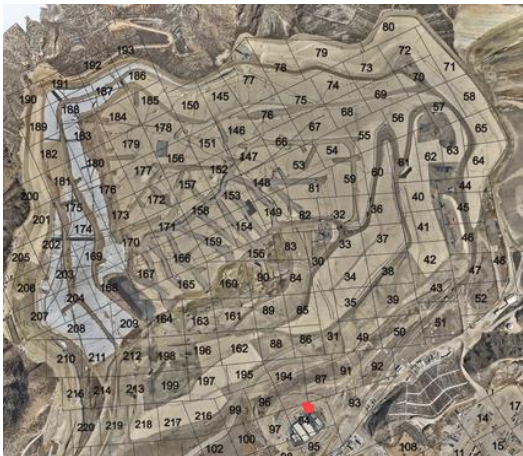
94

Indicate on the map the location

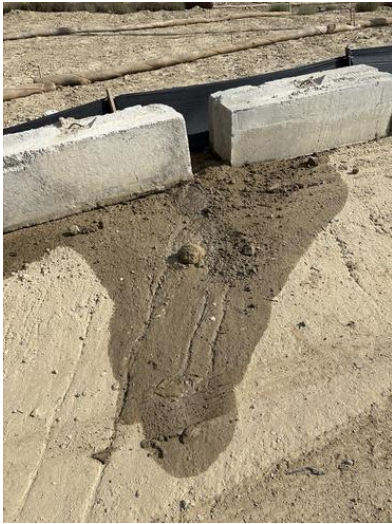
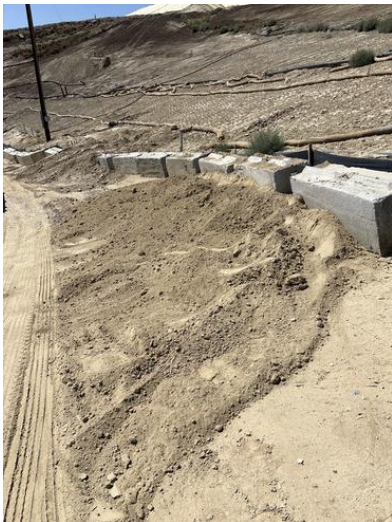
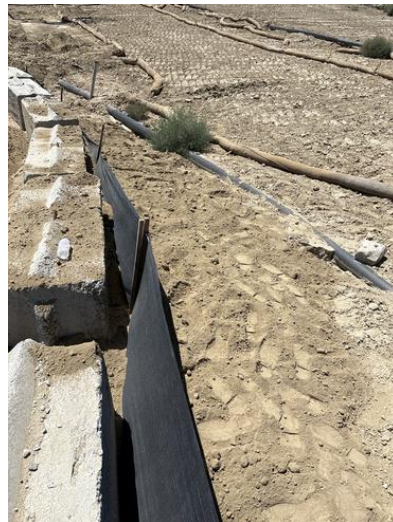
Photo 1

6 hours

11-20 gallons

100 sq ft

Standing free liquid

Soil added to contain seep

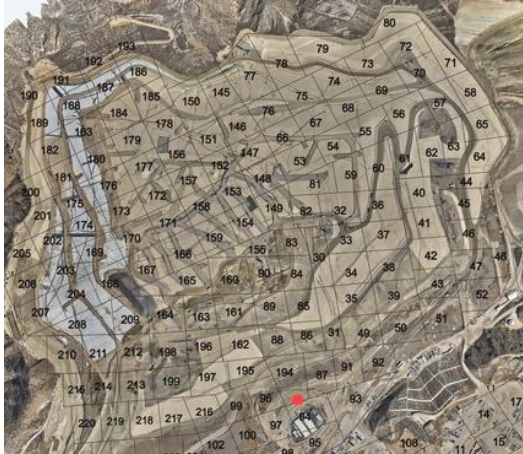
194

**Indicate on the map the location**

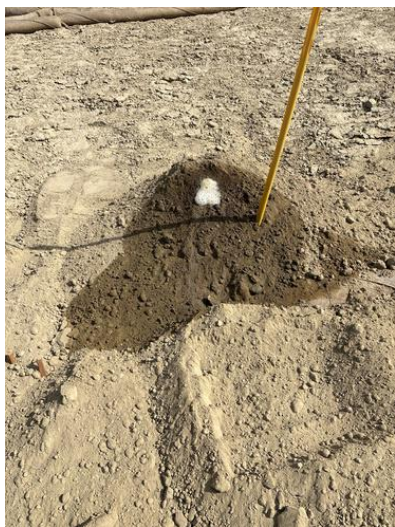
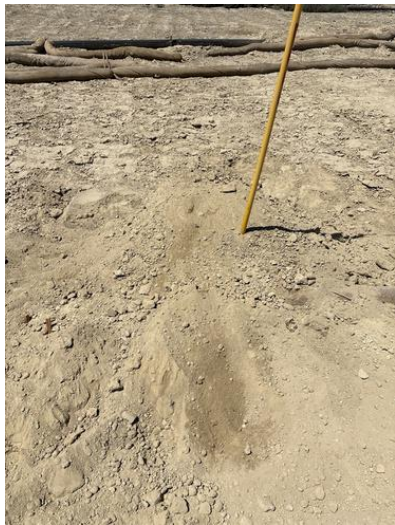
Photo 4

Estimated duration of presence of leachate at such location4 hours

Estimated quantity of leachate1-5 gallons

Extent of area impacted (approximate sq ft impacted)4 sq ft

Surrounding soil saturation levelStanding free liquid

Soil added to contain seep

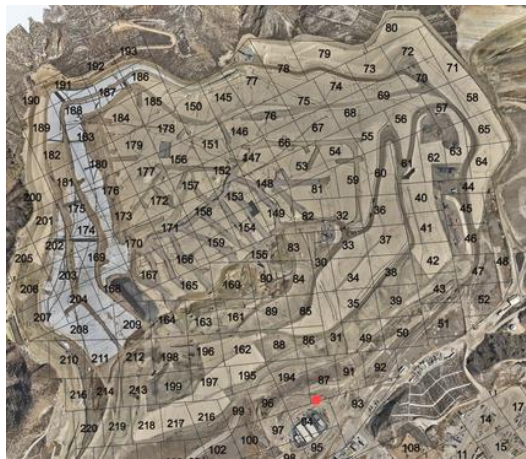
87

Indicate on the map the location

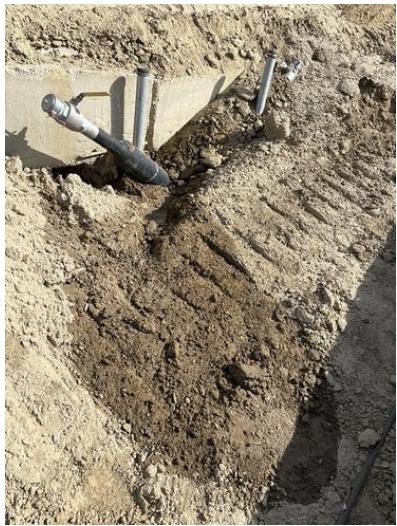
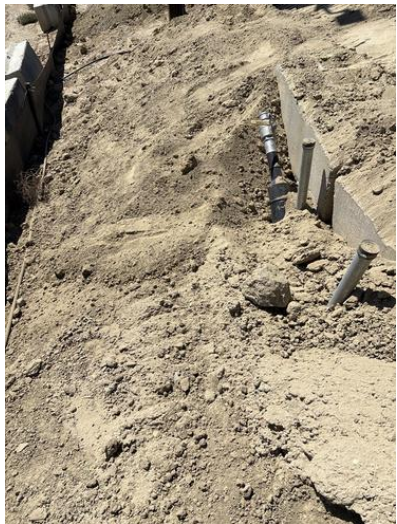
Photo 6

4 hours

1-5 gallons

| Extent of area impacted (approximate sq ft impacted) | 10sq ft |
| Surrounding soil saturation level | Saturated |

Soil added to contain seep

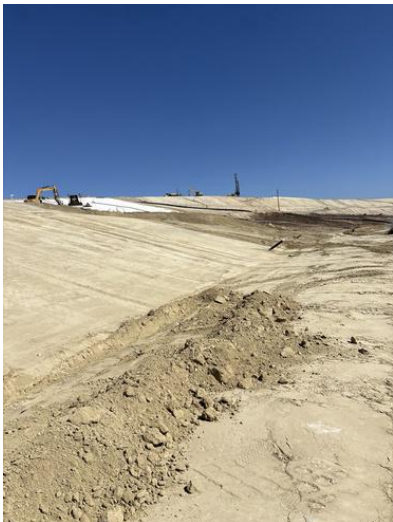
Photo 1

Westside perimeter road. None of the seepage previously observed in this area were observed at the time of this inspection, permanent repairs are being conducted to contain the seepage in this area. The seep observed in grids 94, 194, and 87 were not observed at the time of this inspection.

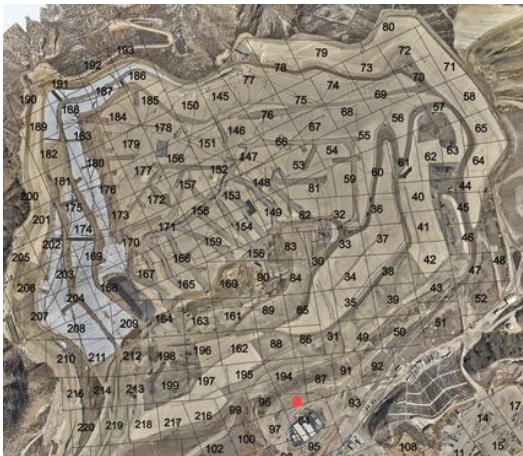
Which grid is the leachate seep/pooling located? 194

Indicate on the map the location

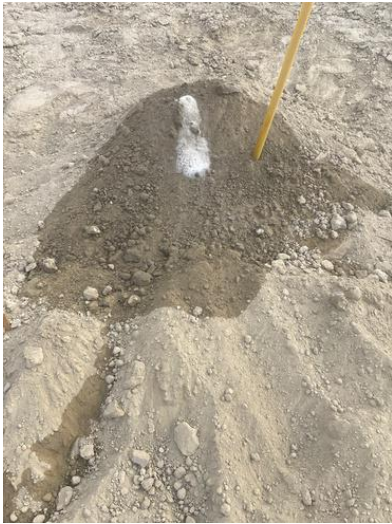
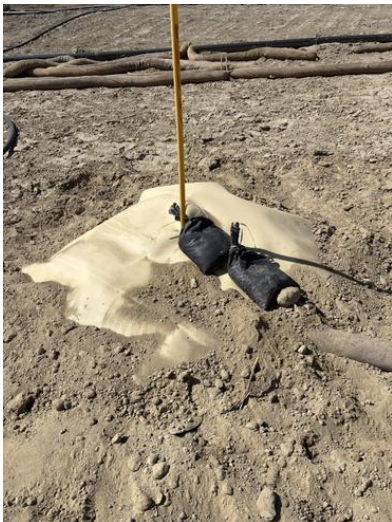
Photo 1

Estimated duration of presence of leachate at such location 4 hours

Estimated quantity of leachate 1-5 gallons

Extent of area impacted (approximate sq ft impacted) 8sq ft

Surrounding soil saturation level Standing free liquid

Dirt added and a piece of liner put in place to contain seep.

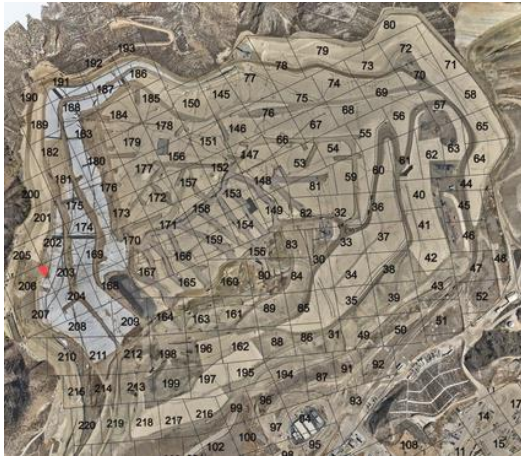
206

**Indicate on the map the location**

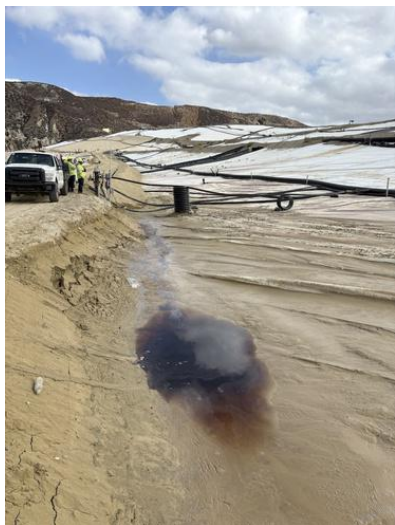
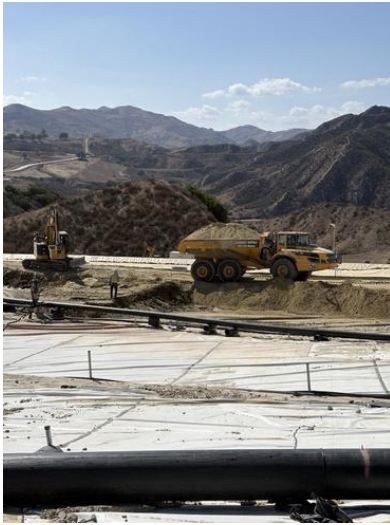
Photo 3

11-20 gallons

150 sq ft

4 - Strong Odor

Standing free liquid

Liquid vacuumed out. The previously buried drainage pipe, which had been temporarily plugged during the West Toe Project, was uncovered and the plug was removed. The pipe is now open and properly draining into the West Toe Project area as intended.

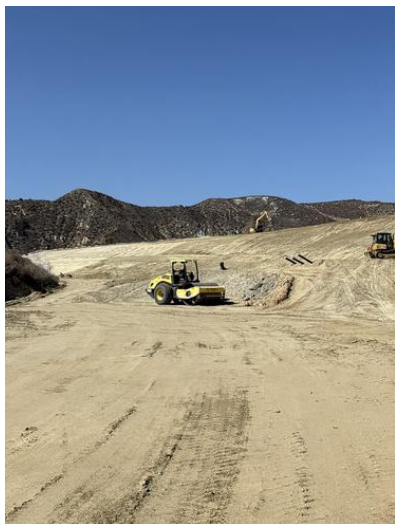
Photo 1

Westside perimeter road. None of the seepage previously observed in this area were observed at the time of this inspection, permanent repairs are being conducted to contain the seepage in this area. The seeps observed in grid 194 and 206 were not observed at the time of this inspection.

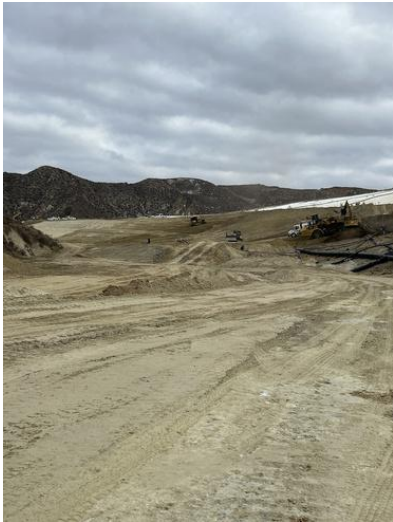
Photo 1

Westside perimeter road. None of the seepage previously observed in this area were observed at the time of this inspection. Permanent repairs are being conducted to contain seepage in this area as well.

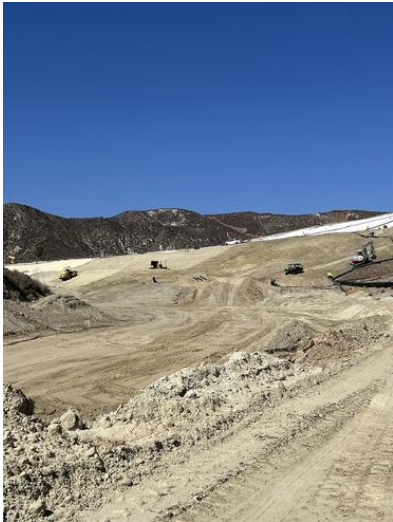
Photo 1

Westside perimeter road. None of the seepage previously observed in this area were observed at the time of this inspection. Permanent repairs are being conducted to contain seepage in this area as well.

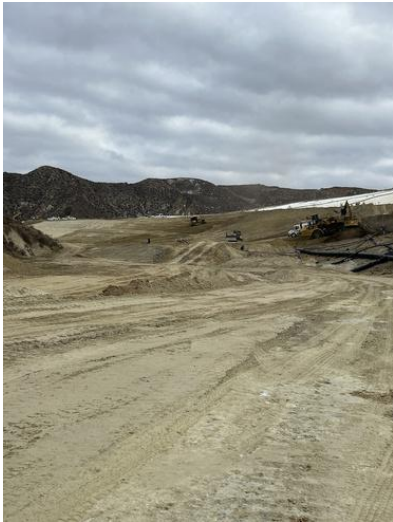
Photo 1

Westside perimeter road. None of the seepage previously observed in this area were observed at the time of this inspection. Permanent repairs are being conducted to contain seepage in this area as well.

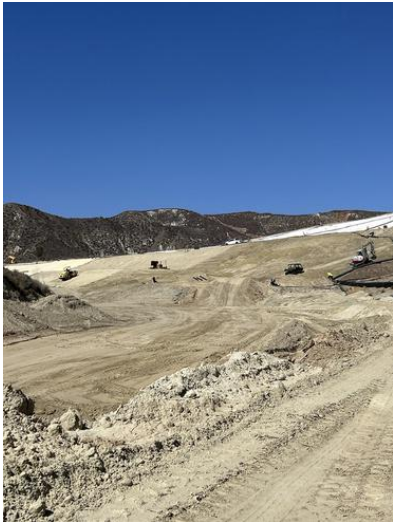
Photo 1

Westside perimeter road. None of the seepage previously observed in this area were observed at the time of this inspection. Permanent repairs are being conducted to contain seepage in this area as well.

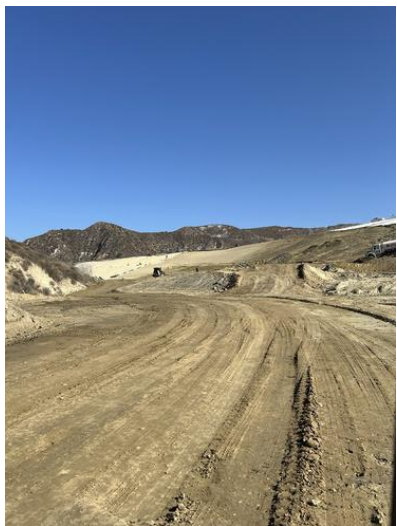
Photo 1

Westside perimeter road. None of the seepage previously observed in this area were observed at the time of this inspection. Permanent repairs are being conducted to contain seepage in this area as well.

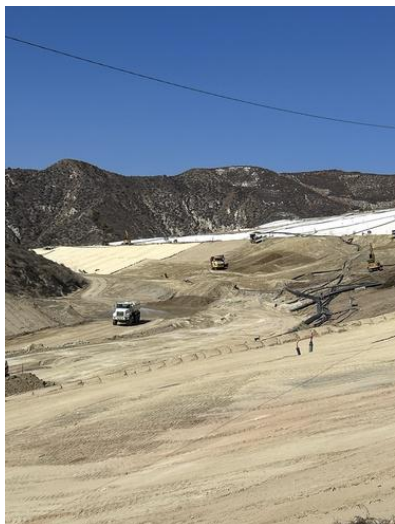
Photo 1

Westside perimeter road. None of the seepage previously observed in this area were observed at the time of this inspection. Permanent repairs are being conducted to contain seepage in this area as well.

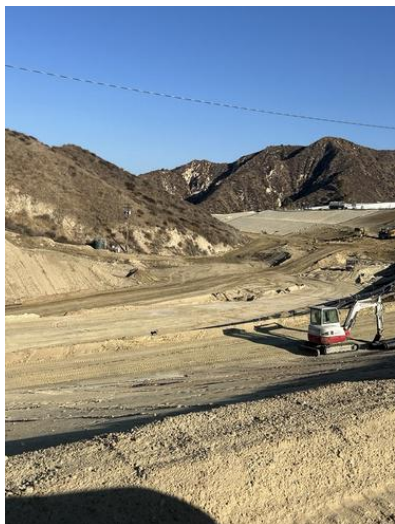
Photo 1

Westside perimeter road. None of the seepage previously observed in this area were observed at the time of this inspection. Permanent repairs are being conducted to contain seepage in this area as well.

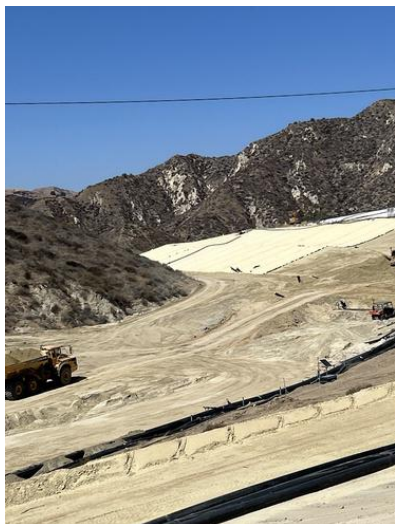
Photo 1

Westside perimeter road. None of the seepage previously observed in this area were observed at the time of this inspection. Permanent repairs are being conducted to contain seepage in this area as well.

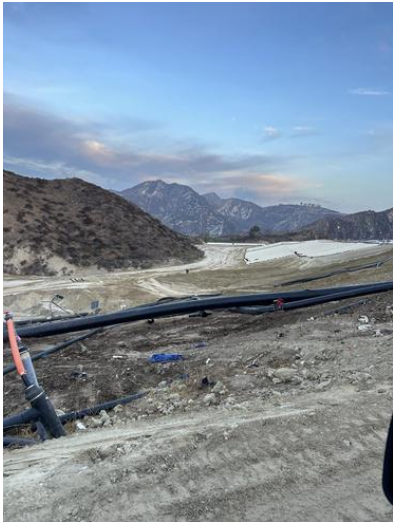
Photo 1

Westside perimeter road. None of the seepage previously observed in this area were observed at the time of this inspection. Permanent repairs are being conducted to contain seepage in this area as well.

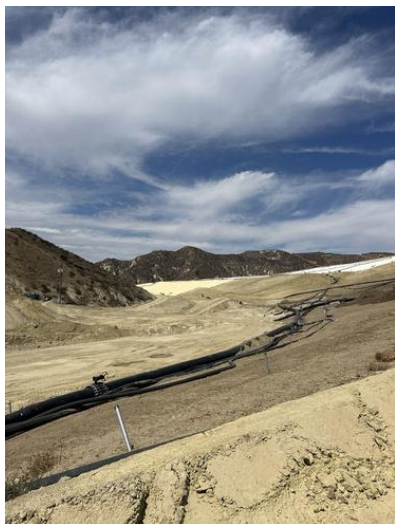
Photo 1

Westside perimeter road. None of the seepage previously observed in this area were observed at the time of this inspection. Permanent repairs are being conducted to contain seepage in this area as well.
