**CHIQUITA CANYON**  
*A Waste Connections Company*

**Re: Chiquita Canyon, LLC's Weekly Report on the Documentation and Tracking of Cover Issues**

Attachment: September 22, 2026 Weekly Cover Issues Report

# 4050 - Geosynthetic Cover Inspection

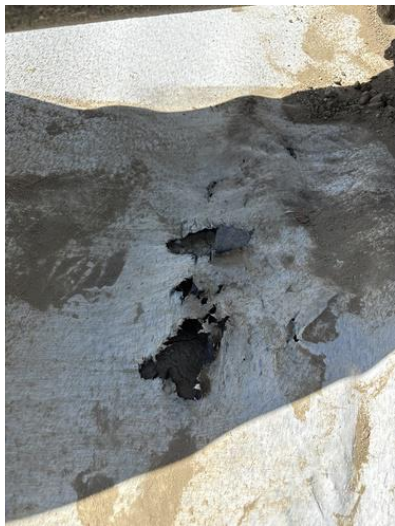
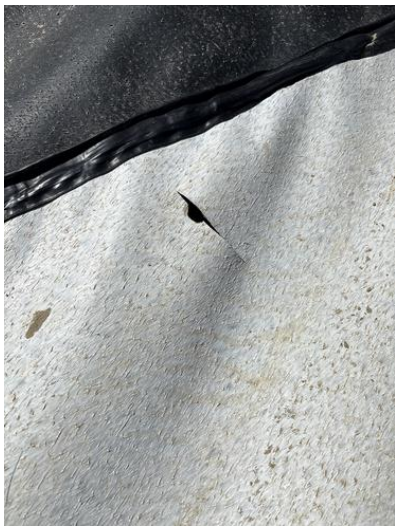
Tears in liner need to be patched/extrusion welded.

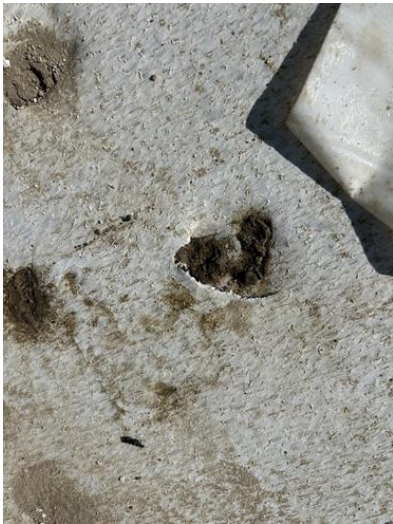
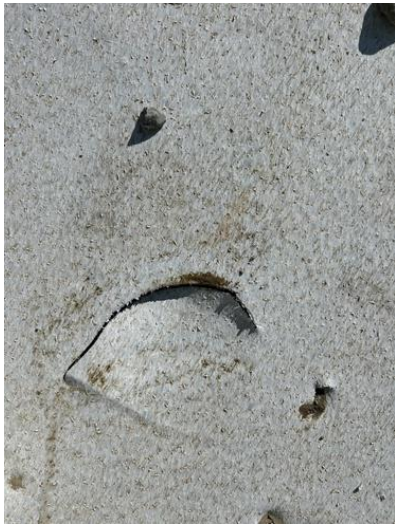
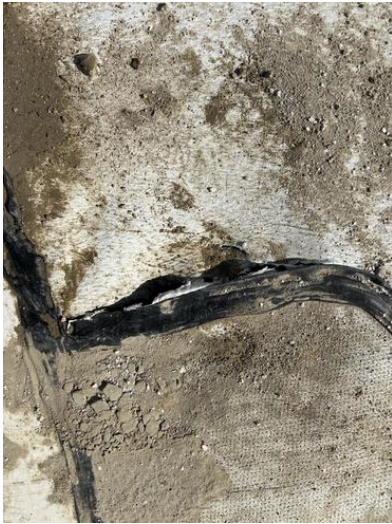
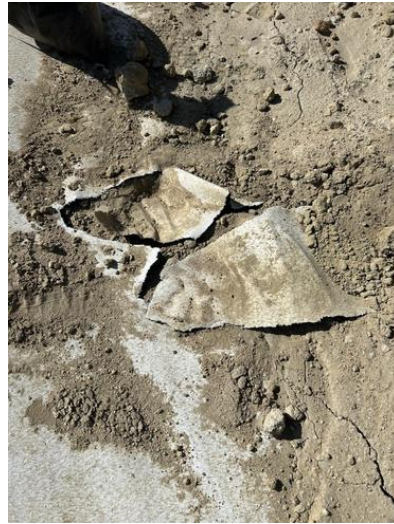
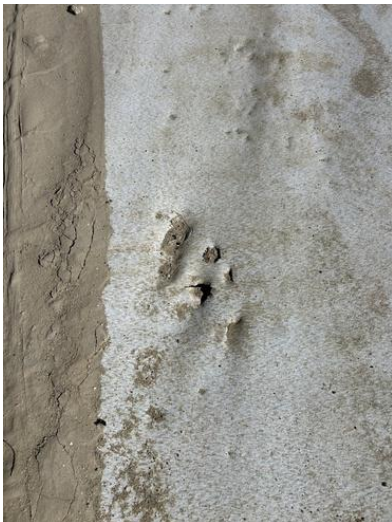
Multiple tears in close proximity.  
Need to be patched and extrusion  
welded

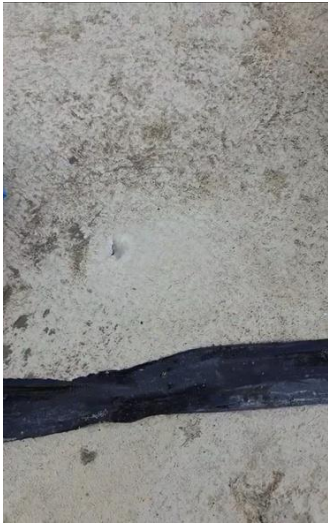
Photo 9

Small tear in liner. Needs to be patched and extrusion welded
