**CHIQUITA CANYON**  
*A Waste Connections Company*

**Re: Chiquita Canyon, LLC's Weekly Report on the Documentation and Tracking of Cover Issues**

# **Fissures and Tension Cracks**

# 4050 - Geosynthetic Cover Inspection

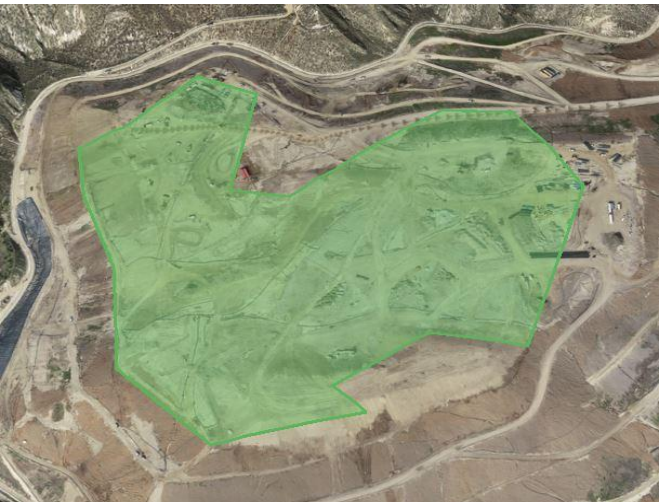
\*Waste fill near reaction area

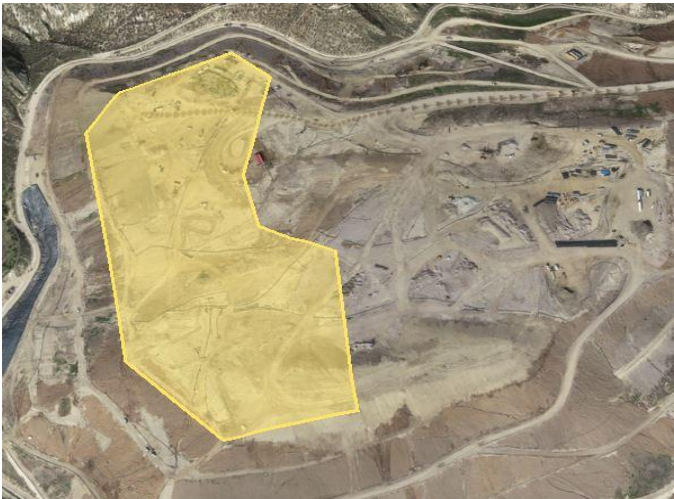
\*Waste fill near reaction area

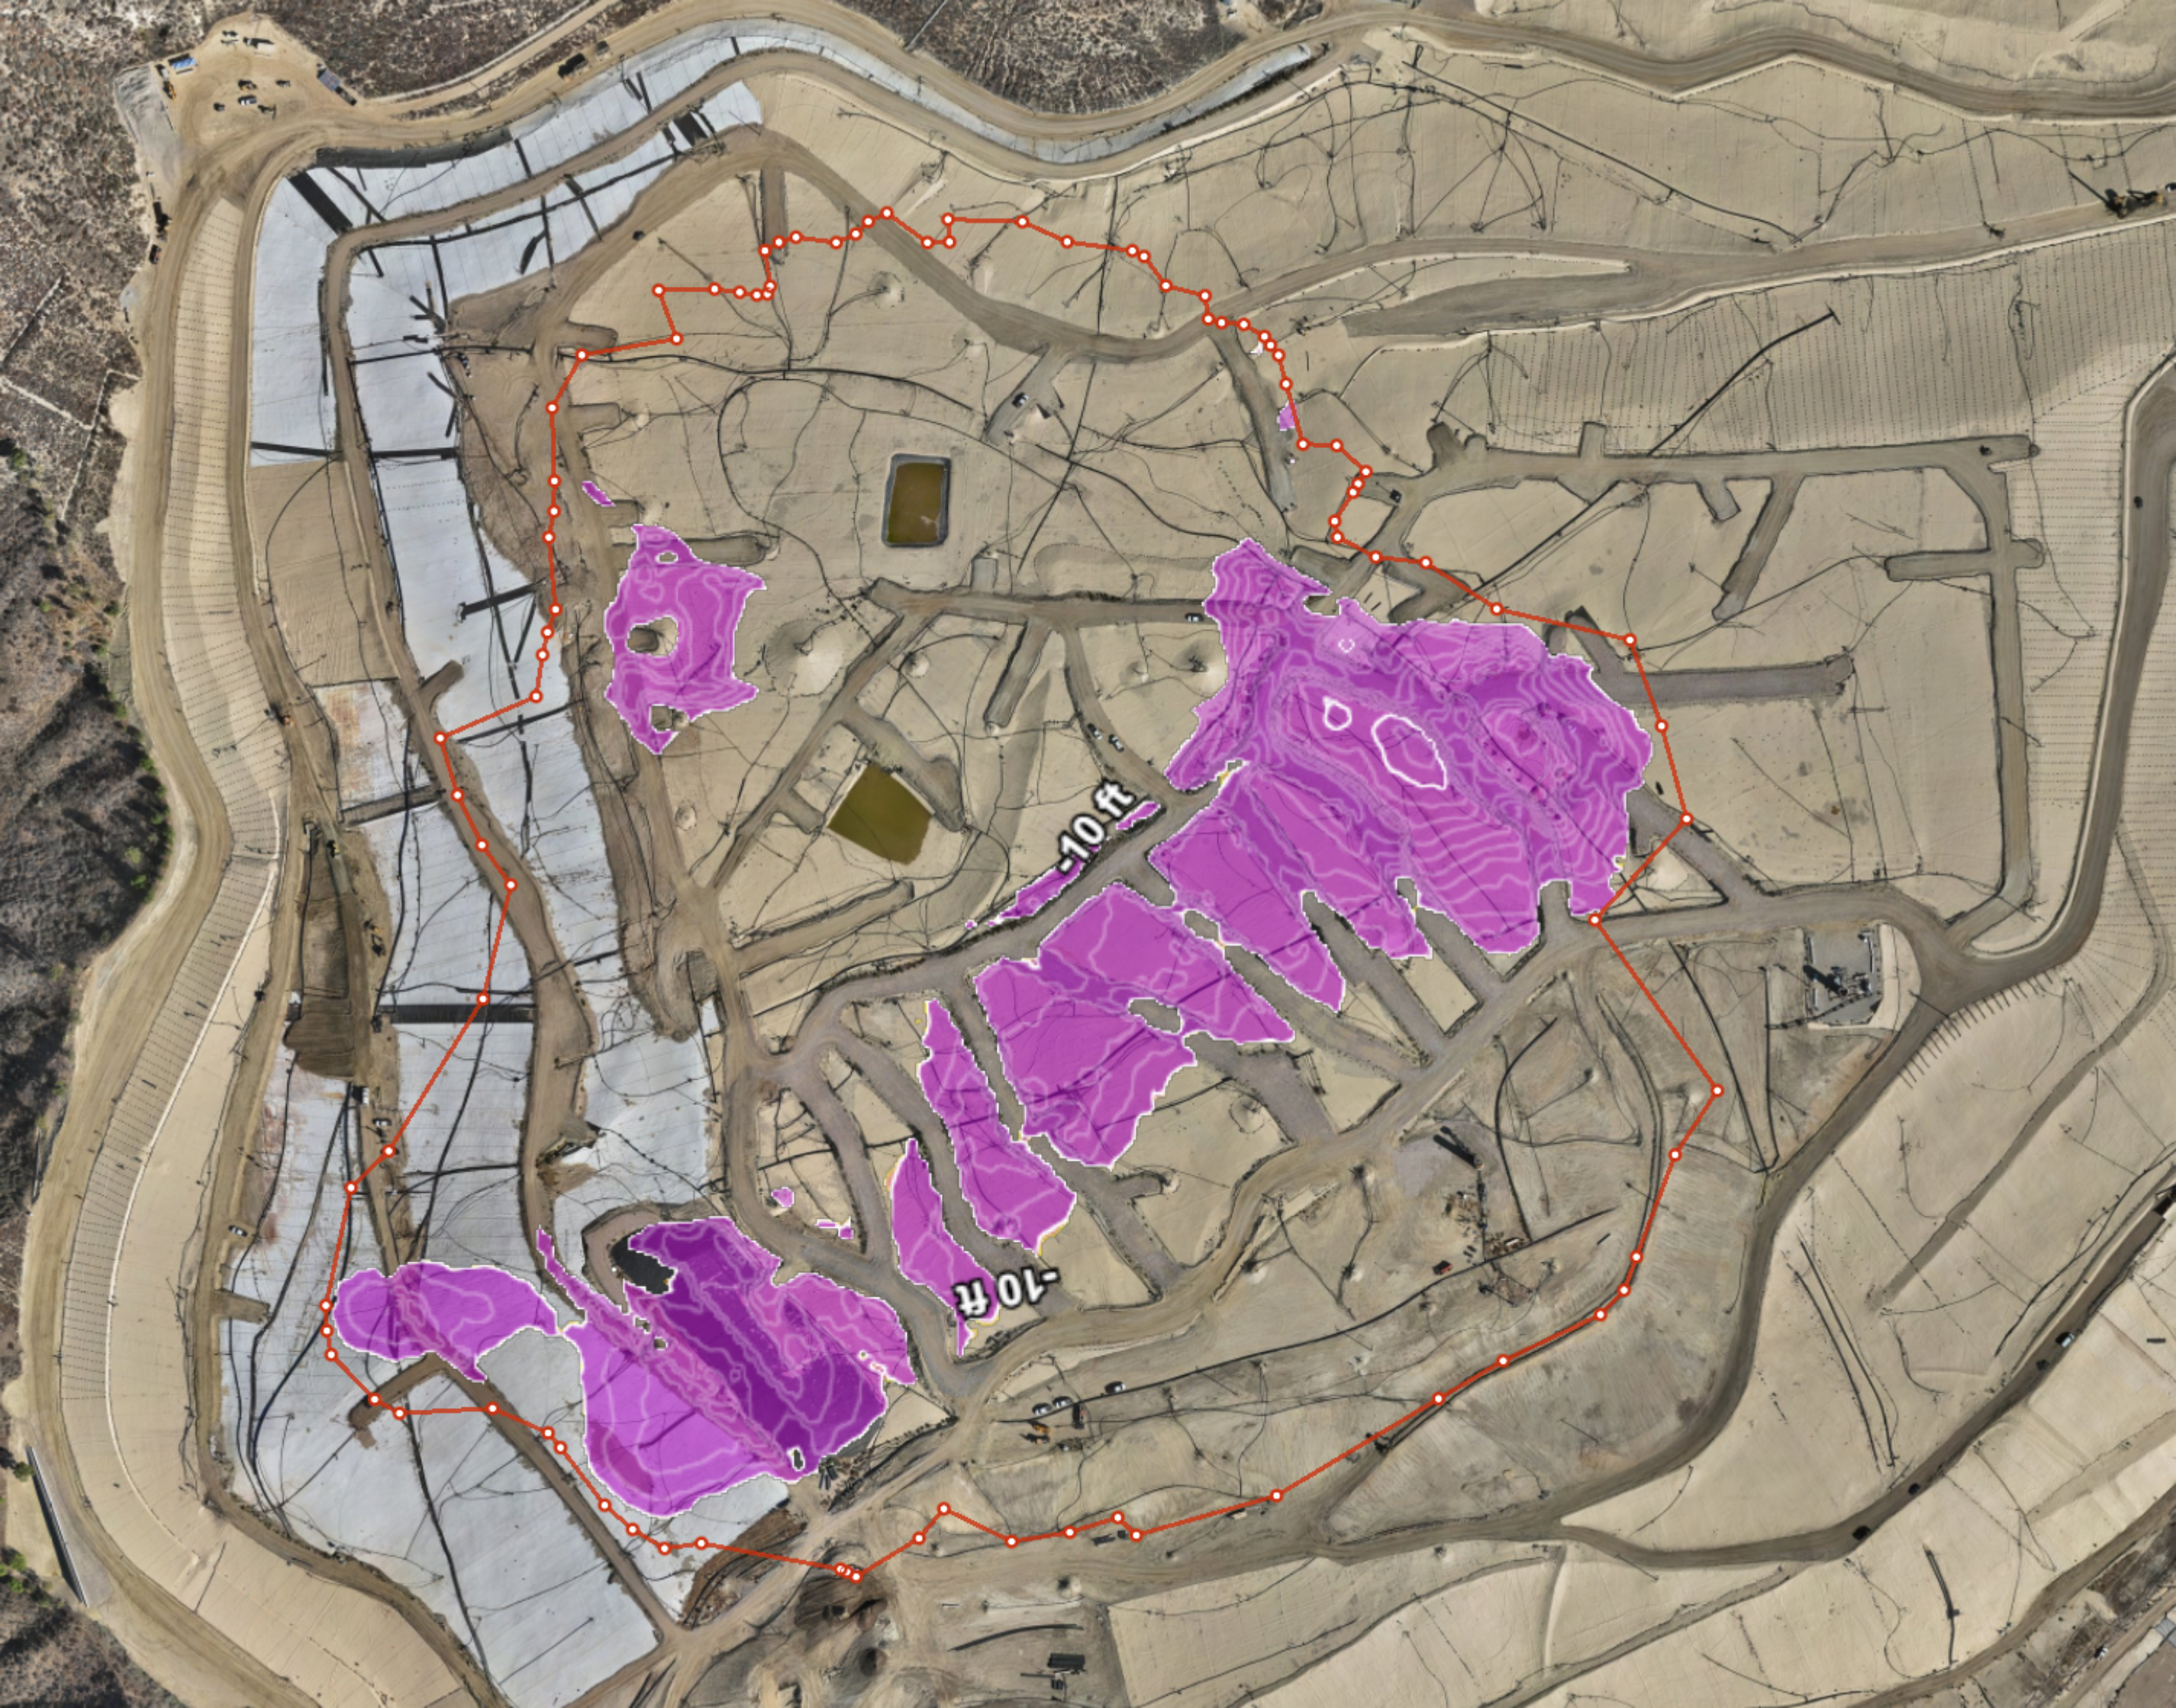
Settlement area between 9/10/2025 and 9/9/2026, submitted on 9/15/2026 and produced here again for comparison.

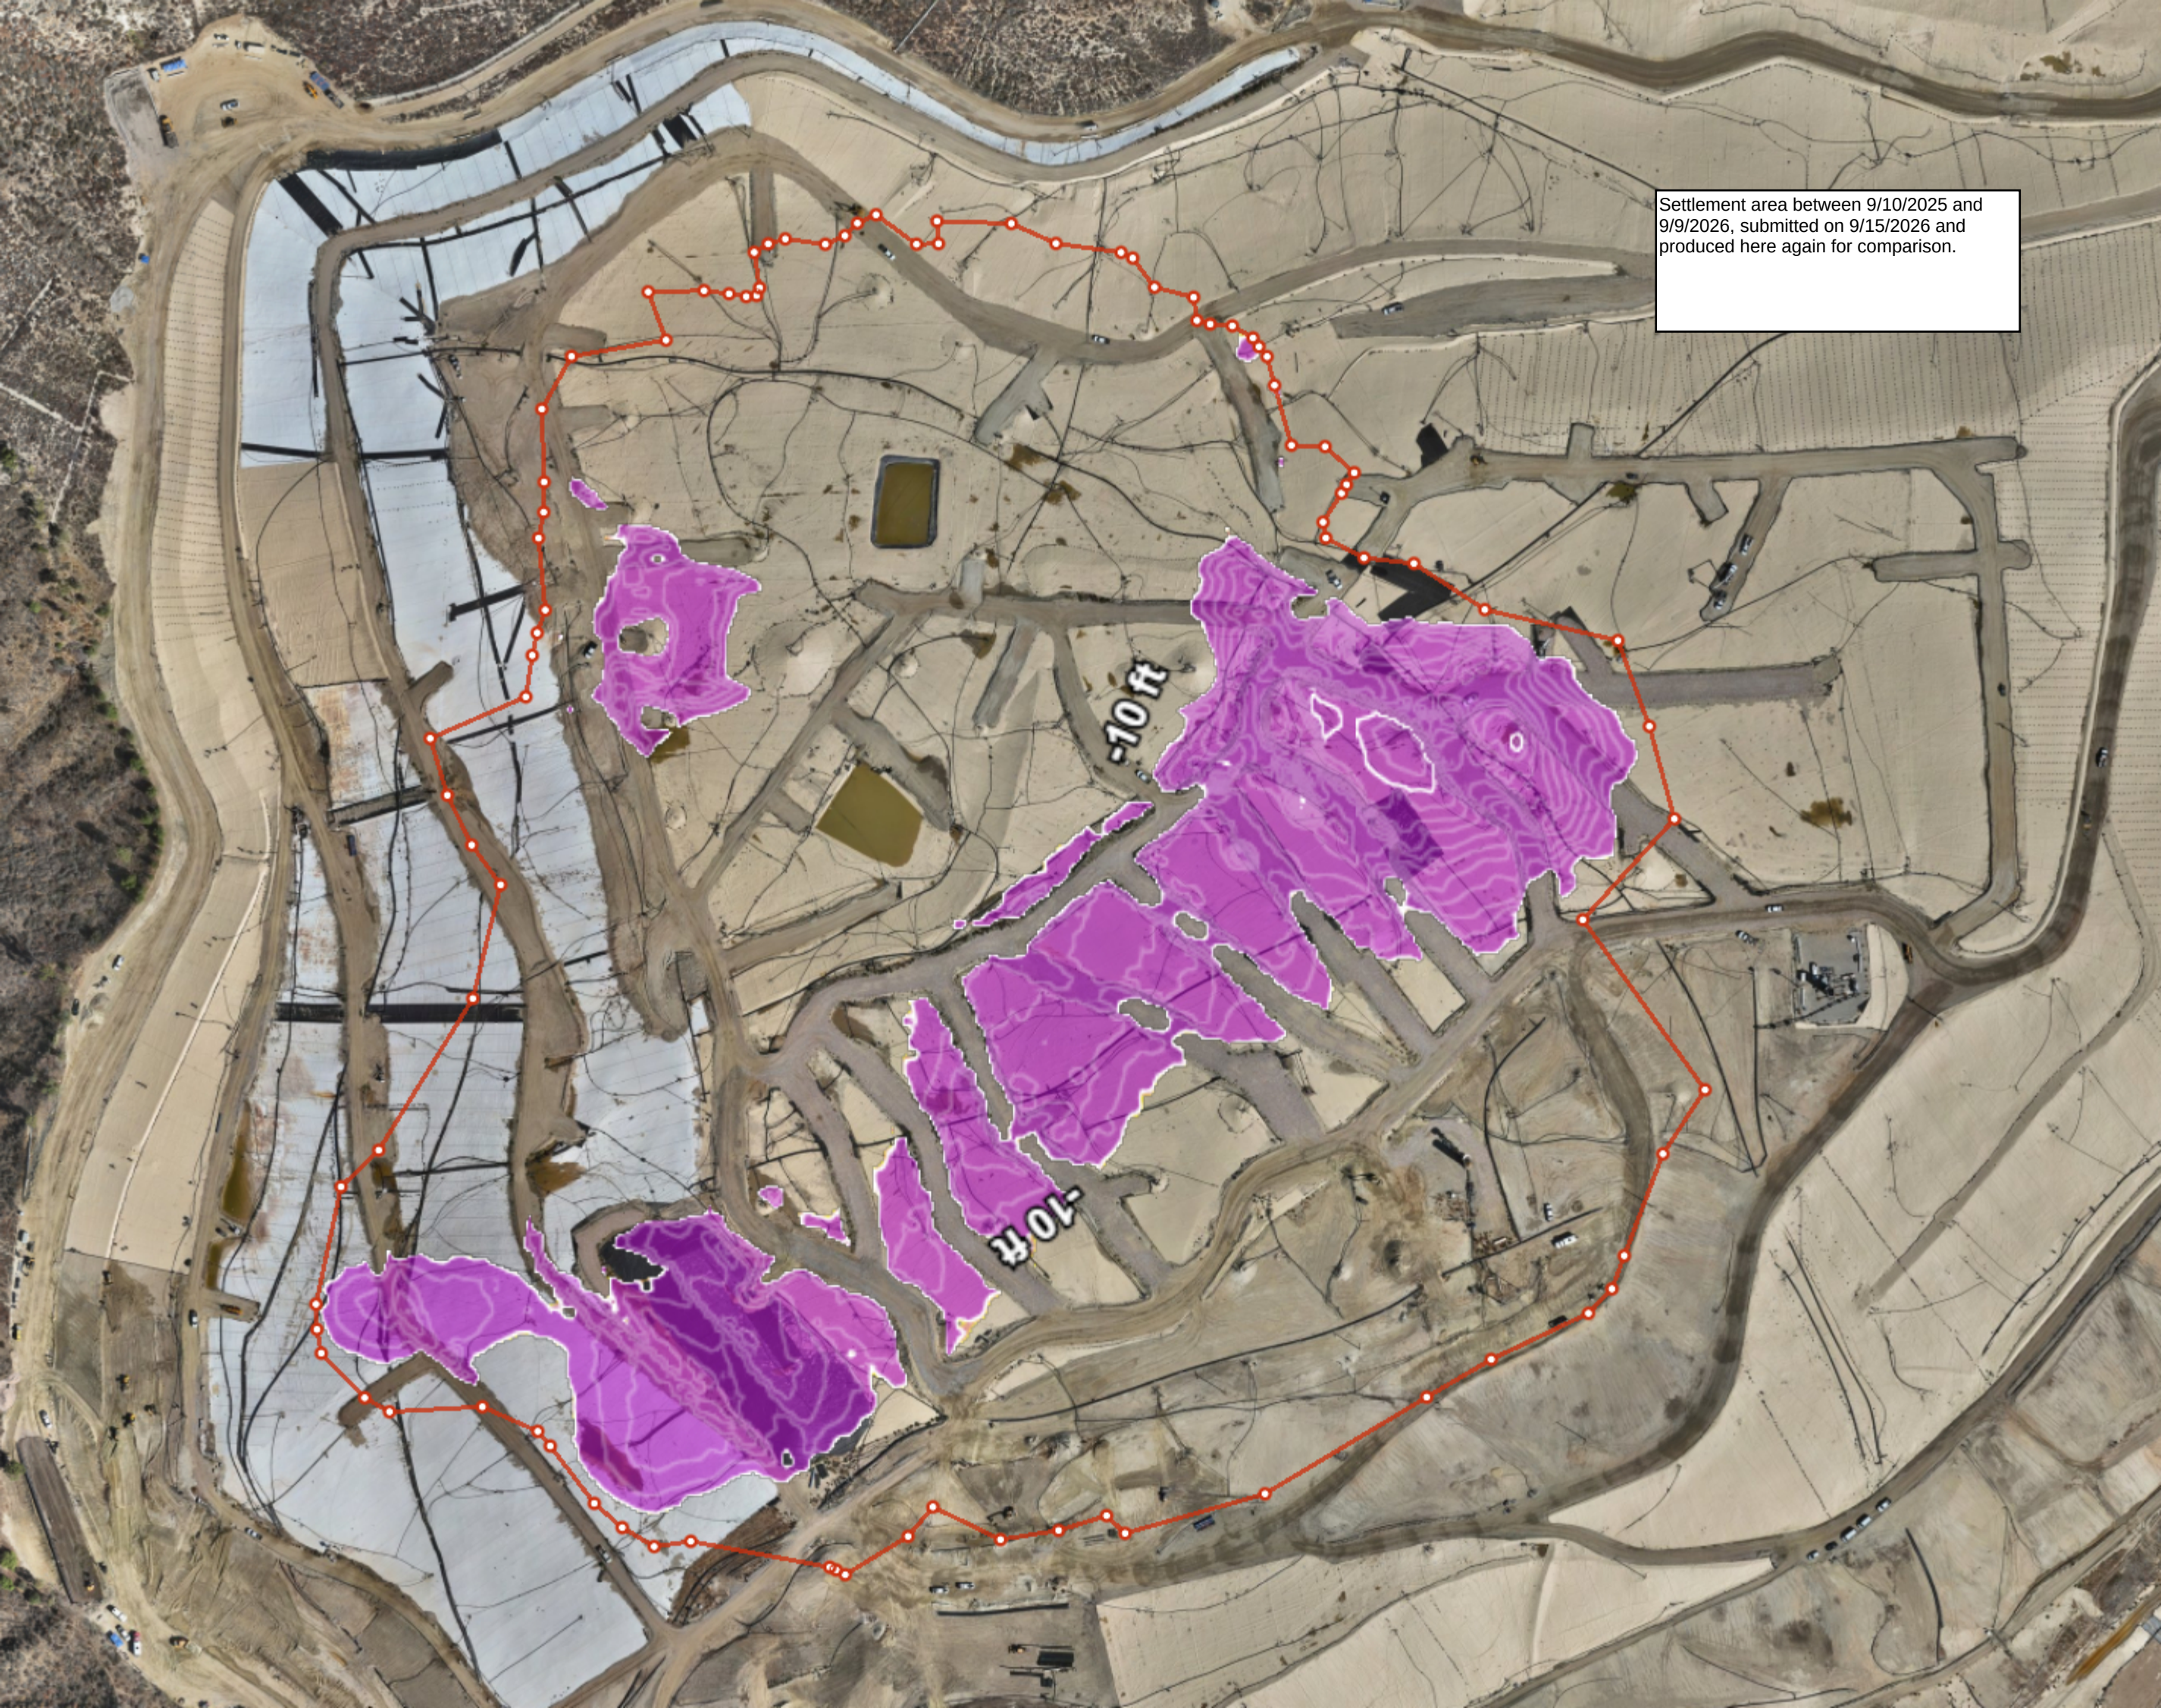
- The map shows the area between 9/24/2025 and 9/23/2026 where the grades have changed more than 10 feet. A typical MSW strain rate is 3% per year - for a landfill with a 300-foot waste column, this would be 9 feet per year.

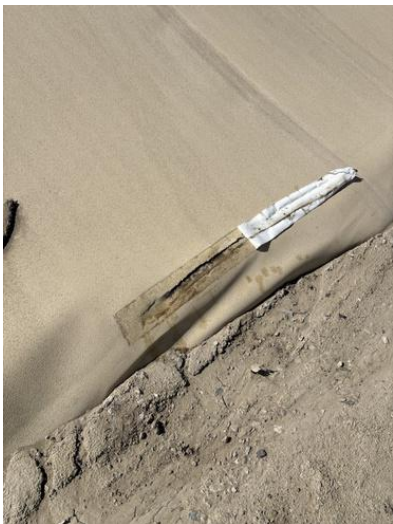
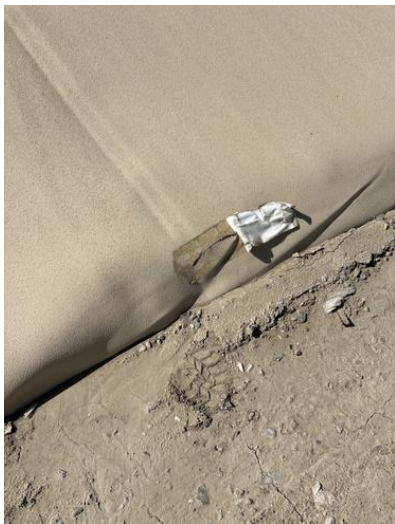
Two tears side by side need to be patched/extrusion welded.

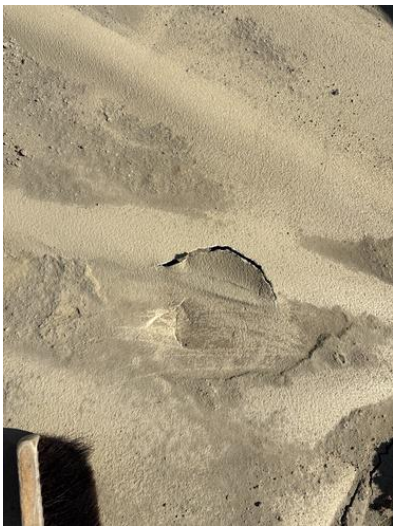
Photo 1

Tear in liner needs to be patched/extrusion welded.

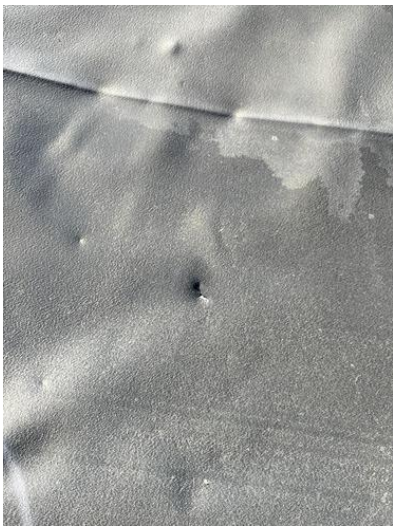
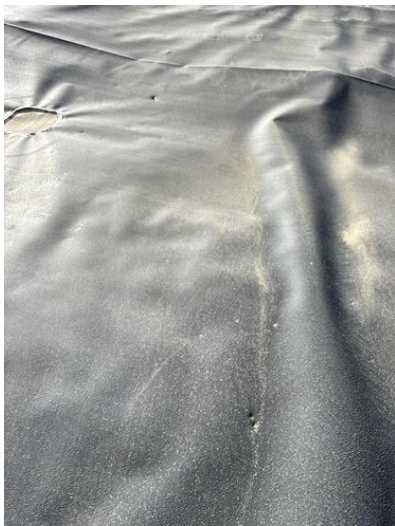
Tears in liner need to be patched/extrusion welded.

**Description of repair work** Tear taped upon discovery.

**Date and time of repair (within 2 hours)** 25 Sep 2026 9:45 AM PDT

**Are further permanent repairs required?** Yes

Permanent repairs scheduled for 9/29/26

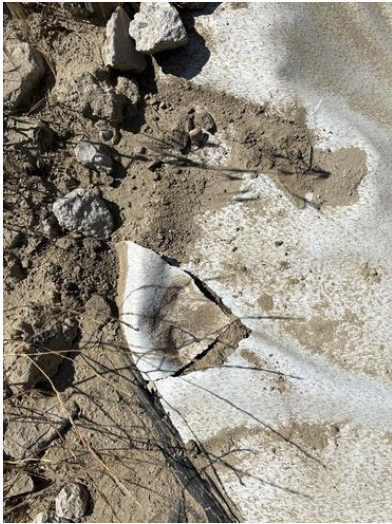
Photo 4

Tear in liner needs to be patched/extrusion welded

Permanent repairs scheduled for 9/29/26
