**Re: Chiquita Canyon, LLC's Weekly Leachate Inspection Report for Stipulated Order for Abatement (Case No. 6177-4), Condition 27(c)**

Attachment: Leachate Seep/Pooling Inspection Logs from September 21 – September 27, 2026

# 4050 - Chiquita Leachate Seep/Pooling Inspection

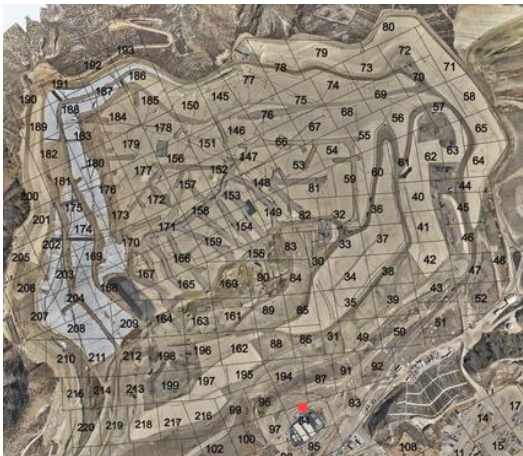
94

Castaic CA 91384  
United States  
(34.429568314455985,  
-118.64553770982519)

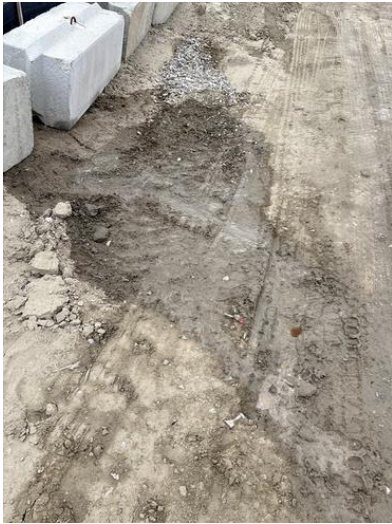
Photo 1

6 hours

1-5 gallons

12 sq ft

1 - Very Light Odor Detected

Standing free liquid

Soil added to contain seep. Construction of leachate interceptor trench to prevent future seepage scheduled to begin this week.

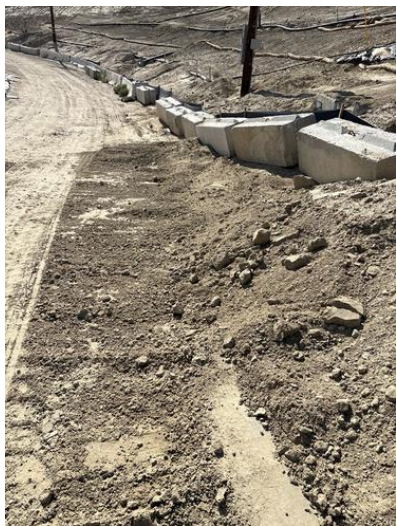
Photo 1

Grid 94. None of the seepage observed in this area or on the Westside was observed at the time of this inspection. Permanent repairs to the westside are currently underway.

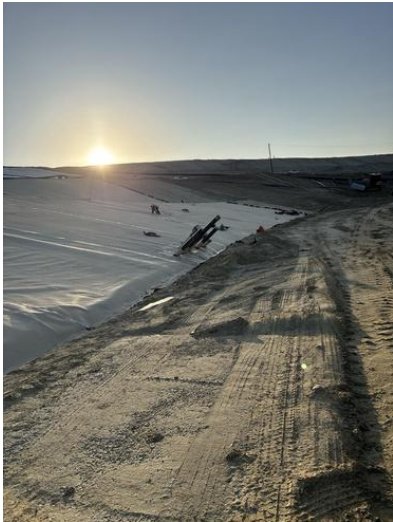
Photo 1

Westside perimeter road. None of the seepage previously observed in this area were observed at the time of this inspection. Permanent repairs are being conducted to contain seepage in this area as well.

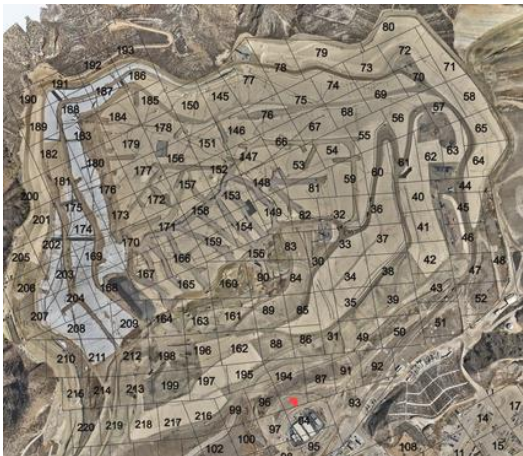
194

Castaic CA 91384  
United States  
(34.42927249578992,  
-118.64584659211286)

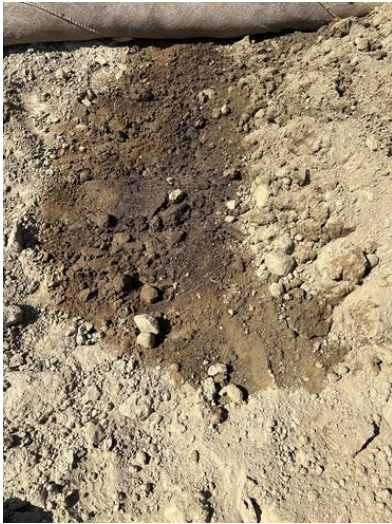
Photo 1

3 hours

1-5 gallons

6 sq ft

1 - Very Light Odor Detected

Saturated

Soil added to contain seep. Construction of interceptor trench scheduled to begin this week.

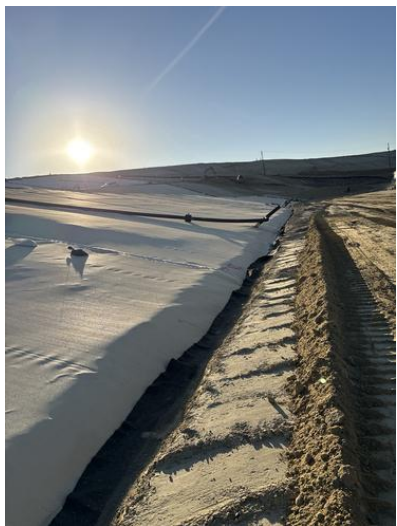
Photo 1

Westside perimeter road. None of the seepage previously observed in this area were observed at the time of this inspection. Permanent repairs are being conducted to contain seepage in this area as well.

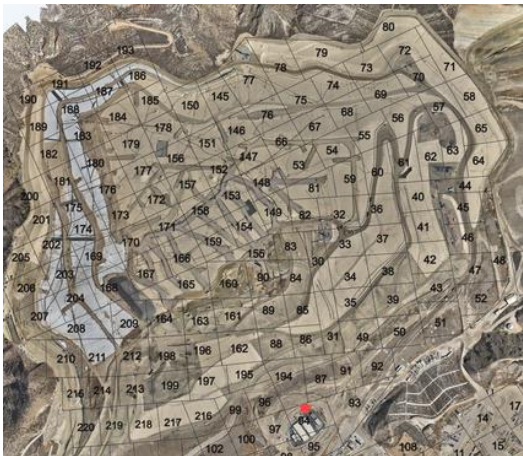
Which grid is the leachate seep/pooling located? 94

Drop Pin to record lat/long of seep/pooling location. Castaic CA 91384  
United States  
(34.42969961471349,  
-118.64579633425224)

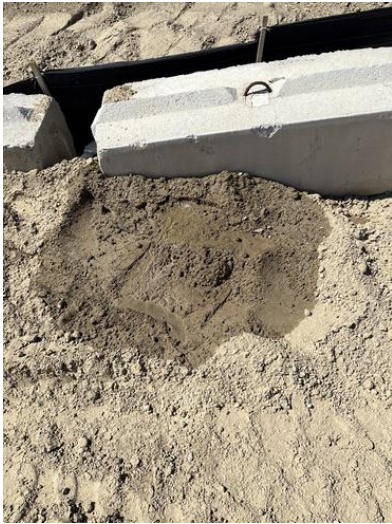
Photo 1

Estimated duration of presence of leachate at such location 2 hours

Estimated quantity of leachate 1-5 gallons

Extent of area impacted (approximate sq ft impacted) 7sq ft

Odor intensity 0 - No Odor Detected

Surrounding soil saturation level Standing free liquid

Soil added to contain seep. Interceptor trench scheduled to begin soon.

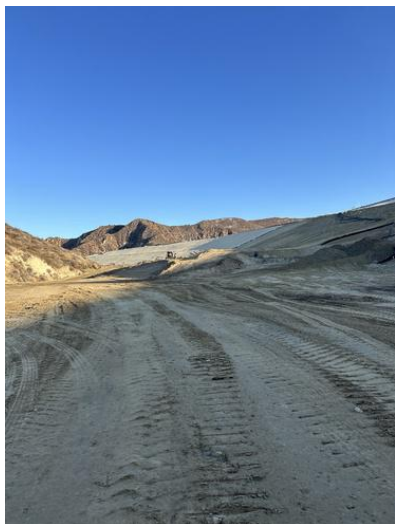
Photo 1

Westside perimeter road. None of the seepage previously observed in this area were observed at the time of this inspection. Permanent repairs are being conducted to contain seepage in this area as well.

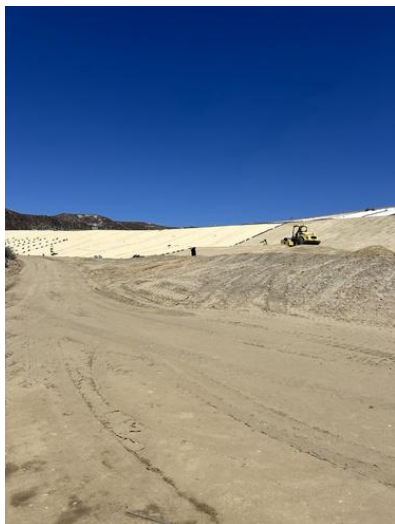
Photo 1

Westside perimeter road. None of the seepage previously observed in this area were observed at the time of this inspection. Permanent repairs are being conducted to contain seepage in this area as well.

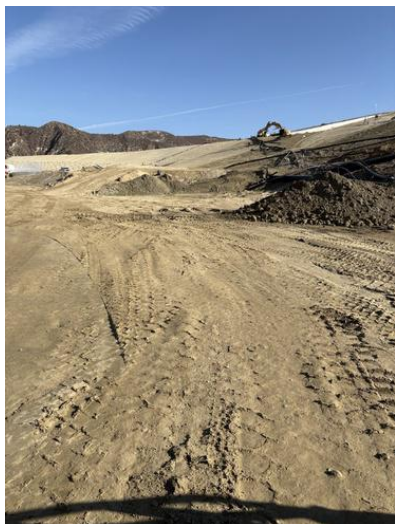
Photo 1

Westside perimeter road. None of the seepage previously observed in this area were observed at the time of this inspection. Permanent repairs are being conducted to contain seepage in this area as well.

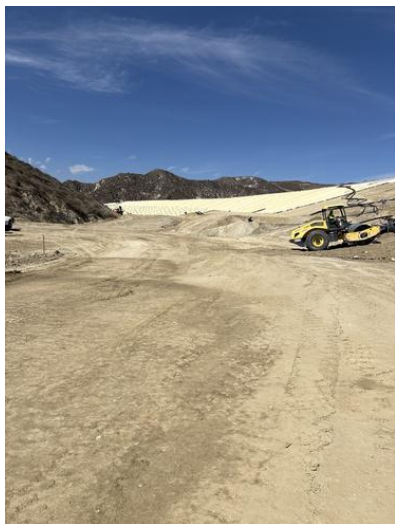
Photo 1

Westside perimeter road. None of the seepage previously observed in this area were observed at the time of this inspection. Permanent repairs are being conducted to contain seepage in this area as well.

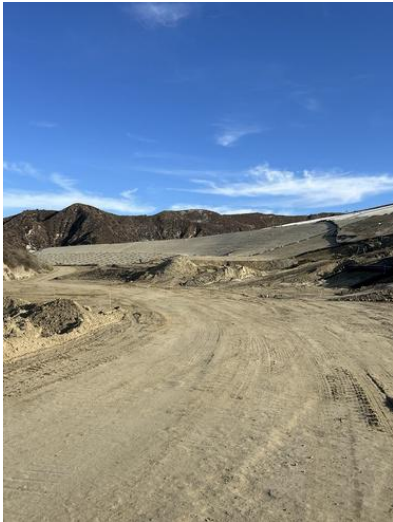
Photo 1

Westside perimeter road. None of the seepage previously observed in this area were observed at the time of this inspection. Permanent repairs are being conducted to contain seepage in this area as well.

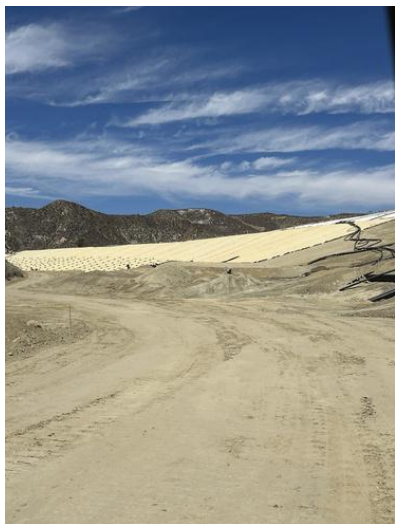
Photo 1

Westside perimeter road. None of the seepage previously observed in this area were observed at the time of this inspection. Permanent repairs are being conducted to contain seepage in this area as well.

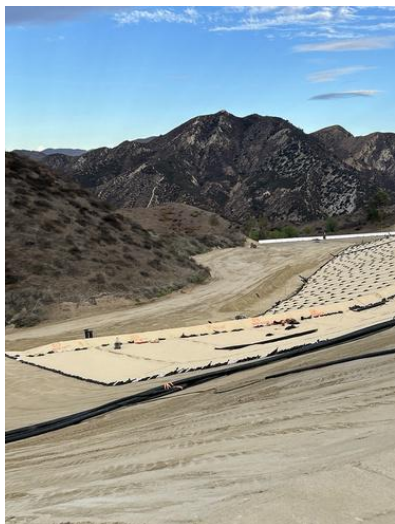
Photo 1

Westside perimeter road. None of the seepage previously observed in this area were observed at the time of this inspection. Permanent repairs are being conducted to contain seepage in this area as well.

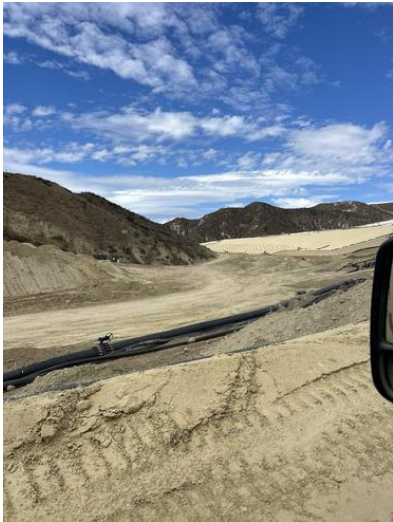
Photo 1

Westside perimeter road. None of the seepage previously observed in this area were observed at the time of this inspection. Permanent repairs are being conducted to contain seepage in this area as well.
