**Re: Chiquita Canyon, LLC's Weekly Leachate Inspection Report for Stipulated Order for Abatement (Case No. 6177-4), Condition 27(c)**

Attachment: Leachate Seep/Pooling Inspection Logs from September 28 – October 4, 2026

# 4050 - Chiquita Leachate Seep/Pooling Inspection

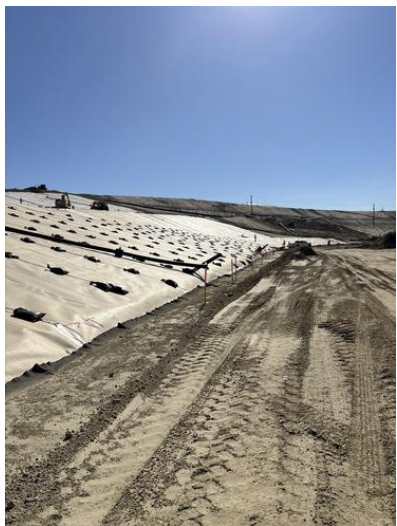
Photo 1

Westside perimeter road. None of the seepage previously observed in this area were observed at the time of this inspection, permanent repairs are being conducted to contain the seepage in this area.

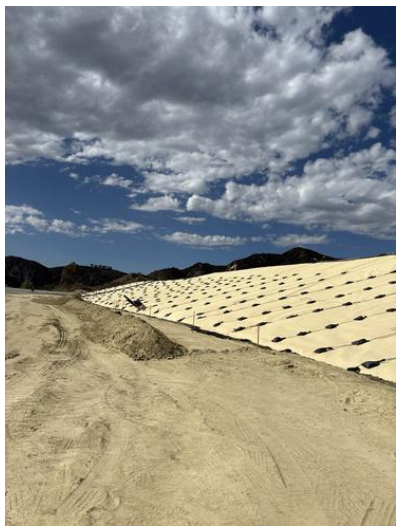
Photo 1

Westside perimeter road. None of the seepage previously observed in this area were observed at the time of this inspection, permanent repairs are being conducted to contain the seepage in this area.

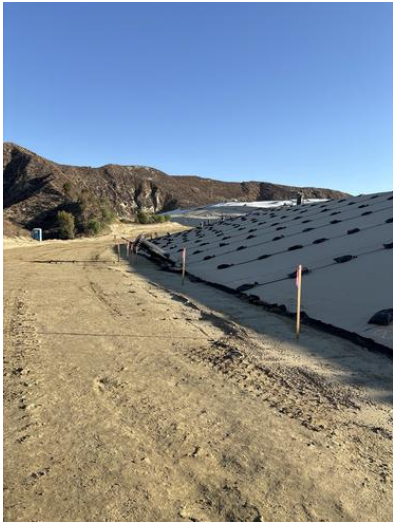
Photo 1

Westside perimeter road. None of the seepage previously observed in this area were observed at the time of this inspection, permanent repairs are being conducted to contain the seepage in this area.

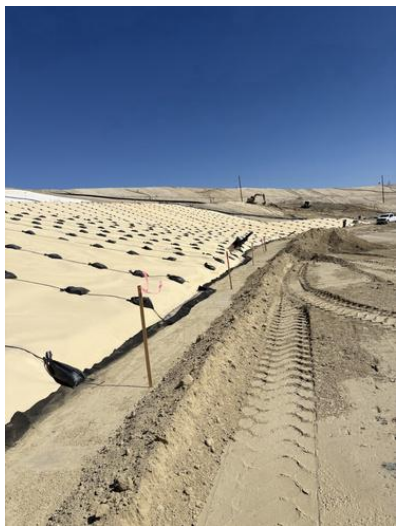
Photo 1

Westside perimeter road. None of the seepage previously observed in this area were observed at the time of this inspection, permanent repairs are being conducted to contain the seepage in this area.

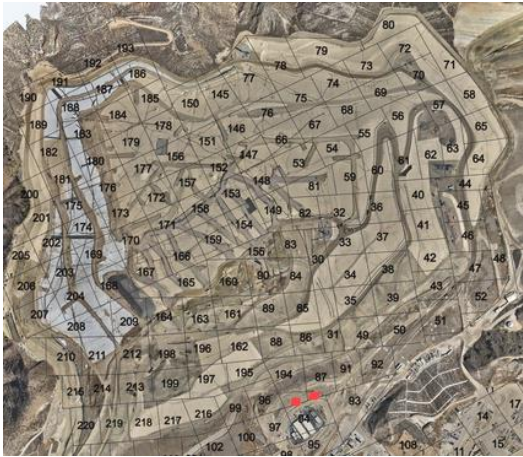
194,87

Seeping from multiple locations, all related.

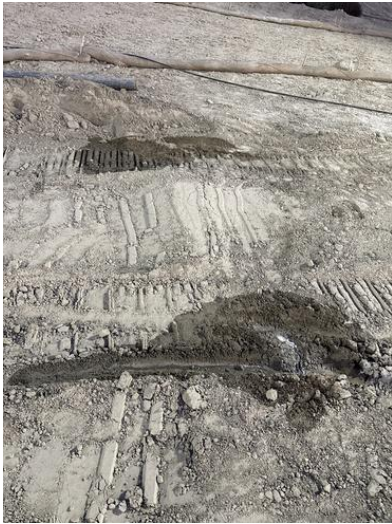
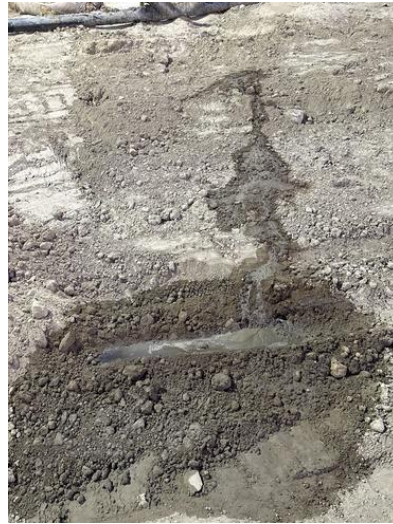
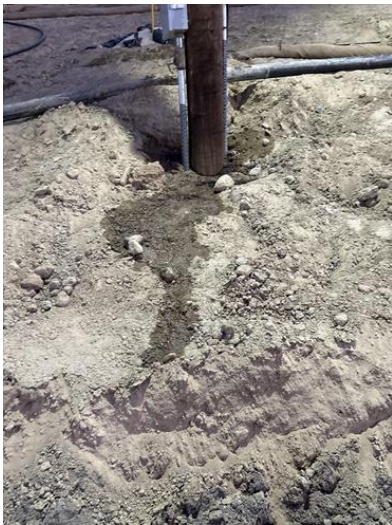
4 hours

6-10 gallons

25 sq ft (combined between  
locations)

2 - Light Odor Detected

Standing free liquid

Soil added to contain seeps. Seep collector construction is in progress.

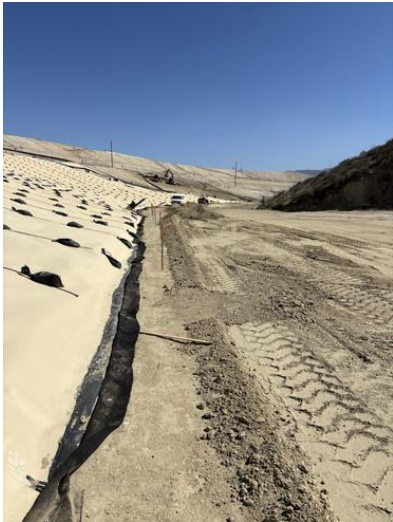
Photo 1

Westside perimeter road. None of the seepage previously observed in this area were observed at the time of this inspection, permanent repairs are being conducted to contain the seepage in this area. The seeps observed in grid 194 and 87 were also not observed at the time of this inspection.

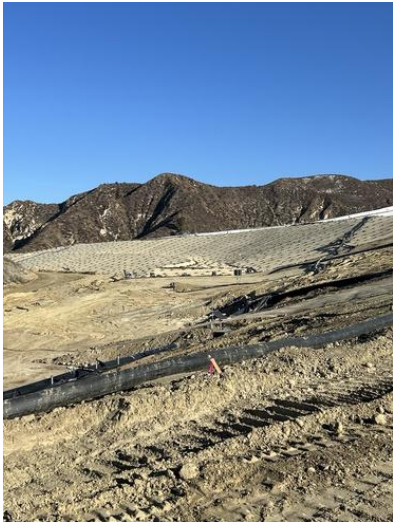
Photo 1

Westside perimeter road. None of the seepage previously observed in this area were observed at the time of this inspection. Permanent repairs are being conducted to contain seepage in this area as well.

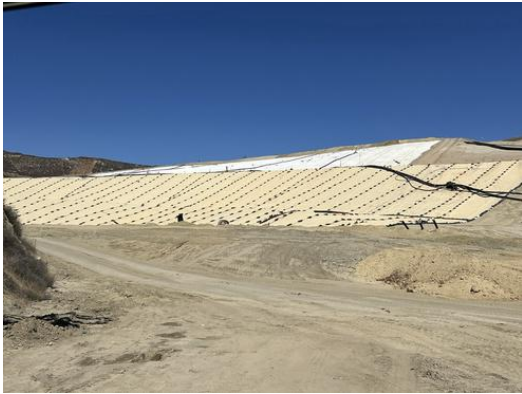
Photo 1

Westside perimeter road. None of the seepage previously observed in this area were observed at the time of this inspection. Permanent repairs are being conducted to contain seepage in this area as well.

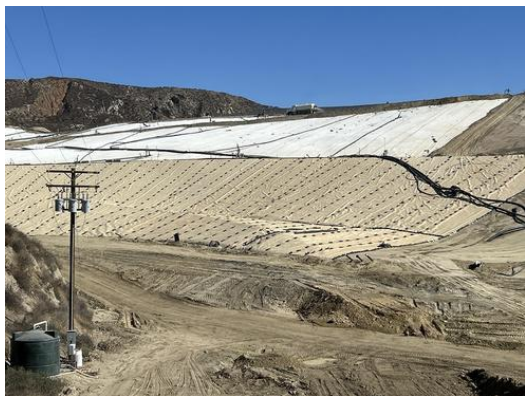
Photo 1

Westside perimeter road. None of the seepage previously observed in this area were observed at the time of this inspection. Permanent repairs are being conducted to contain seepage in this area as well.

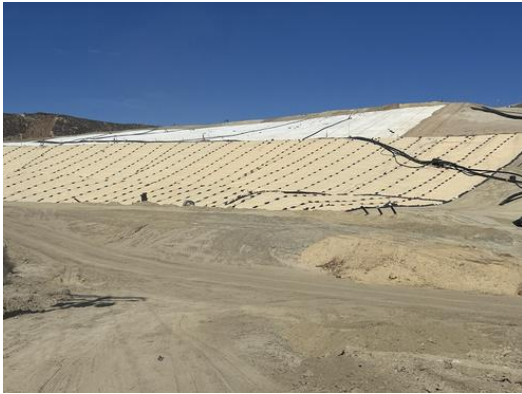
Photo 1

Westside perimeter road. None of the seepage previously observed in this area were observed at the time of this inspection. Permanent repairs are being conducted to contain seepage in this area as well.

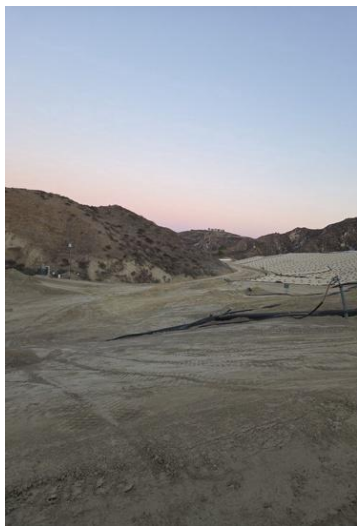
Photo 1

Westside perimeter road. None of the seepage previously observed in this area were observed at the time of this inspection. Permanent repairs are being conducted to contain seepage in this area as well.

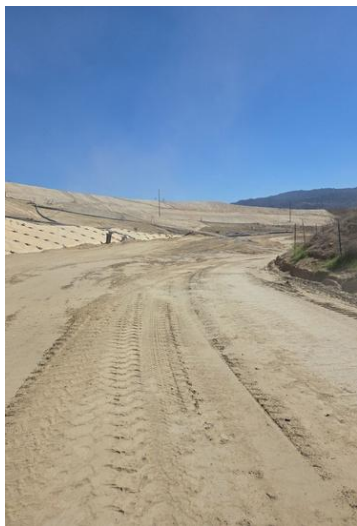
Photo 1

Westside perimeter road. None of the seepage previously observed in this area were observed at the time of this inspection. Permanent repairs are being conducted to contain seepage in this area as well.

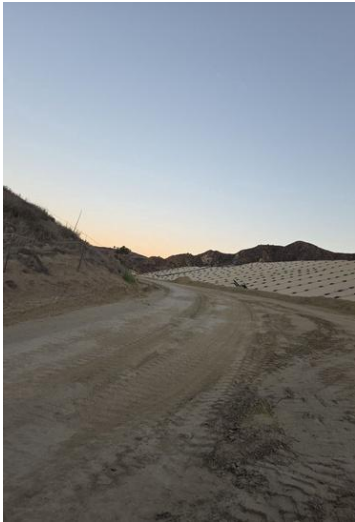
Photo 1

Westside perimeter road. None of the seepage previously observed in this area were observed at the time of this inspection. Permanent repairs are being conducted to contain seepage in this area as well.

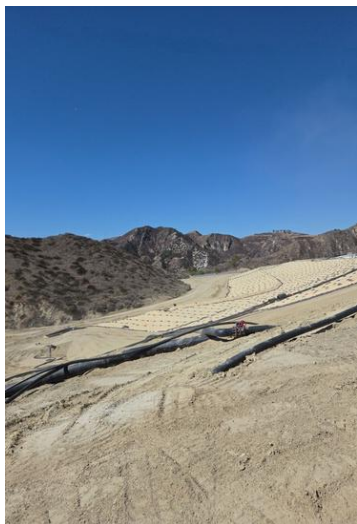
Photo 1

Westside perimeter road. None of the seepage previously observed in this area were observed at the time of this inspection. Permanent repairs are being conducted to contain seepage in this area as well.
