**Re: Inspection Report Response, April 10, 2026 Inspection  
Los Angeles Regional Water Quality Control Board**

**Attachment A – April 2026 Industrial Stormwater Inspection Report**

Los Angeles Regional Water Quality Control Board  
**INDUSTRIAL STORMWATER INSPECTION REPORT**  
(State Water Resources Control Board Order WQ 2018-0028-DWQ, NPDES No. CAS000001)

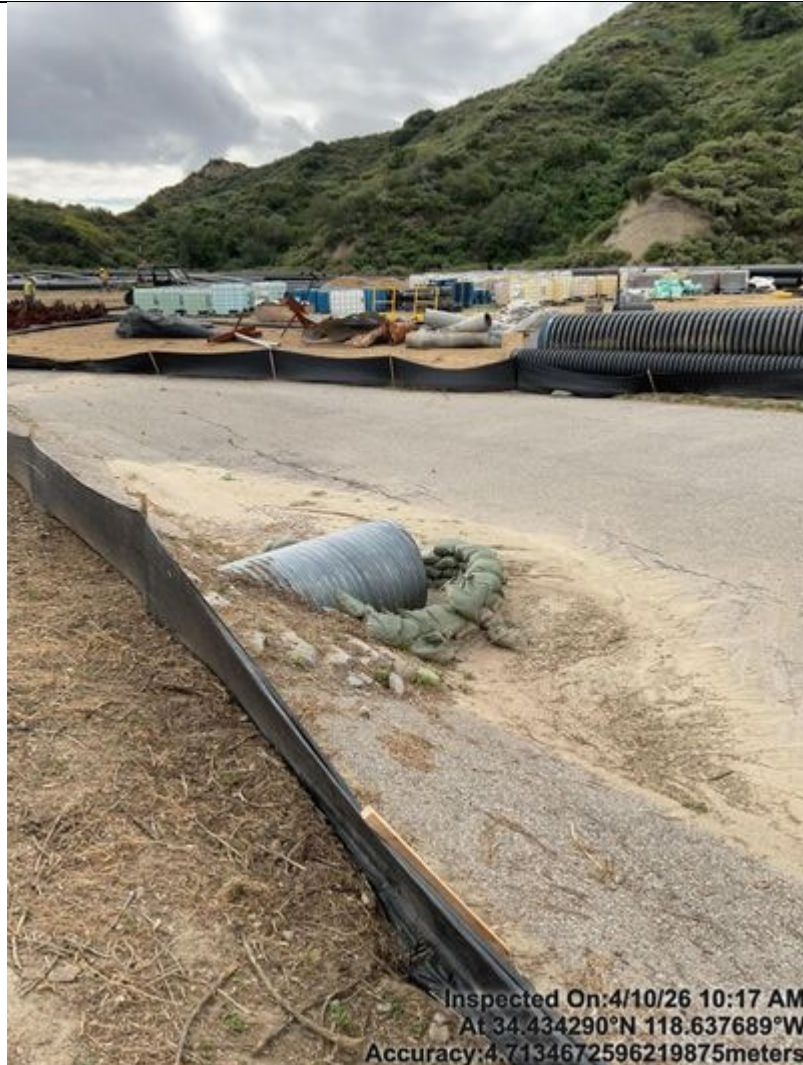
Photo 29  
Close-up of the culvert. I observed sediment accumulation around the sandbags

- The silt fence and sand bag best management practices ("BMPs") in the Canyon B area were repaired the week of June 1, 2026 as shown in the enclosed Photos 1, 2, 3, and 4. The silt fence and sand bag BMPs are maintained as needed based upon inspection and are one of many Erosion and Sediment Control BMPs installed, maintained, and implemented at the Landfill.
- Ongoing preparations for installation of the ethylene vinyl alcohol/high-density polyethylene geomembrane cover ("EVOH cover") changed the condition of the area depicted in the Report's Photo 83 and eliminated the need for the temporary hay-bale erosion control BMP at that location. The former BMP, including the hay bales and

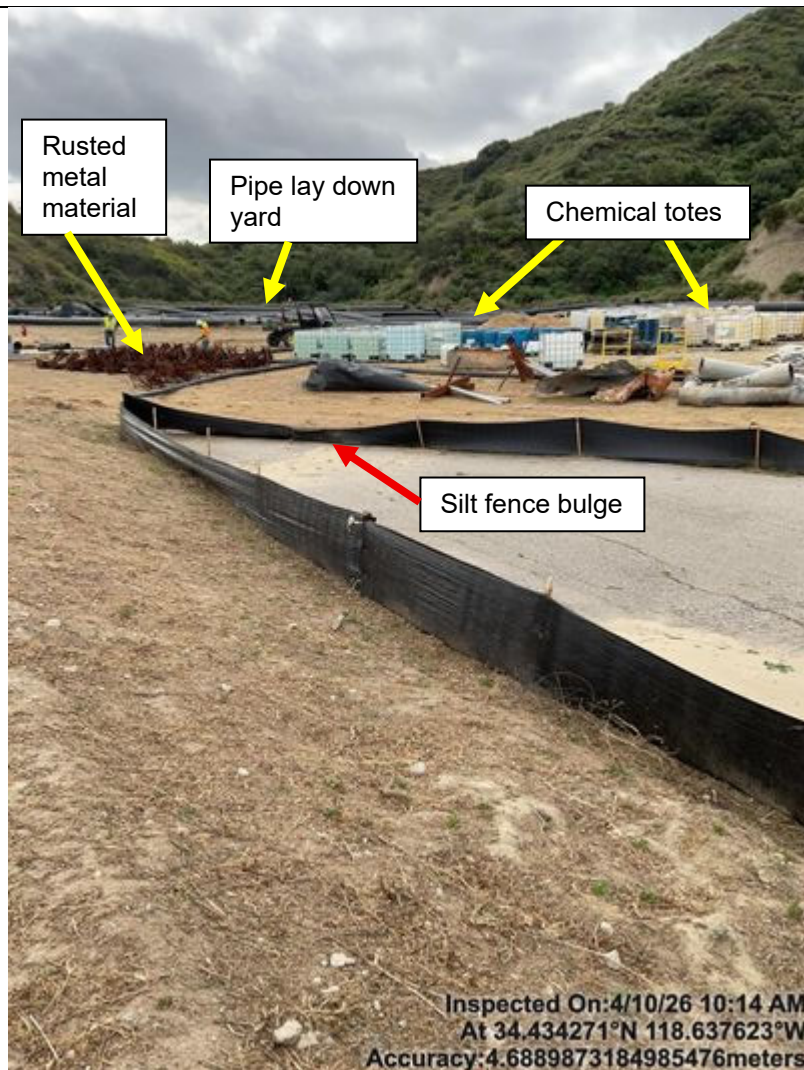
Photo 31

We then drove to the culvert near the equipment storage/pipe lay down yard at the existing Canyon B landfill. We saw a culvert that directs stormwater to the East Basin (Photos 27-31). I observed that the sandbags in front of the culvert were in need of repair (Photos 39-41). I also observed sediment accumulation in front of the sandbags and in the culvert (Photos 27-31, 39-41). We informed Mr. Breuer that the sandbags need to be repaired and placed properly. I also observed that the silt fence surrounding this area was installed improperly (Photos 30-38, 42). We informed Mr. Breuer that the silt fence needs to be repaired in several places and correctly installed per BMP guidelines. Near the culvert, I saw the equipment storage area and pipe lay down yard. I saw drum and tote storage outdoors without secondary containment (Photos 44-49). I saw equipment stored directly on the ground, upgradient of the culvert, without BMPs in place (Photos 50-52). I observed rusted metal material in this area (Photos 50-52). We informed Mr. Breuer that BMPs should be implemented in this area.

Culvert on map. Sediment accumulation in front of culvert. Sand bags in need of repair

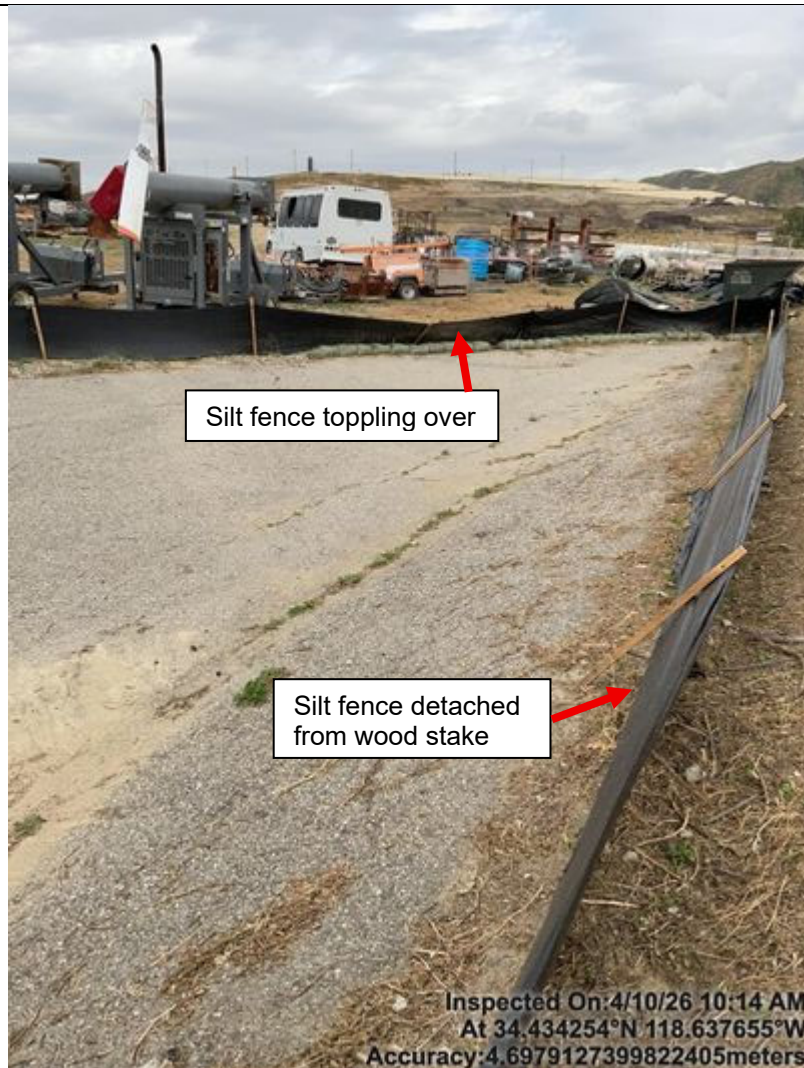
During the inspection I observed inadequate BMPs including ripped/missing sandbags, silt fences in improperly placed and in need of repair, sediment buildup, and evidence of erosion. I also observed a lack of BMPs in the equipment storage area. These observations were communicated to Mr. Breuer during the inspection.

Photo 33  
Silt fence with improper installation in need of repair.

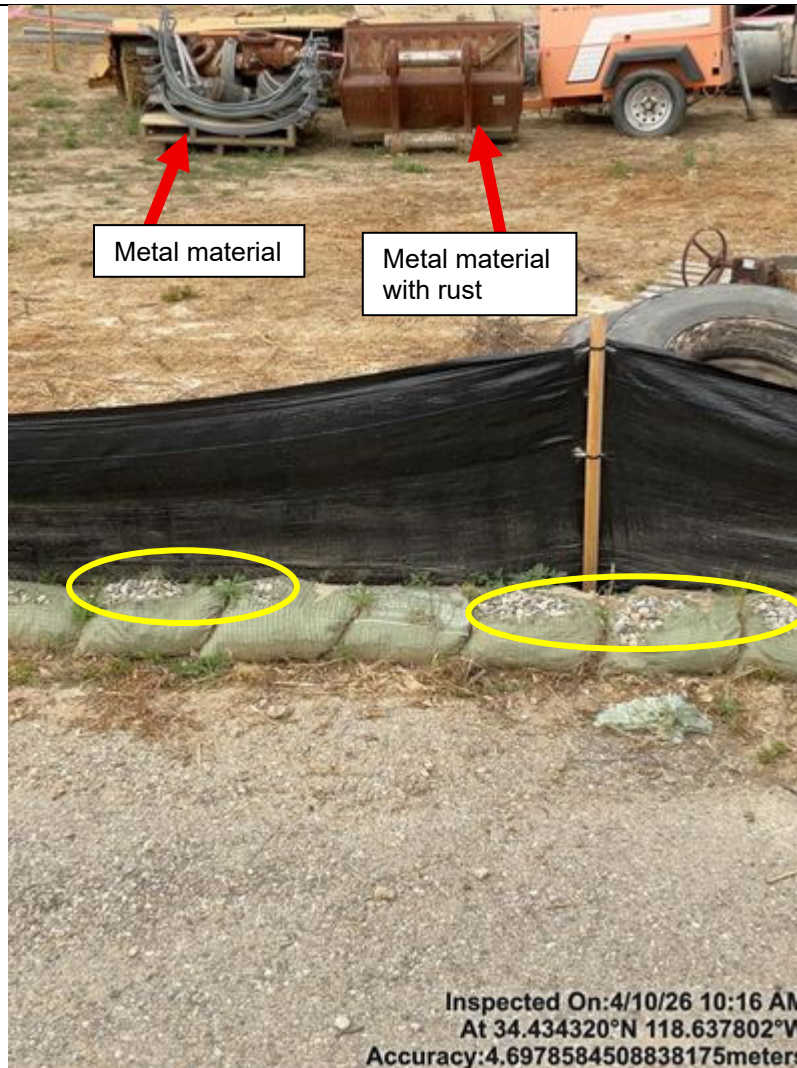
Photo 34  
Silt fence with improper installation in need of repair.

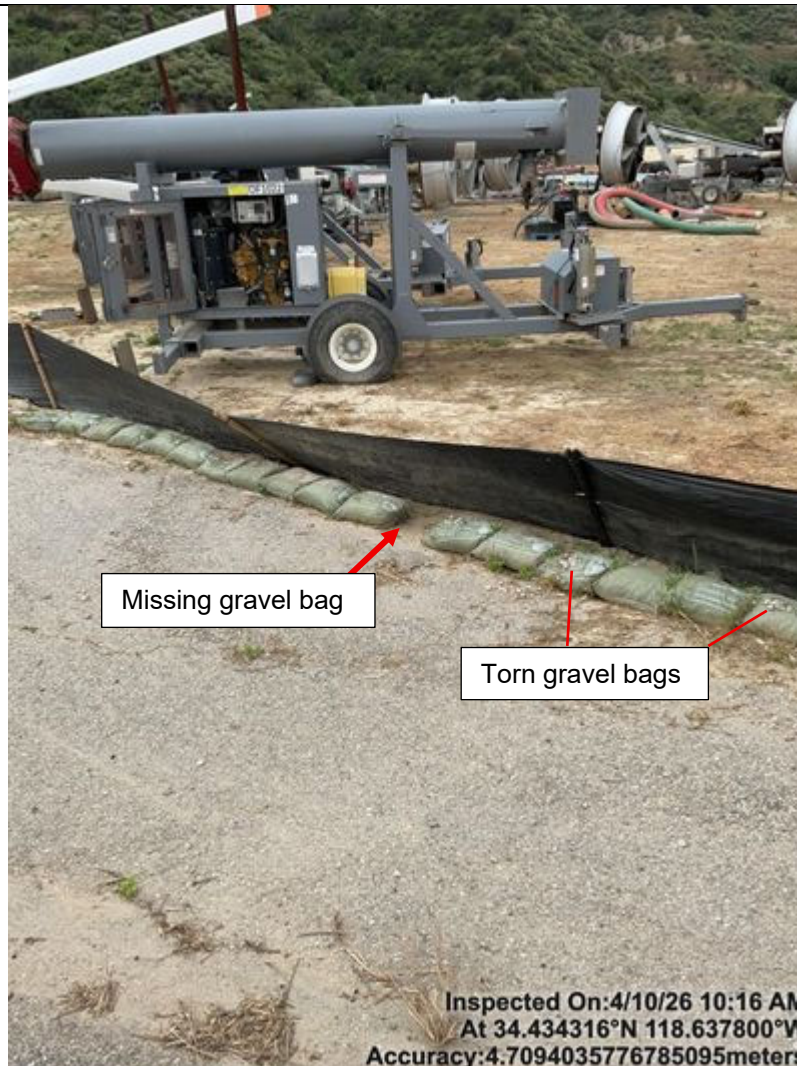
Photo 35  
Close-up of ripped gravel bags in need of repair, circled in yellow

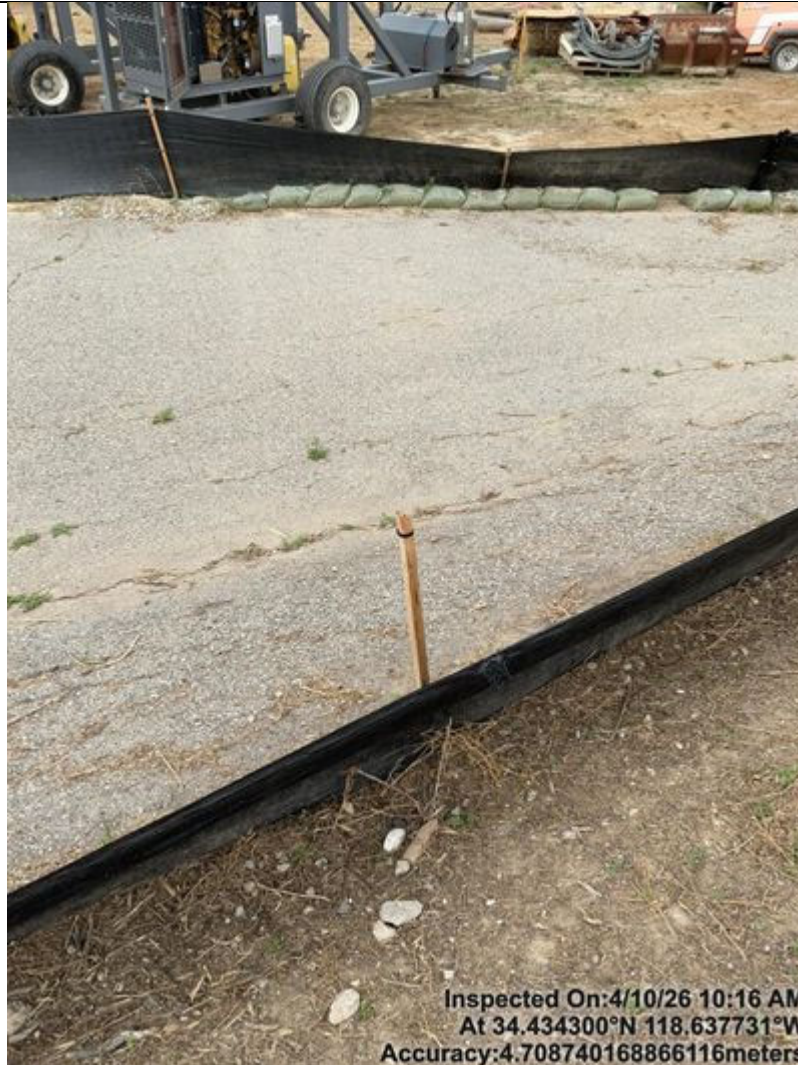
Photo 36  
Close-up of incorrect silt fence installation and torn/missing gravel bags

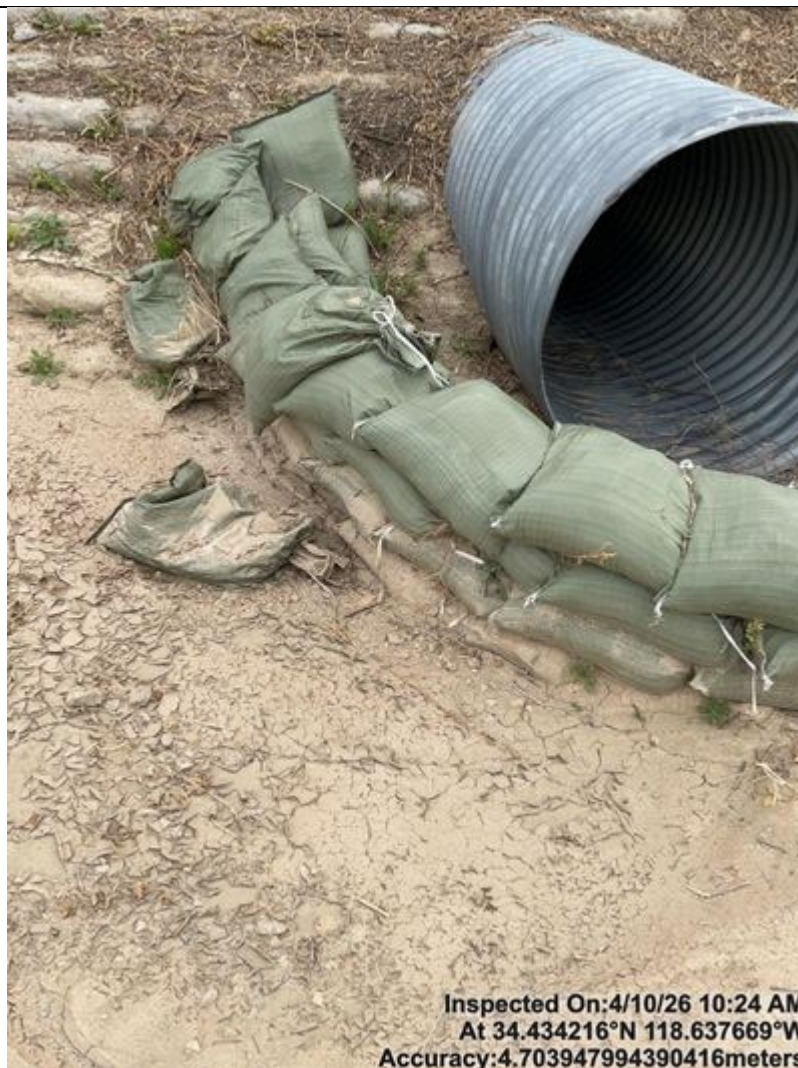
Photo 39  
Close-up of culvert with sandbags in need of repair

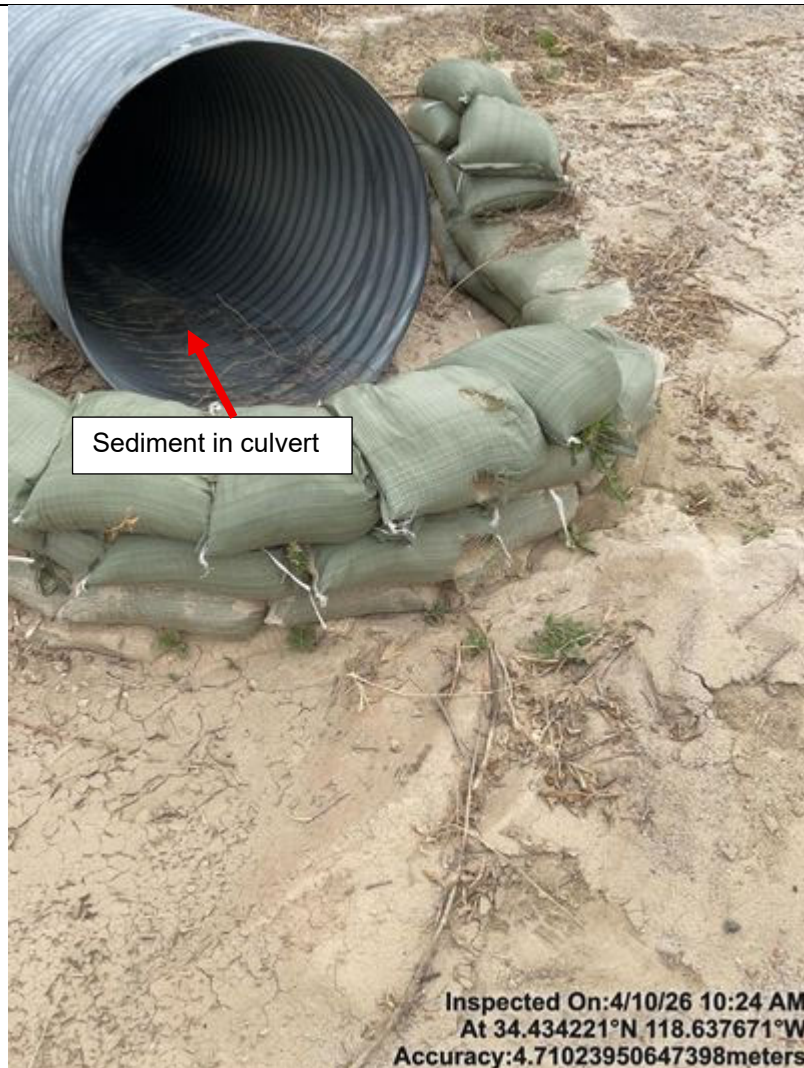
Photo 40  
Sediment buildup around sandbags

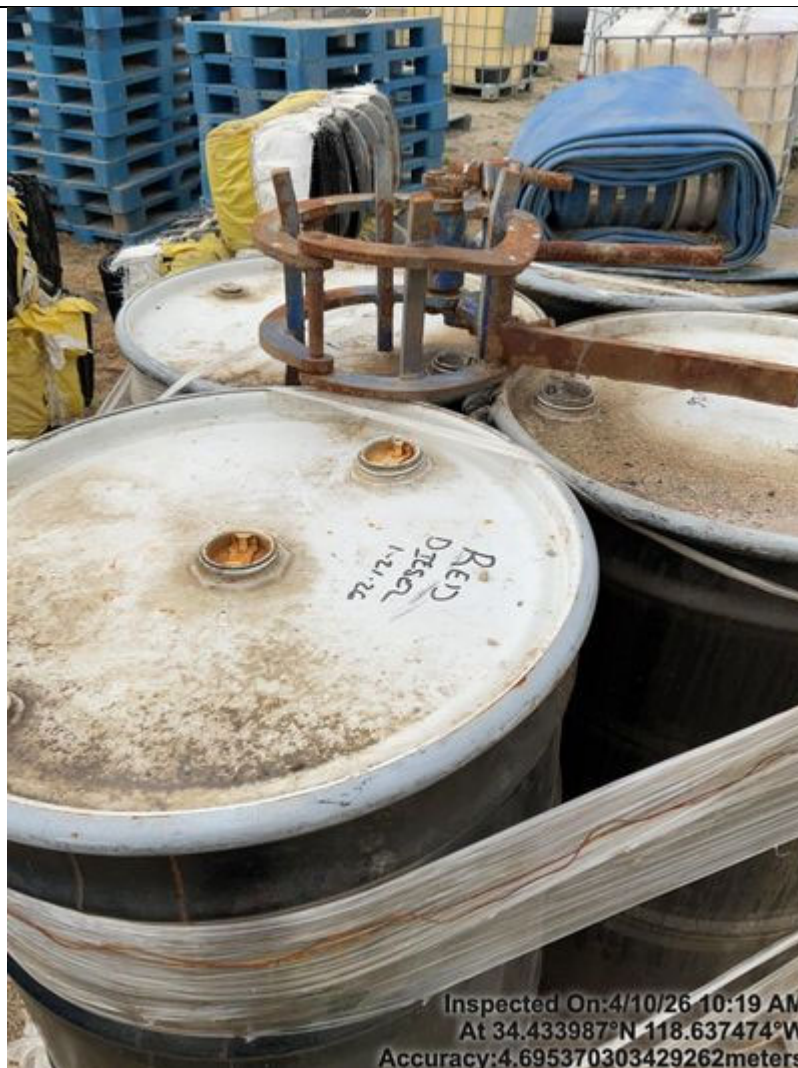
- Good Housekeeping BMPs were not observed in the equipment storage area and pipe lay down yard. This is a violation of IGP Section X.H.1.a.
- Erosion and Sediment Control BMPs were observed to be ineffective throughout the Site. This is a violation of IGP Section X.H.1.e.

Photo 44  
Drum and tote storage outdoors without secondary containment

- The drums and totes observed near the culvert were removed from the equipment storage and pipe laydown area and relocated to the Primary Canyon storage area, where they are maintained with secondary containment. See the enclosed Photo 11 showing the Canyon B equipment storage and laydown area without the drums or totes observed during the inspection.
- Chiquita actively uses this Canyon B area to store equipment necessary to operate and maintain the Landfill. Such equipment which is intended to be stored outdoors may contain varying levels of rust, which is not a significant contributor of pollutants. BMPs to address potential pollutants from equipment storage areas are implemented as outlined in the SWPPP.

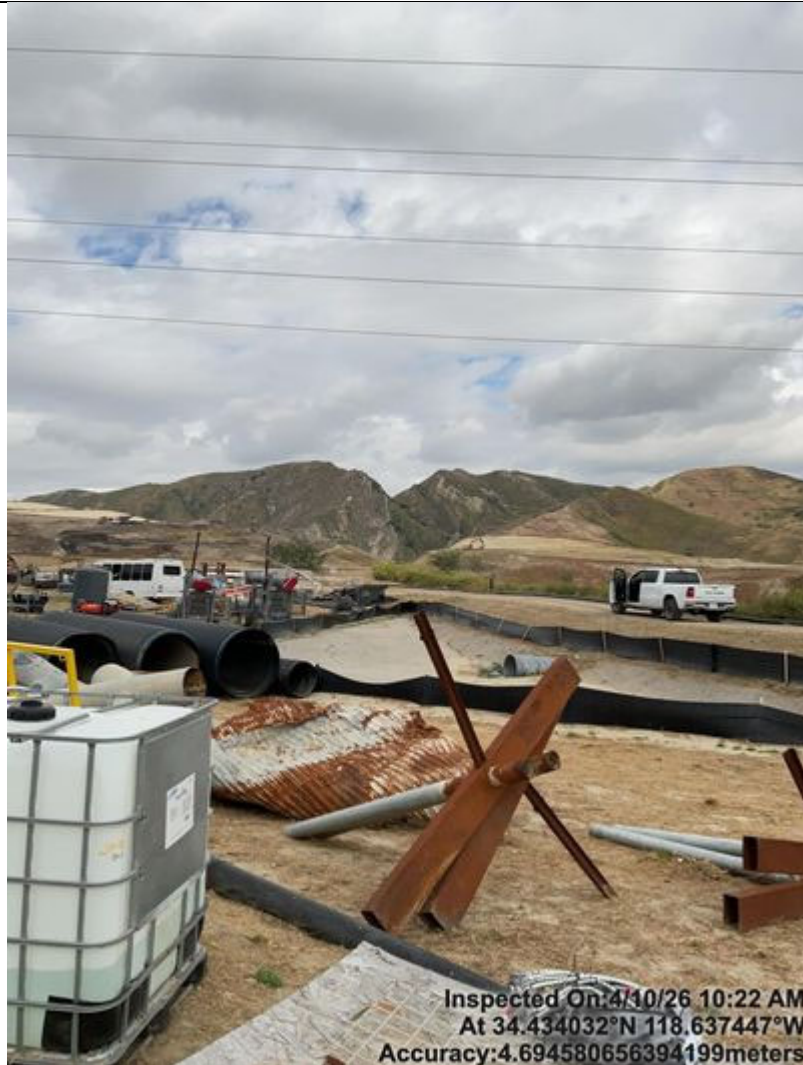
During the inspection, we observed BMPs in disrepair and discussed them with you. We also discussed BMPs that needed to be implemented in the equipment storage area, where we observed rusted metal in areas of exposure. Per our discussion, we would also like to know if pesticide and herbicide use occurs at CCL, since our monitoring results from the south basin show detection of pesticides and herbicides. Please provide the following information regarding pesticide/herbicide use at CCL:

Photo 51  
Metal material stored outdoors. I observed rust on the metal material

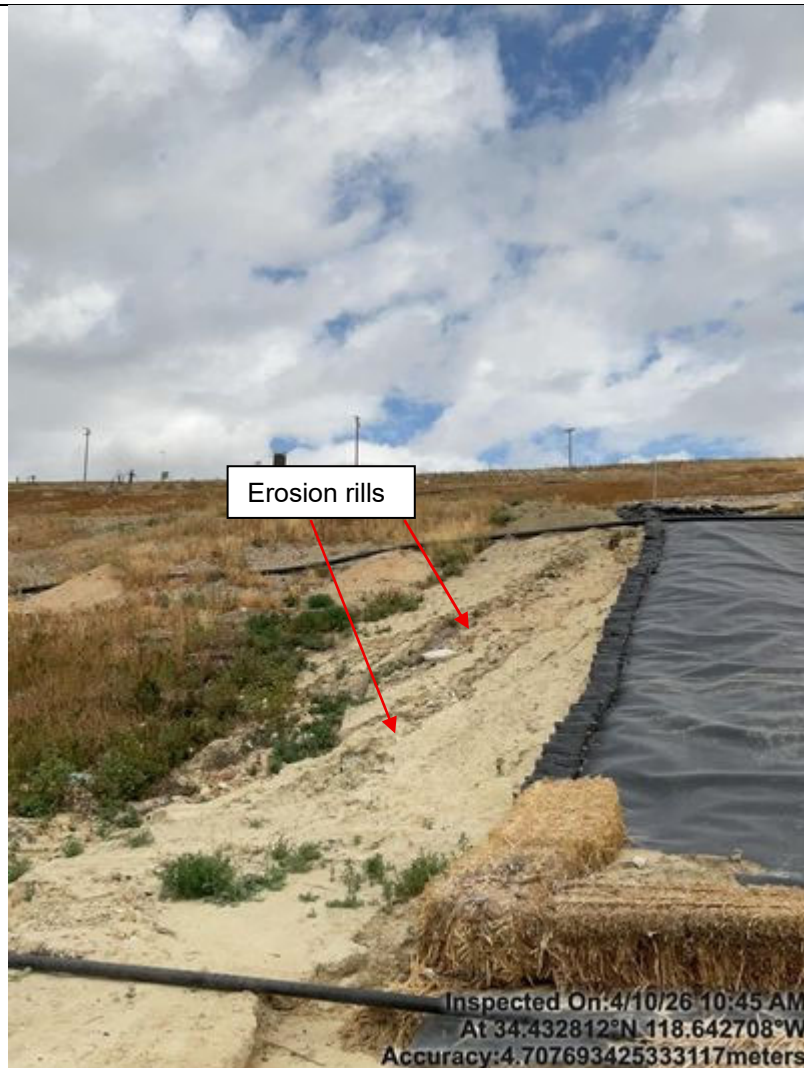
A view of the erosion control BMP with sandbags along the sides and hay bales at the front

associated accumulated sediment, was removed by Chiquita staff prior to receipt of the Report. The current condition as of September 30, 2026, of the area is shown below. The area will be covered in EVOH soon. See enclosed Photos 5 and 6.

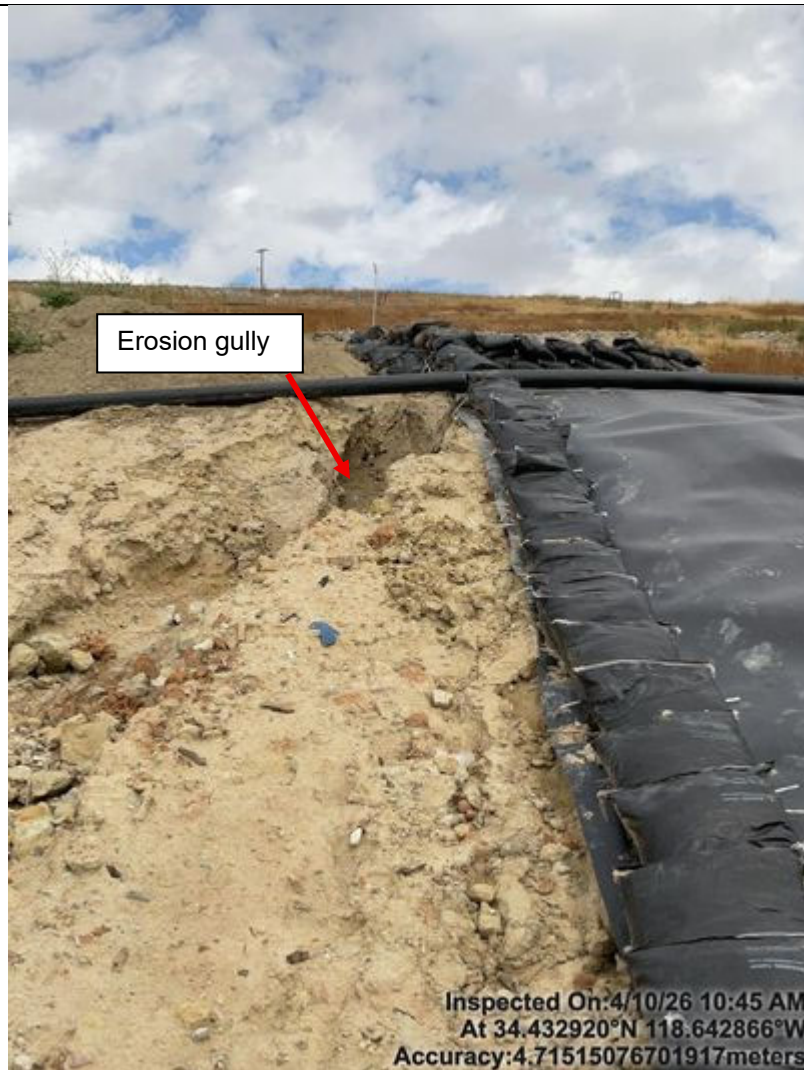
I observed erosion rills next to the erosion control BMP

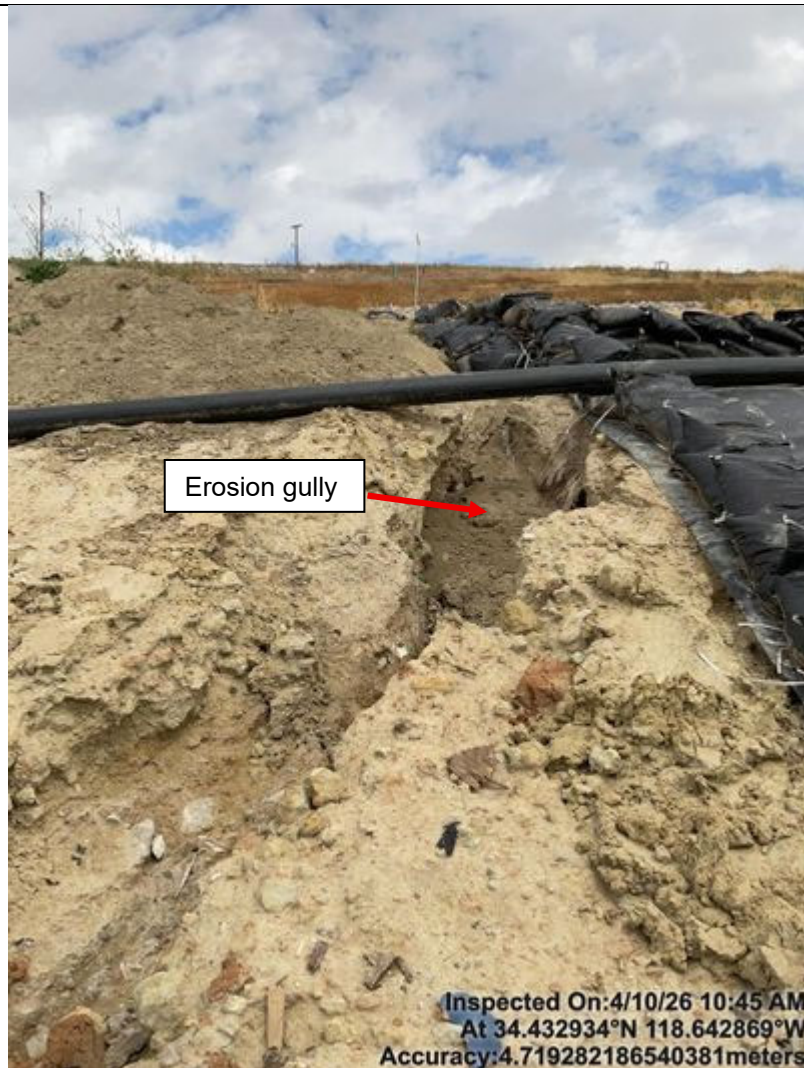
Photo 75  
Close up of erosion gully next to the erosion control BMP

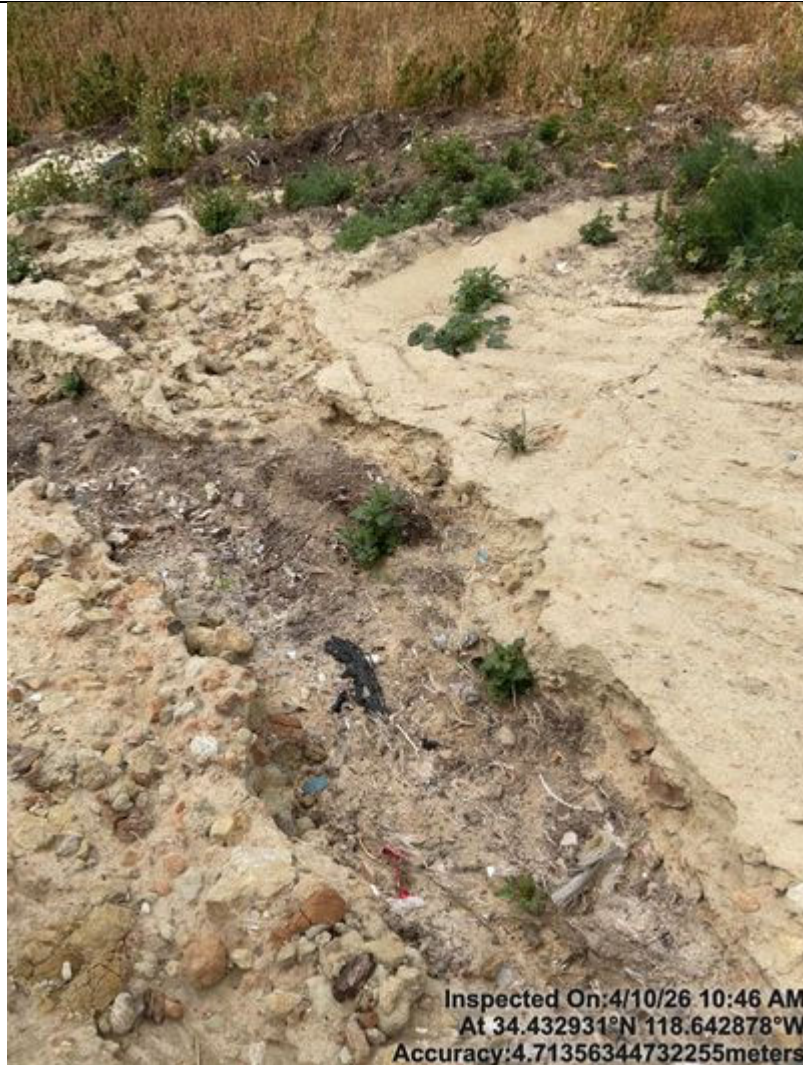
Photo 76  
Close up of erosion gully next to the erosion control BMP

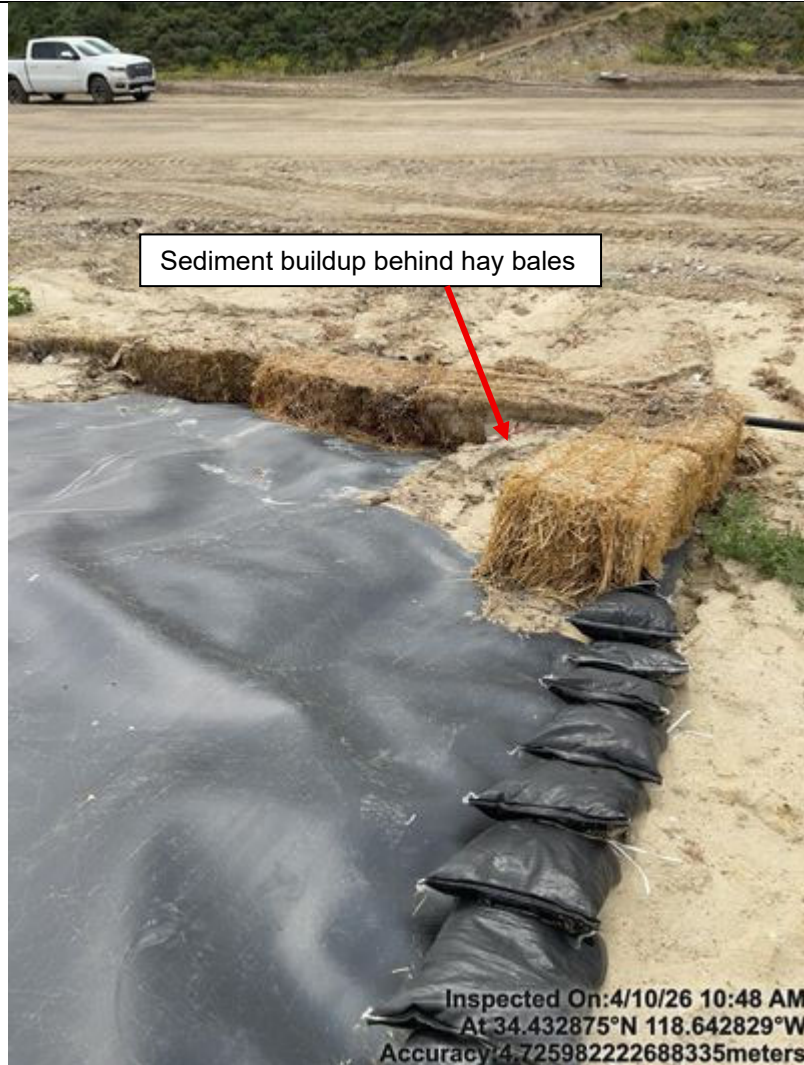
Photo 81  
Close-up of erosion next to erosion control BMP

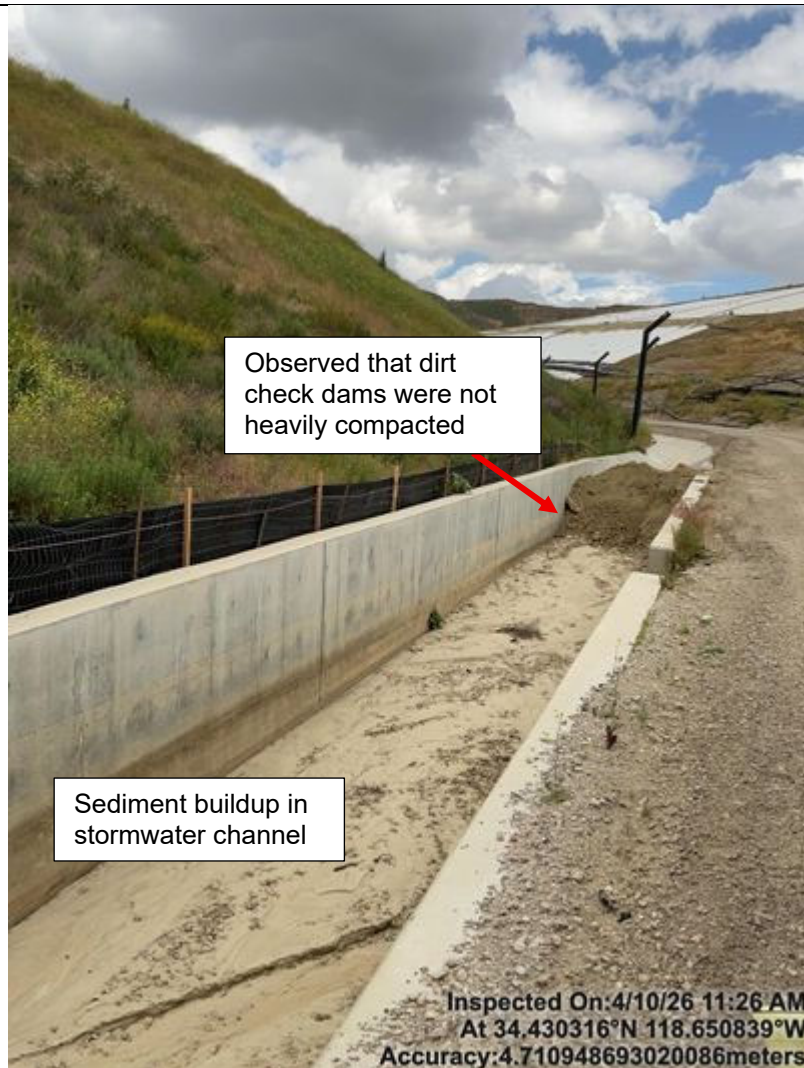
Photo 100  
Stormwater channel

I observed sediment buildup in the stormwater channel (Photos 100-103). I also observed that the dirt check dams put in place were not heavily compacted.

- The area identified in the Report's Photos 100-103 was subsequently incorporated into the West Toe project. As part of that work, the stormwater channel area and the material within it were covered, graded, and compacted, so the previously observed sediment is no longer exposed within the channel. The dirt check dams remain in place as flow-control BMPs for potential spills, leaks, or seeps. The check dams are installed and functioning as intended, which was verified during the September 6, 2026 rain event. The enclosed Photos 7, 8, and 9 show the channel and check-dam conditions as of September 30, 2026.

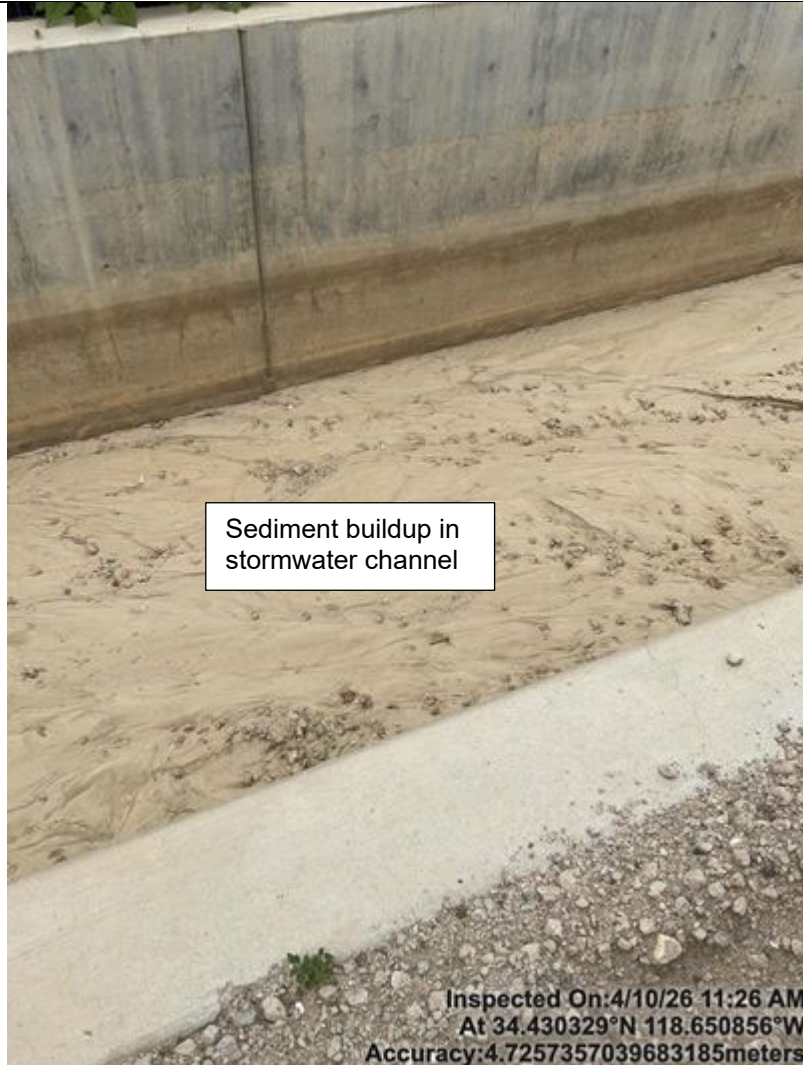
Photo 101  
Sediment buildup in stormwater channel

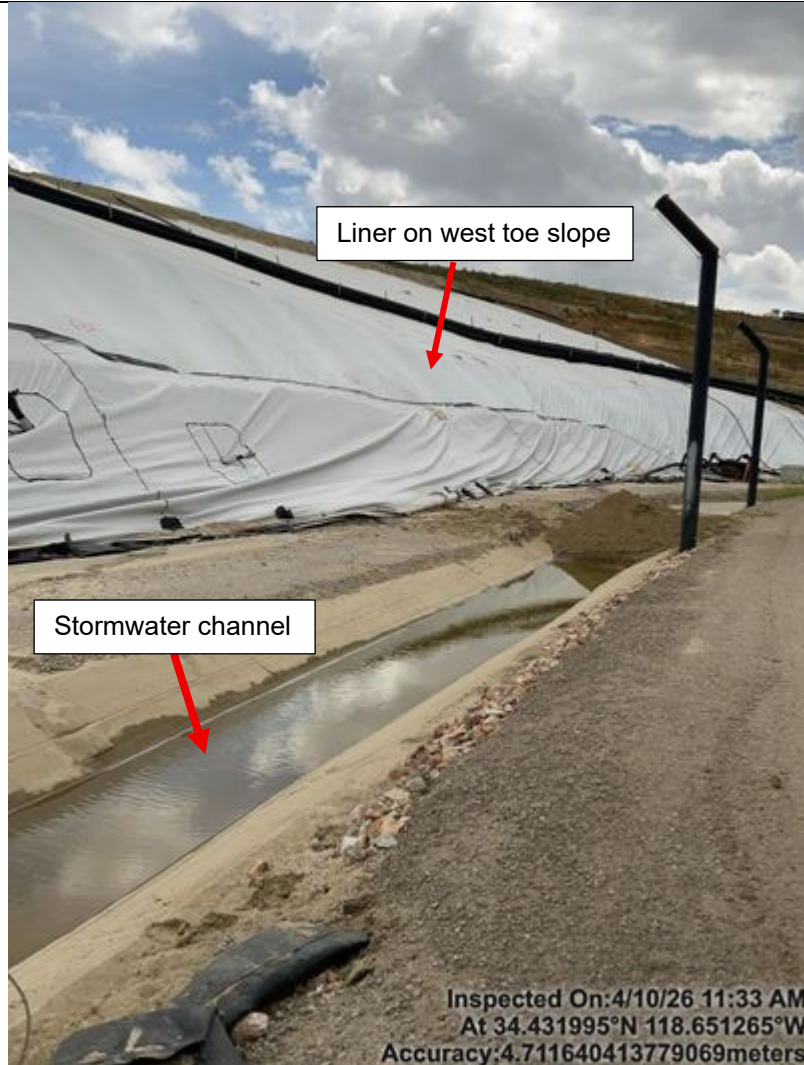
Liner on the west toe slope. Mr. Breuer explained that the slope will be buttressed up to prevent failure as part of a large project. Mr. Breuer stated that the finished slope will look like 3:1 slopes of dirt to contain the slope failure

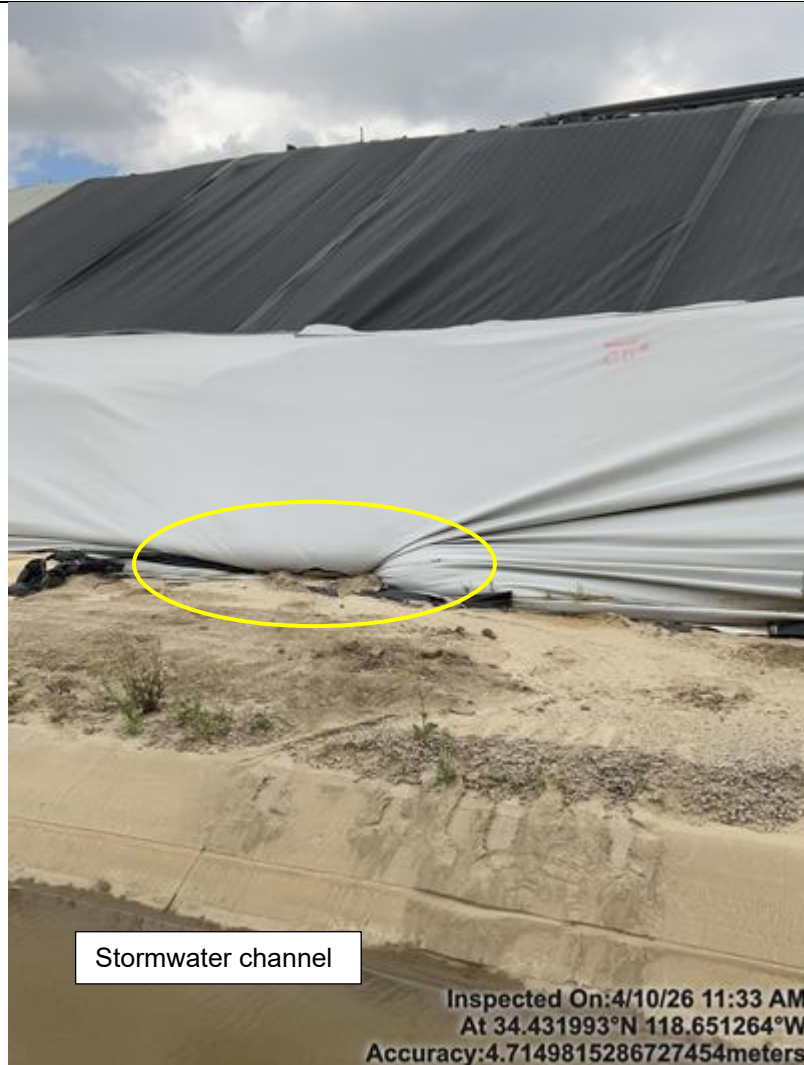
I observed a bulge in the liner (circled in yellow) due to dirt from the slope settling and stretching against the liner.

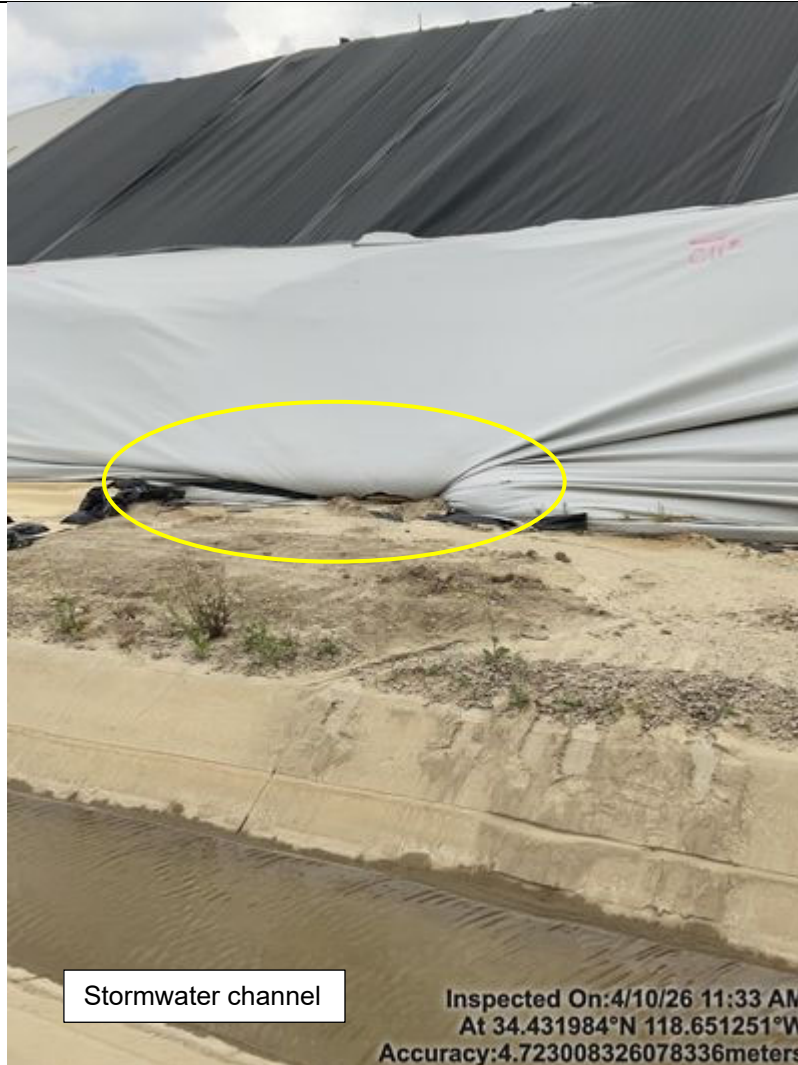
I observed a bulge in the liner (circled in yellow) due to dirt from the slope settling and stretching against the liner.

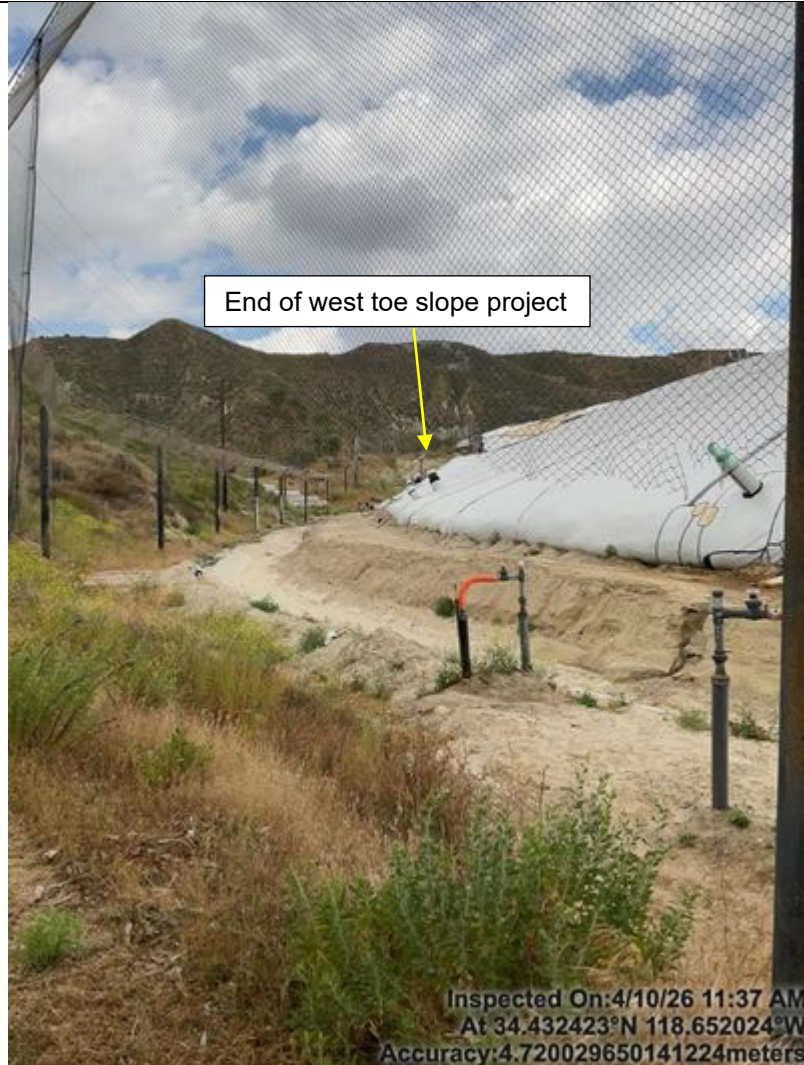
West toe project. Will go until the next curve. 15 crew members working on sediment in channel.  
Right now in emergency plan mode with check dams.

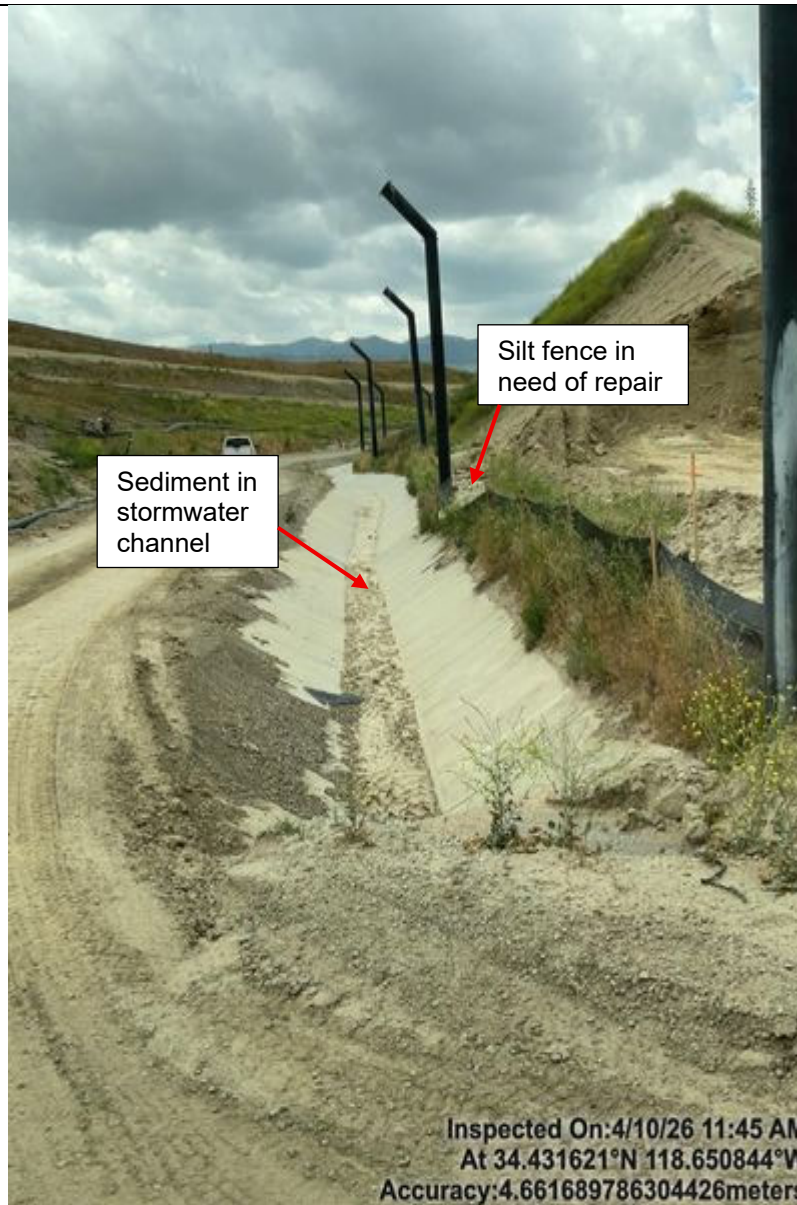
Photo 111  
Stormwater channel

We drove past a stormwater V-ditch channel and I observed sediment buildup (Photos 111-112). I also noticed that the silt fence placed at the top of the V-ditch was in need of repair (Photos 111-112).

- The V-ditch area identified in the Report's Photos 111-112 was incorporated into the West Toe project and has been covered. As a result, the previously observed V-ditch, sediment buildup, and silt fence are no longer present in the configuration documented during the inspection. The enclosed Photo 10 shows the current condition of the area as of September 30, 2026.
