**Re: Chiquita Canyon, LLC's Weekly Leachate Inspection Report for Stipulated Order for Abatement (Case No. 6177-4), Condition 27(c)**

Attachment: Leachate Seep/Pooling Inspection Logs from October 5 – October 11, 2026

# 4050 - Chiquita Leachate Seep/Pooling Inspection

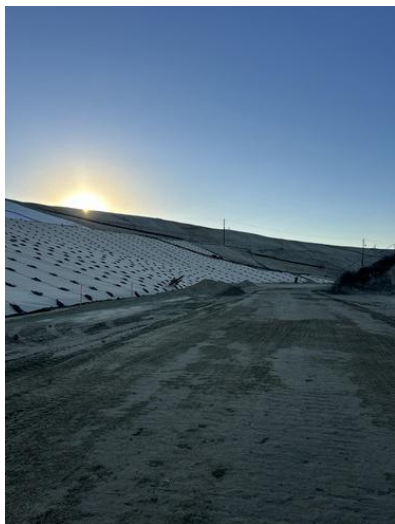
Photo 1

No

Westside perimeter road. None of the seepage previously observed in this area were observed at the time of this inspection. Permanent repairs are being conducted to contain seepage in this area as well.

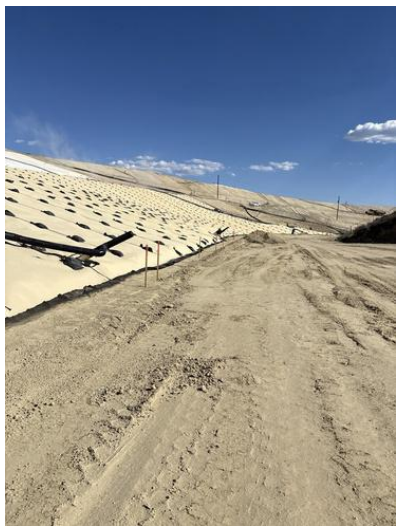
Photo 1

No

Westside perimeter road. None of the seepage previously observed in this area were observed at the time of this inspection, permanent repairs are being conducted to contain the seepage in this area.

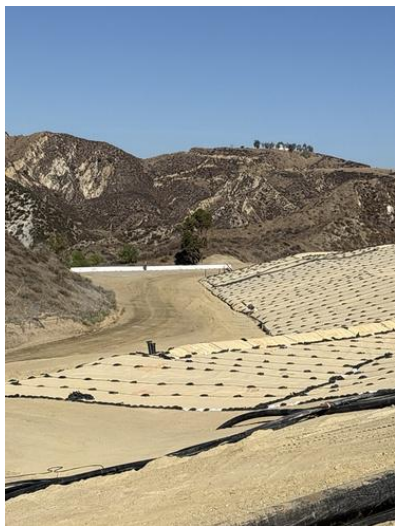
Photo 1

No

Westside perimeter road. None of the seepage previously observed in this area were observed at the time of this inspection, permanent repairs are being conducted to contain the seepage in this area.

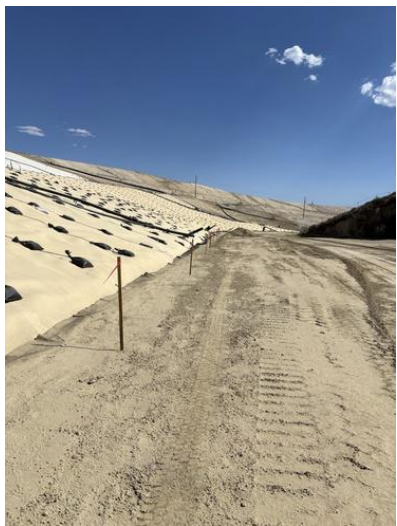
Photo 1

No

Westside perimeter road. None of the seepage previously observed in this area were observed at the time of this inspection, permanent repairs are being conducted to contain the seepage in this area.

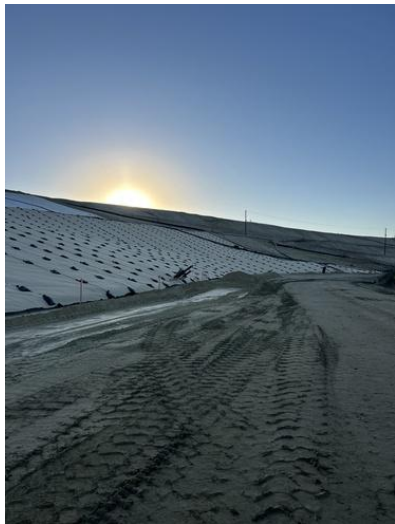
Photo 1

No

Westside perimeter road. None of the seepage previously observed in this area were observed at the time of this inspection. Permanent repairs are being conducted to contain seepage in this area as well.

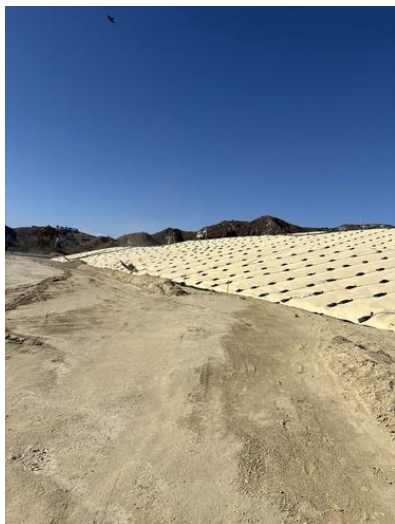
Photo 1

No

Westside perimeter road. None of the seepage previously observed in this area were observed at the time of this inspection, permanent repairs are being conducted to contain the seepage in this area.

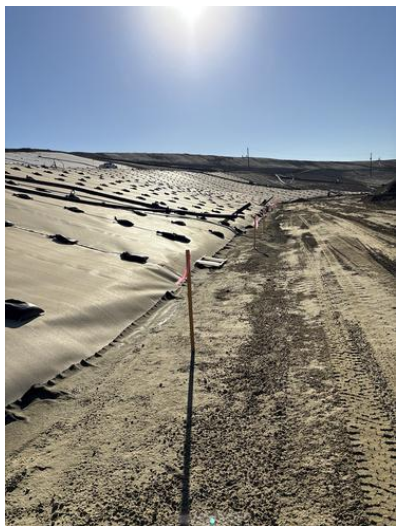
Photo 1

No

Westside perimeter road. None of the seepage previously observed in this area were observed at the time of this inspection, permanent repairs are being conducted to contain the seepage in this area.

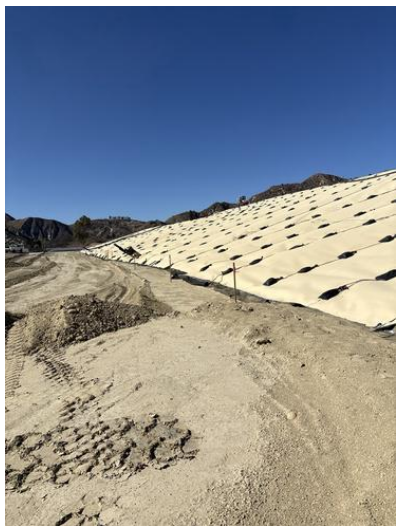
Photo 1

No

Westside perimeter road. None of the seepage previously observed in this area were observed at the time of this inspection, permanent repairs are being conducted to contain the seepage in this area.

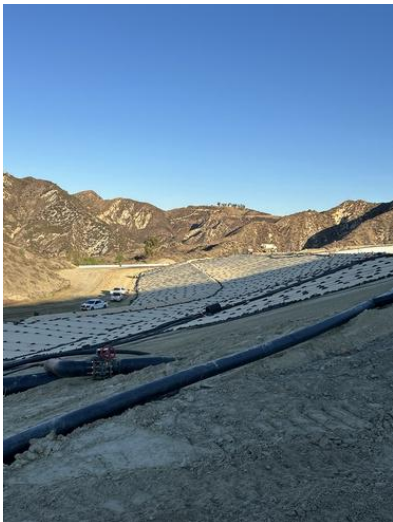
Photo 1

No

Westside perimeter road. None of the seepage previously observed in this area were observed at the time of this inspection. The portion of the west toe project pertaining to seeps is considered to be complete.

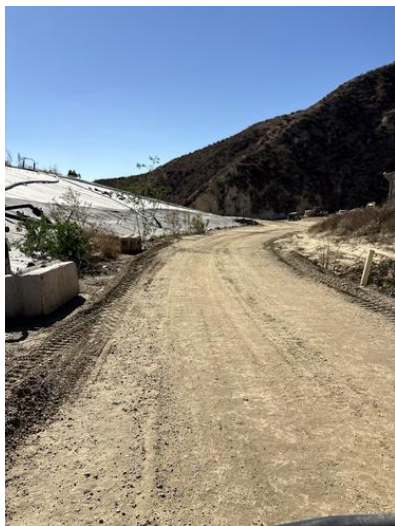
Photo 1

No

North perimeter road.

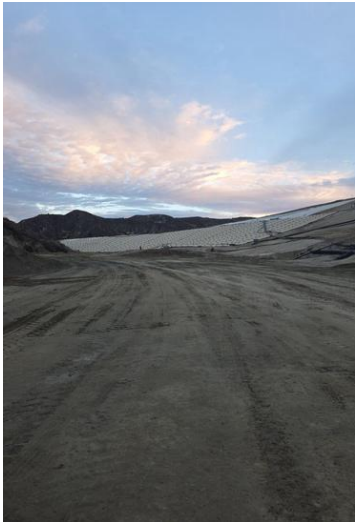
Photo 1

No

West side perimeter road

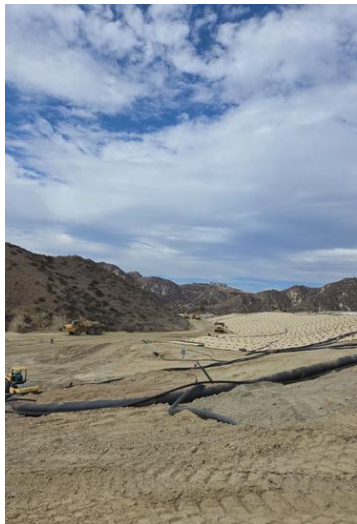
Photo 1

No

West side perimeter road

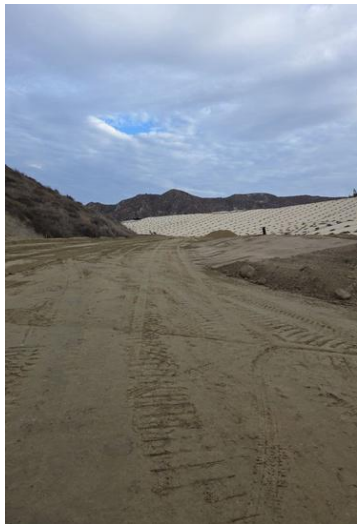
Photo 1

No

West side perimeter road

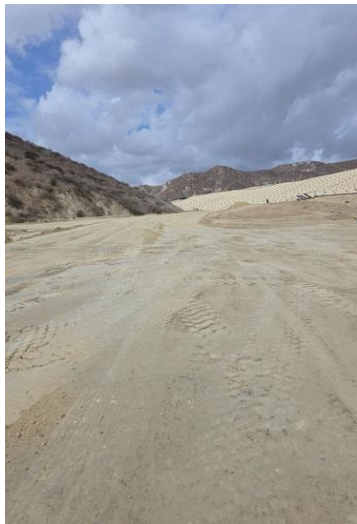
Photo 1

No

West side perimeter road
