**Re: Chiquita Canyon, LLC's Weekly Leachate Inspection Report for Stipulated Order for Abatement (Case No. 6177-4), Condition 27(c)**

Attachment: Leachate Seep/Pooling Inspection Logs from October 12 – October 18, 2026

# 4050 - Chiquita Leachate Seep/Pooling Inspection

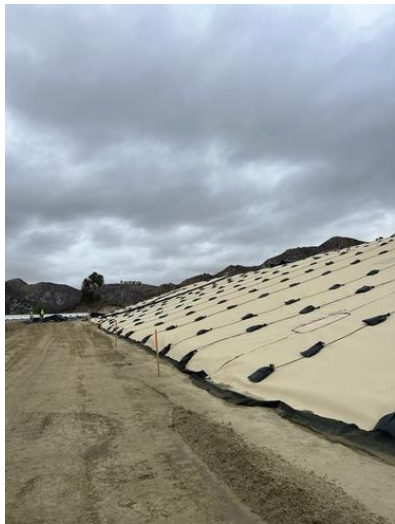
Photo 1

West side perimeter road

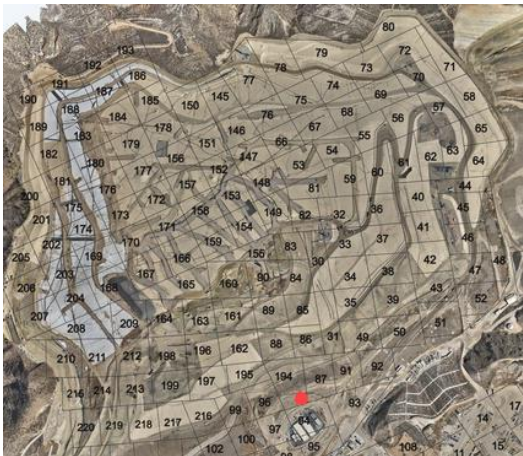
194

Castaic CA 91384  
United States  
(34.43022154493459,  
-118.64540116514746)

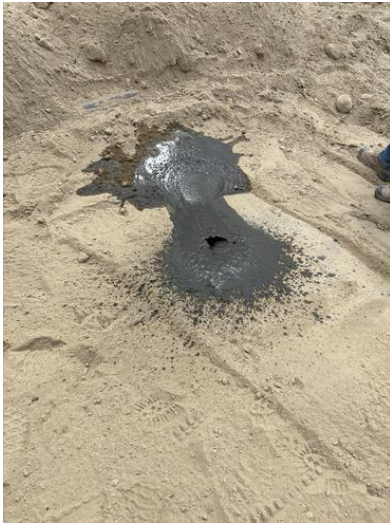
Photo 1

1/2 hour

1-5 gallons

6 sq ft

Leachate

2 - Light Odor Detected

Standing free liquid

No

An abandoned well was found and a cap was added to slow the flow of liquid and new lateral interceptor was added to direct the liquid to the existing toe drain which flows to a sump.

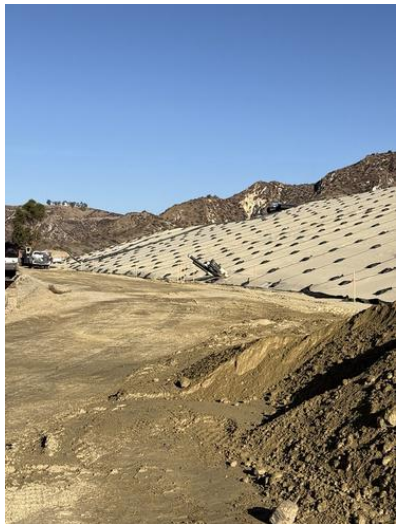
Photo 1

Westside perimeter road. Seep observed yesterday in Grid 194 was not observed during this inspection.

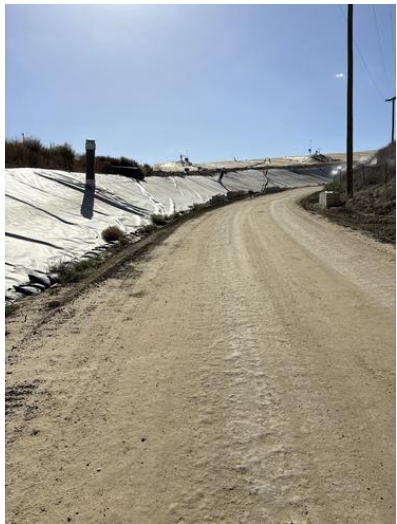
Photo 1

North perimeter road.

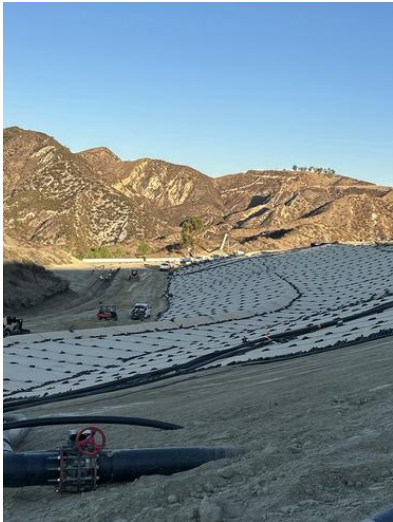
Photo 1

Westside perimeter road

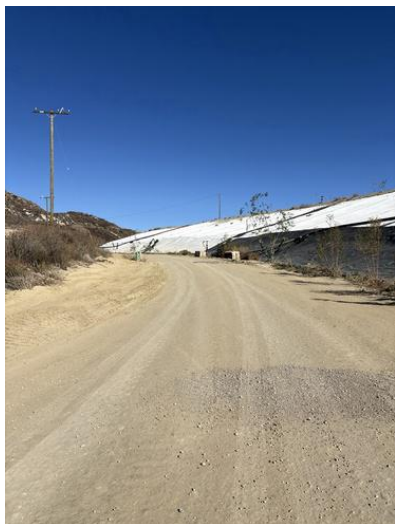
Photo 1

North perimeter road.

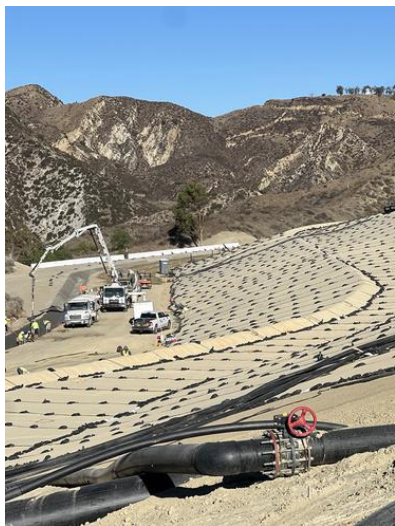
Photo 1

Westside perimeter road.

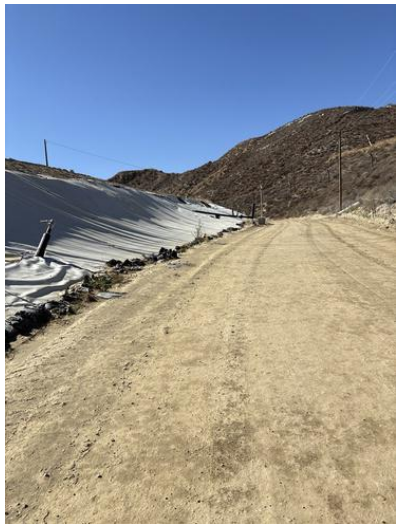
Photo 1

North perimeter road.

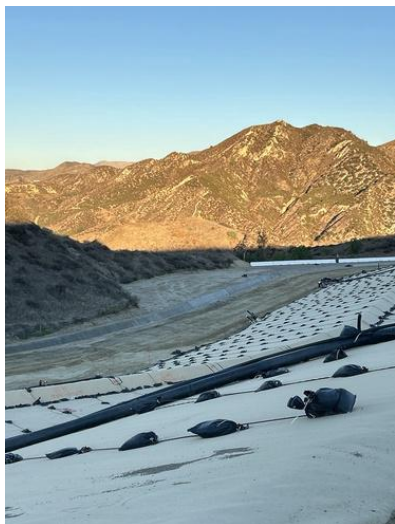
Photo 1

Westside perimeter road

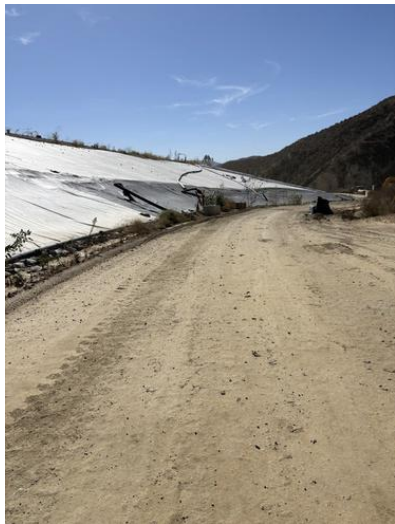
Photo 1

North perimeter road.

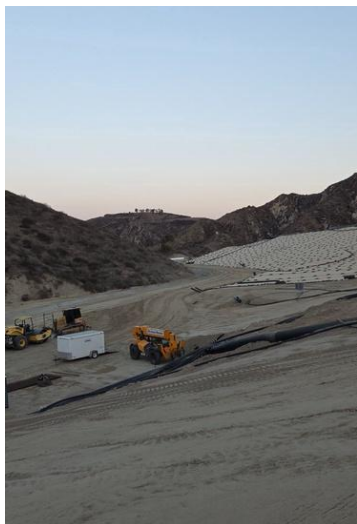
Photo 1

No pooling or leaking on the Westside perimeter road

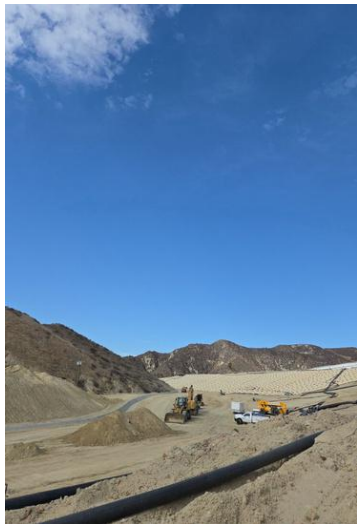
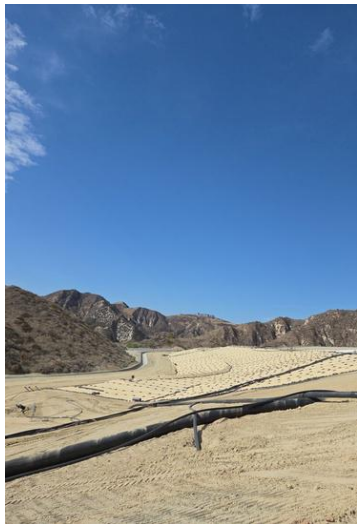
No seepage or pooling on the Westside perimeter road

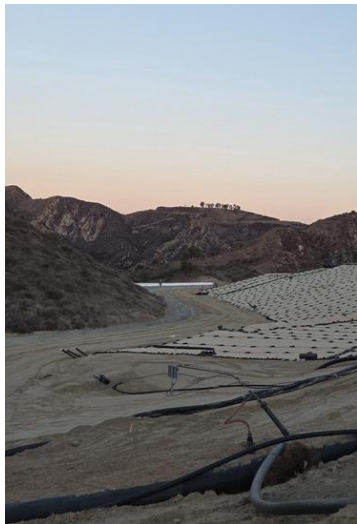
Photo 1

No seep or pooling on westside perimeter road

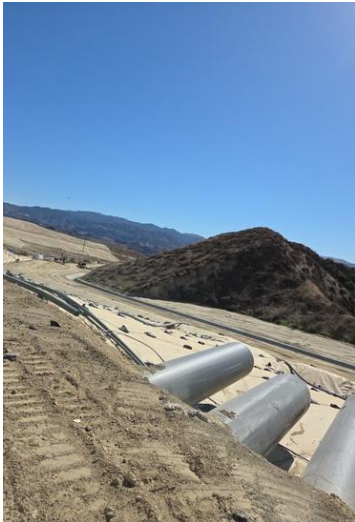
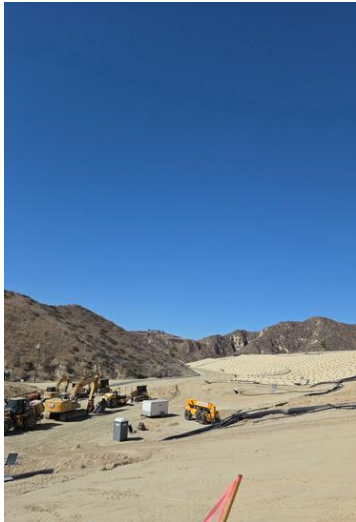
No seeping or pooling on westside perimeter road
