**CHIQUITA CANYON**  
*A Waste Connections Company*

**Re: Chiquita Canyon, LLC's Weekly Report on the Documentation and Tracking of Cover Issues**

Attachment: October 20, 2026 Weekly Cover Issues Report

# 4050 - Chiquita Reaction Area Tracking of Fissures and Tension Cracks

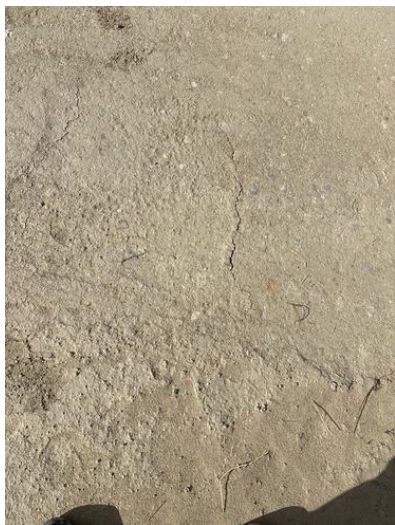
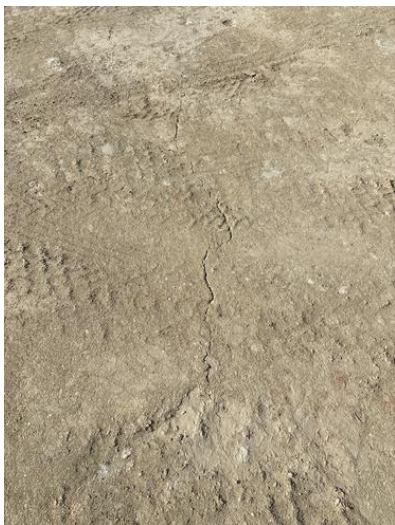
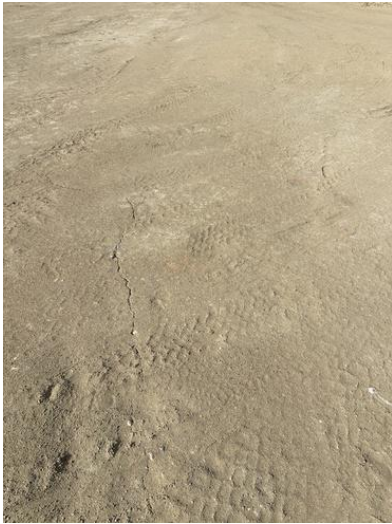
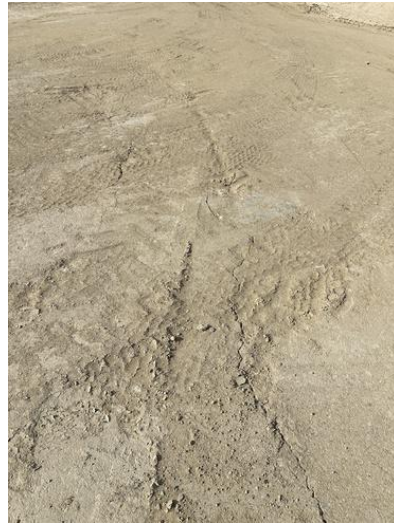
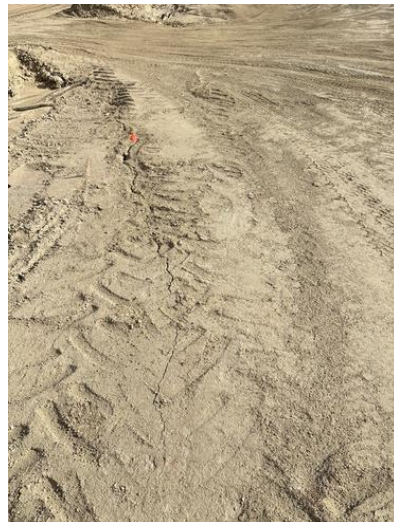
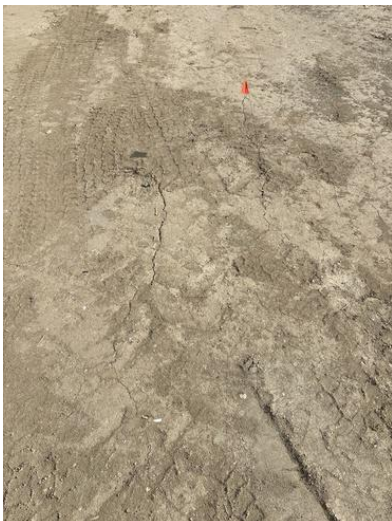
Grid Location

160

120ft x 80ft

No individual crack 50ft or longer

| Horizontal Offset (width) | Small 0.5-2" in width |
| Vertical Offset (height) | Extra small <0.5" in height |
| Orientation (direction) | NE to SW |

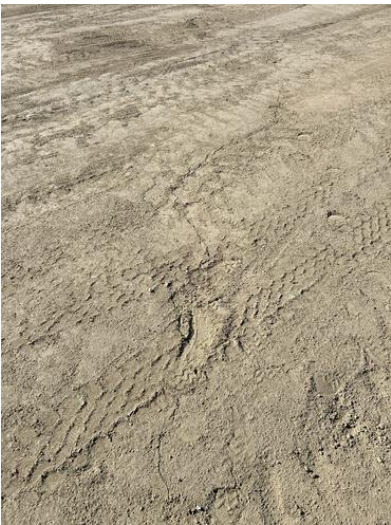
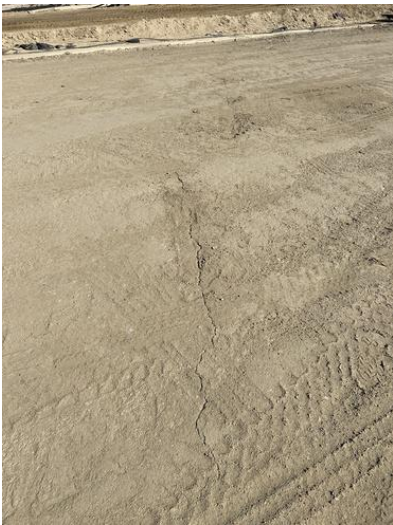
163

35ft

Extra Small <0.5 in width

Extra small <0.5" in height

NE to SW

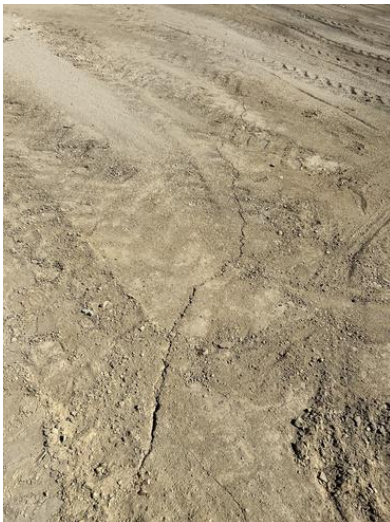
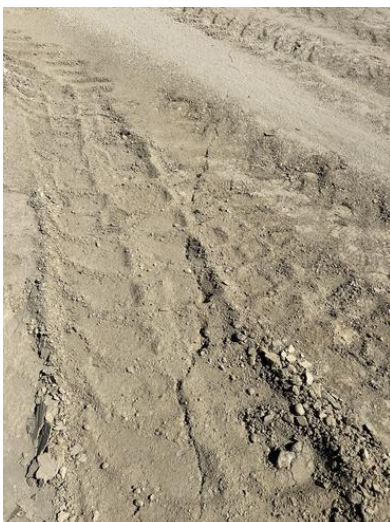
163

| <b>Length of crack (ft) or area containing multiple cracks (ft x ft)</b> | 20ft |
| <b>Horizontal Offset (width)</b> | Extra Small <0.5 in width |
| <b>Vertical Offset (height)</b> | Extra small <0.5" in height |
| <b>Orientation (direction)</b> | NE to SW |

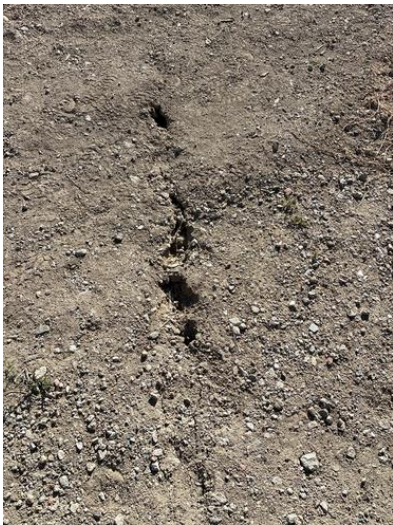
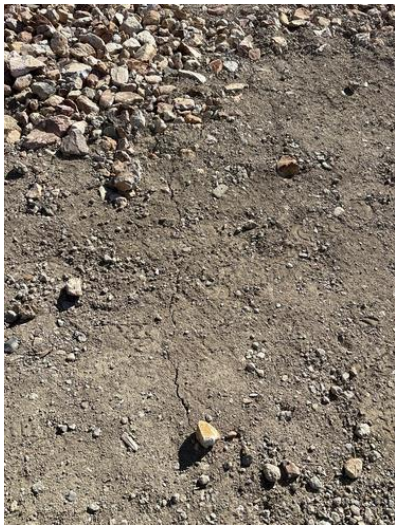
90

6ft x 3ft

Medium 2-4" in width

Extra small <0.5" in height

E to W

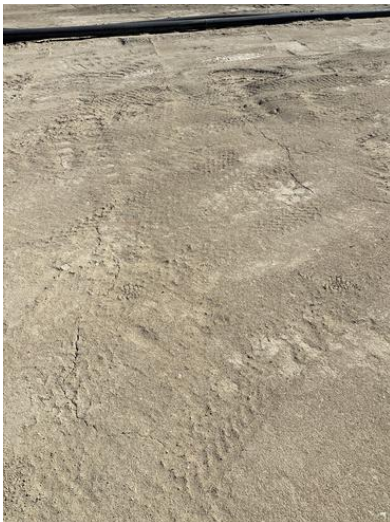
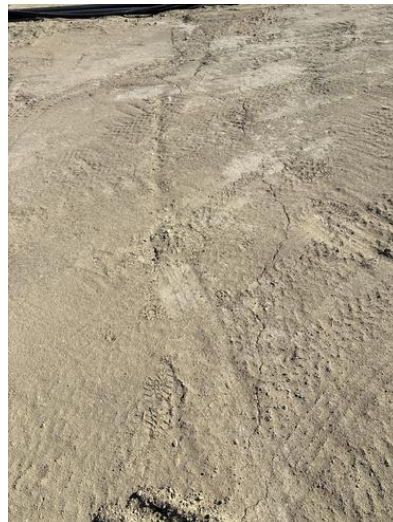
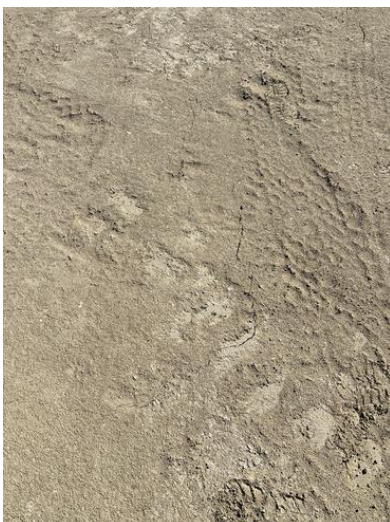
160

| Length of crack (ft) or area containing multiple cracks (ft x ft) | 30ft x 25ft |
| Horizontal Offset (width) | Extra Small <0.5 in width |
| Vertical Offset (height) | Extra small <0.5" in height |
| Orientation (direction) | NE to SW |

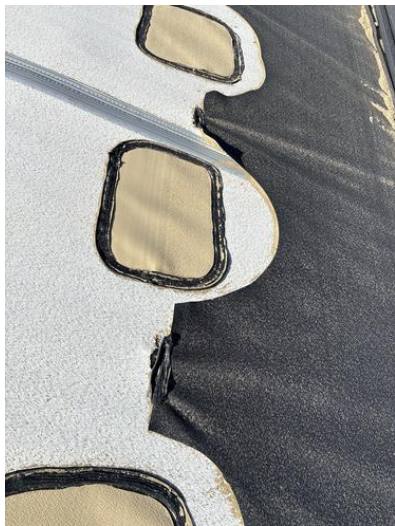
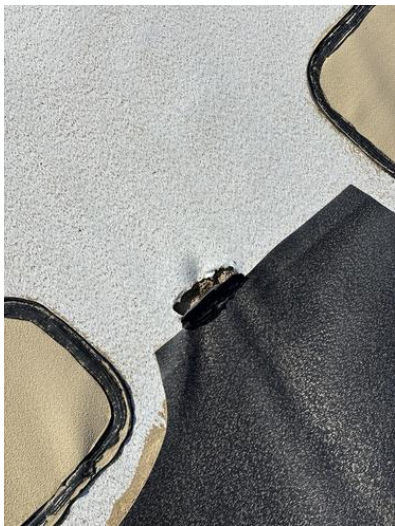
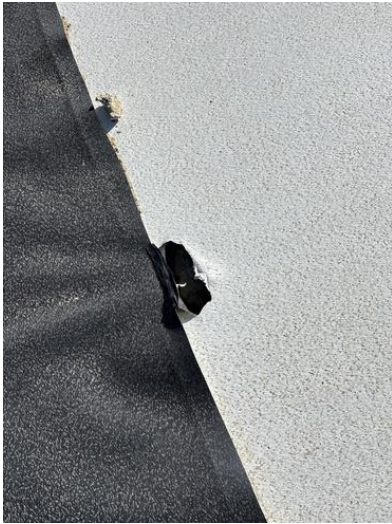
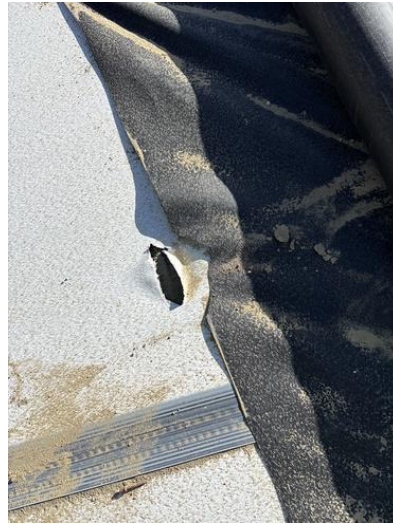
187

Tears in liner need to be patched/extrusion welded.

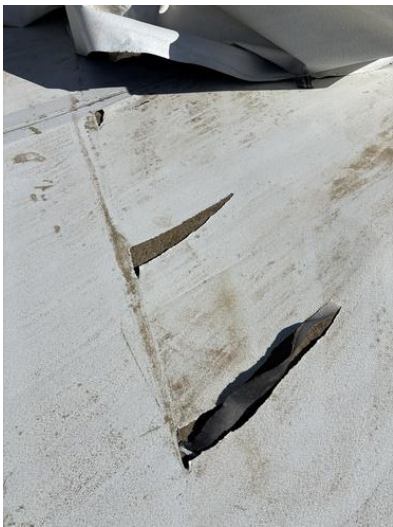
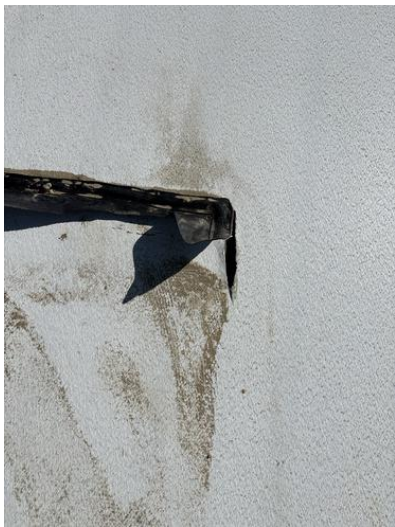
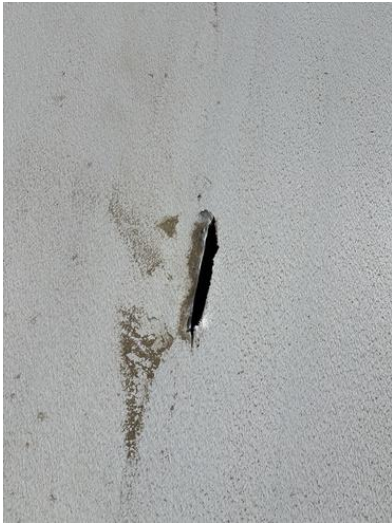
180

Tears in liner need to be patched/extrusion welded.

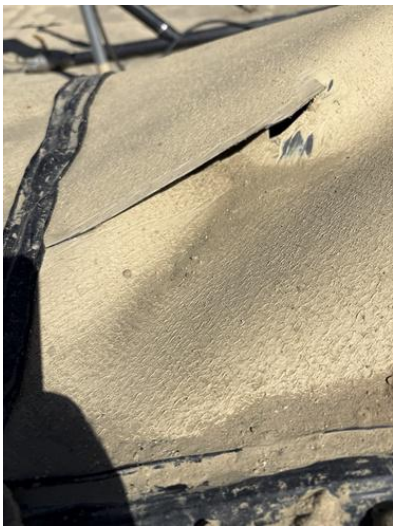
Photo 1

182

Tear in liner needs to be patched/extrusion welded.
