***Phase I Environmental
Site Assessment Report***

**Selected Parcels along Upper Llagas Creek
Reaches 4, 5, 6 and 7B
Morgan Hill, California
Volume No. 1**

December 2003

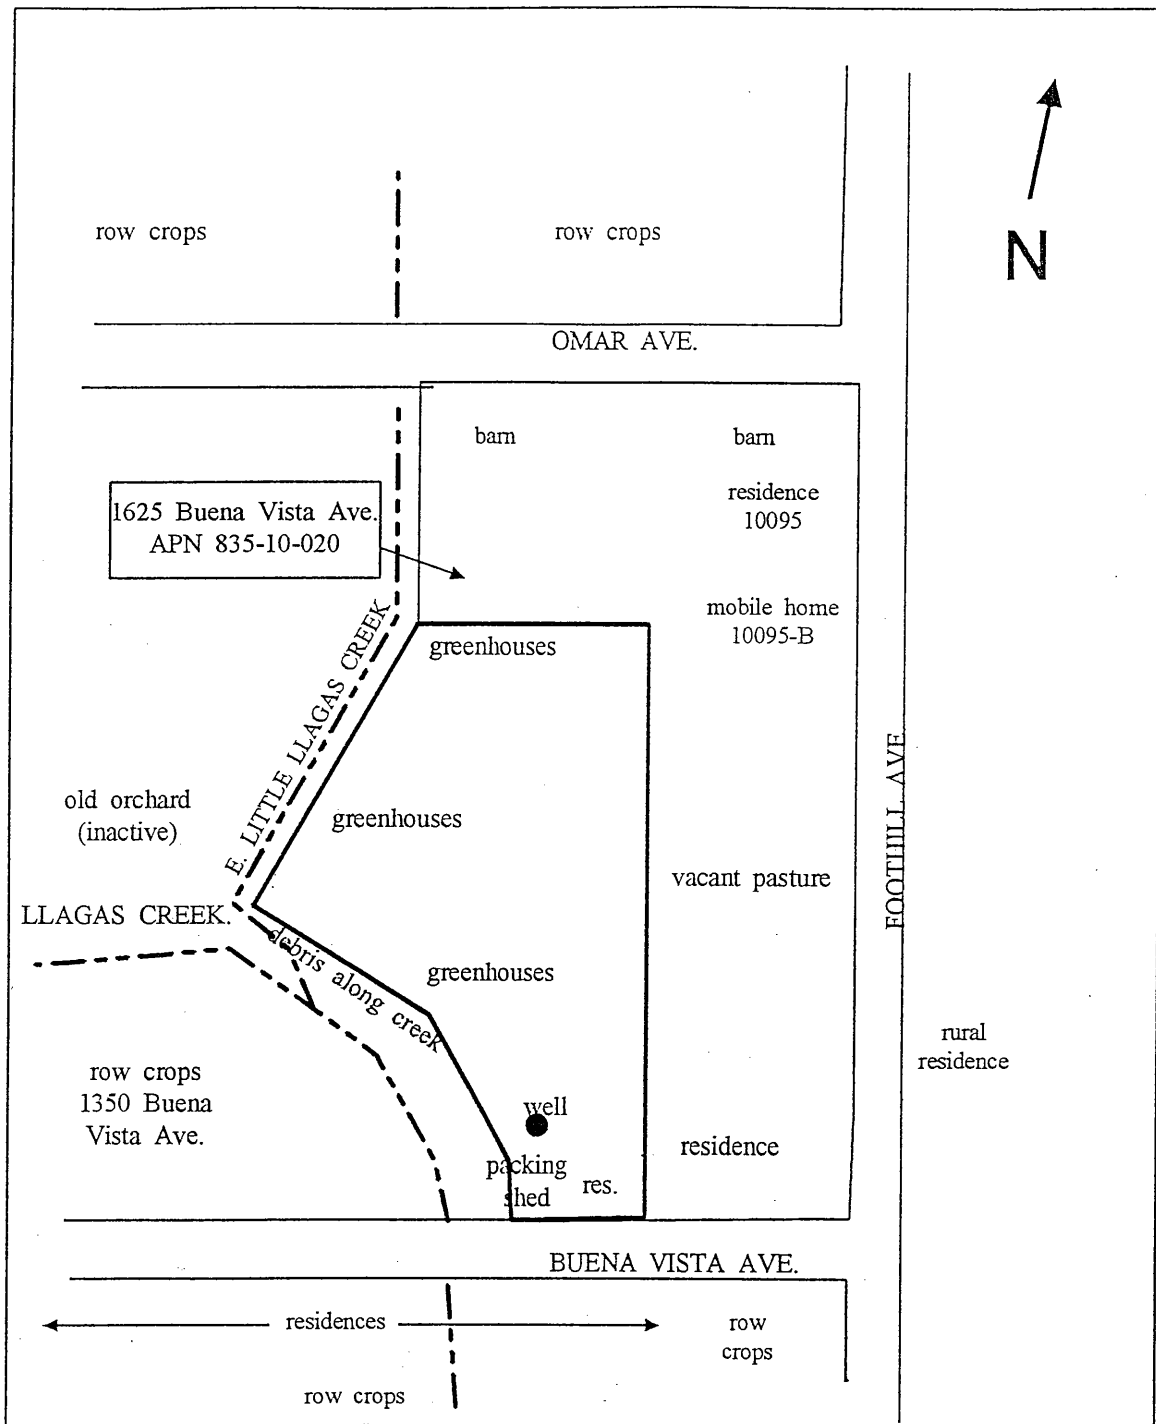
FIGURE 18
PROPERTY SITE PLAN

- At 1625 Buena Vista Avenue, some trash and debris has been disposed of adjacent to Llagas Creek, and small drainage ditches have been excavated from the greenhouse operation at the parcel, towards Llagas Creek. The trash and debris and drainage construction does not appear to have created a significant environmental condition, however, the District should be aware of these conditions during construction activities.
- The recognized environmental conditions based on site inspections, owner interviews, aerial photograph reviews, historical city directory reviews, regulatory agency reviews (fire, building, health, etc.) and regulatory agency database reviews are summarized in table format in Section 5.8. A full review of each parcel for each type of research conducted is detailed in Section 5.1.

1625 BUENA VISTA AVENUE
GILROY, REACH 4, UPPER LLAGAS CREEK

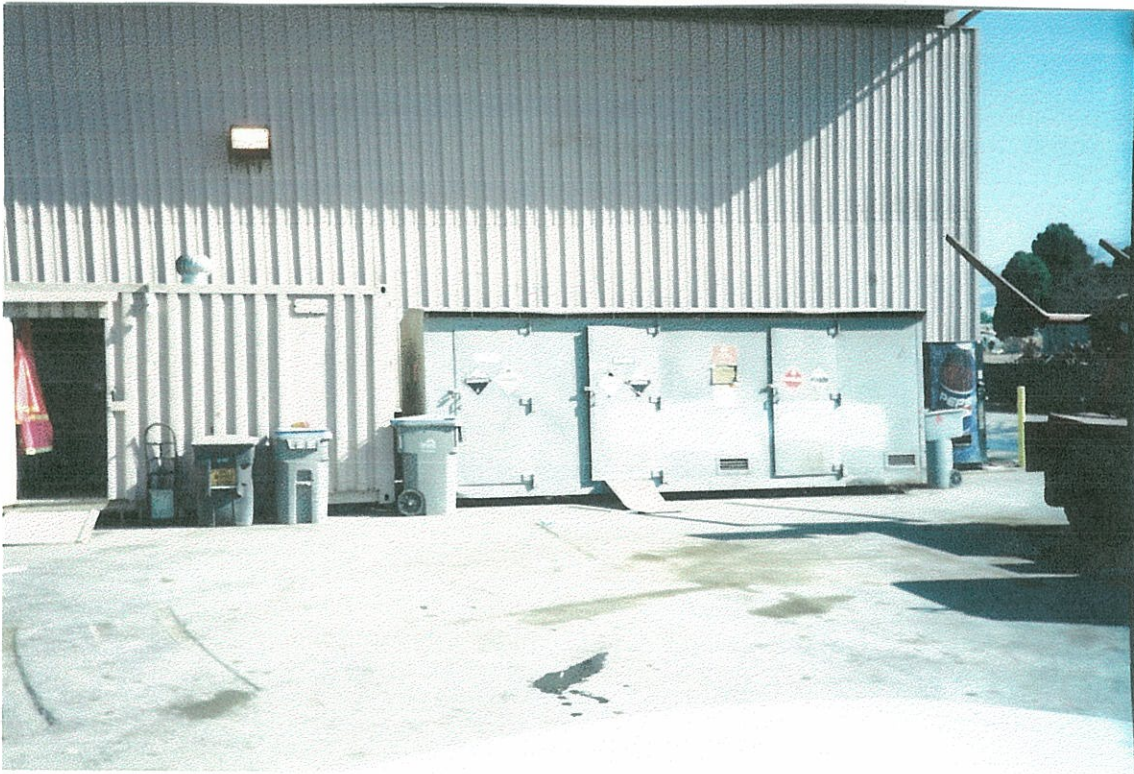
Photo #3: 14070 Llagas Ave. (APN 825-08-051), San Martin Transfer Station, hazardous materials storage.

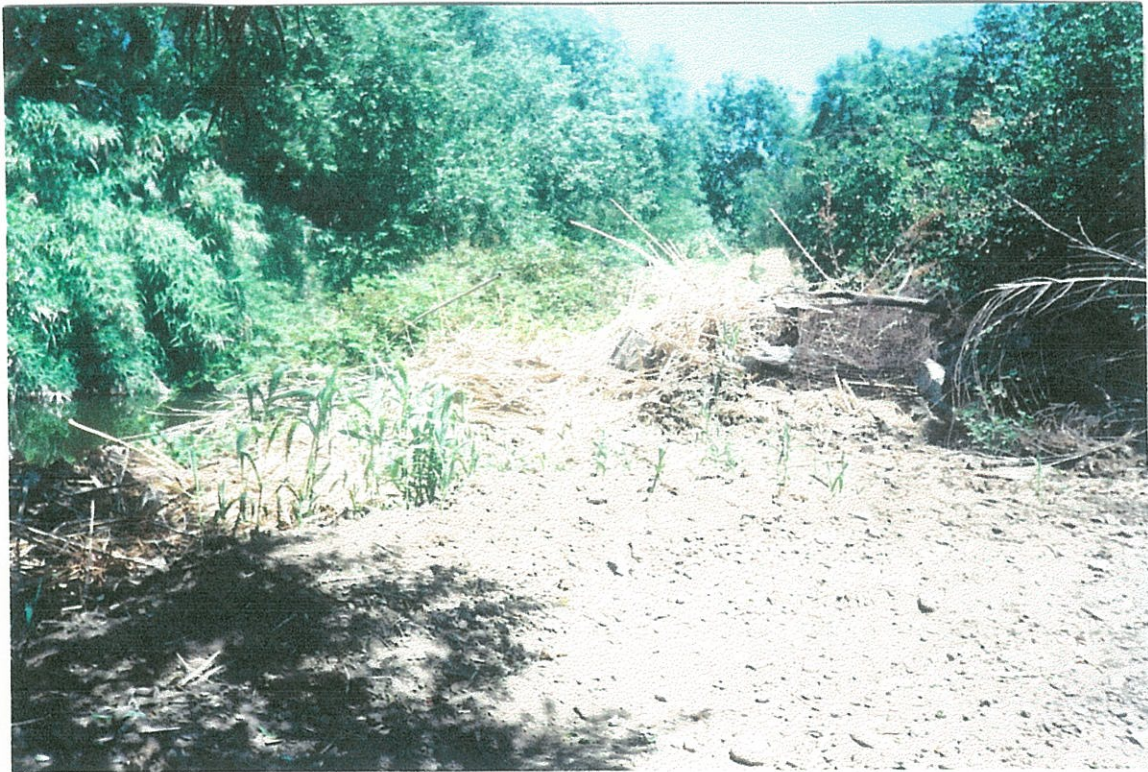
Photo #13: 13110 Llagas Avenue (APN 825-37-019), view of grading activity by Llagas Creek.

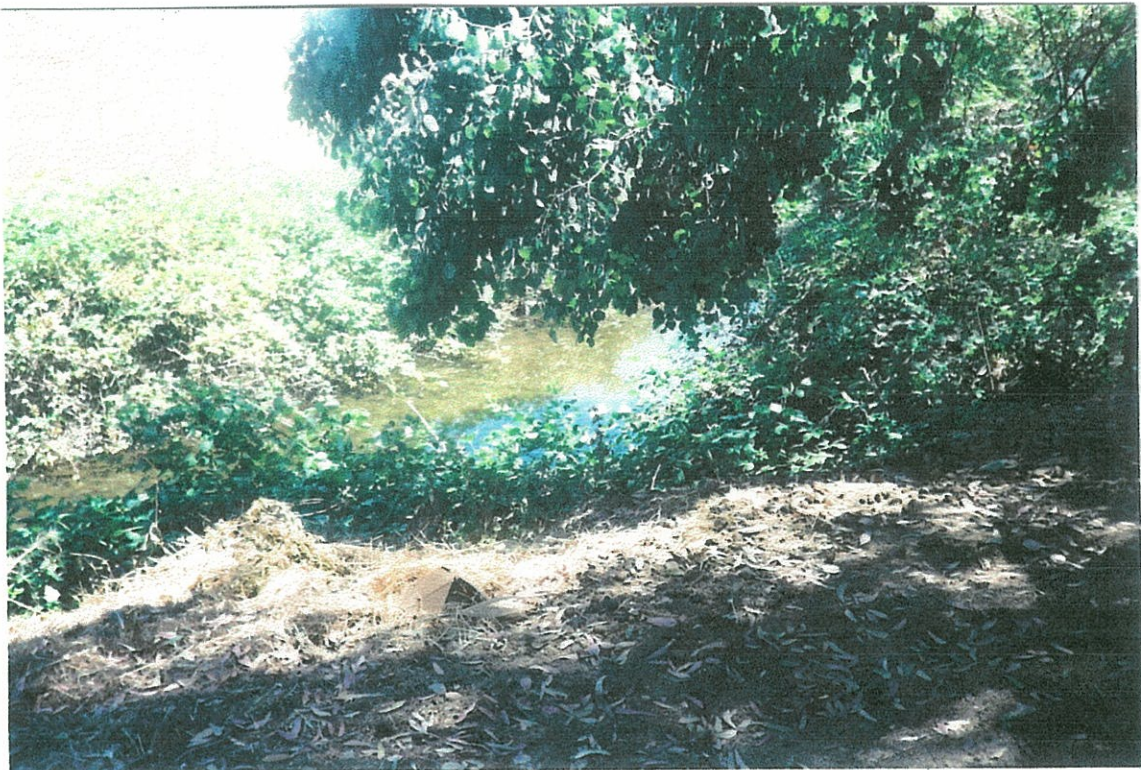
Photo #14: 12280 Llagas Avenue (APN 825-37-004), view of horse pasture area by Llagas Creek.

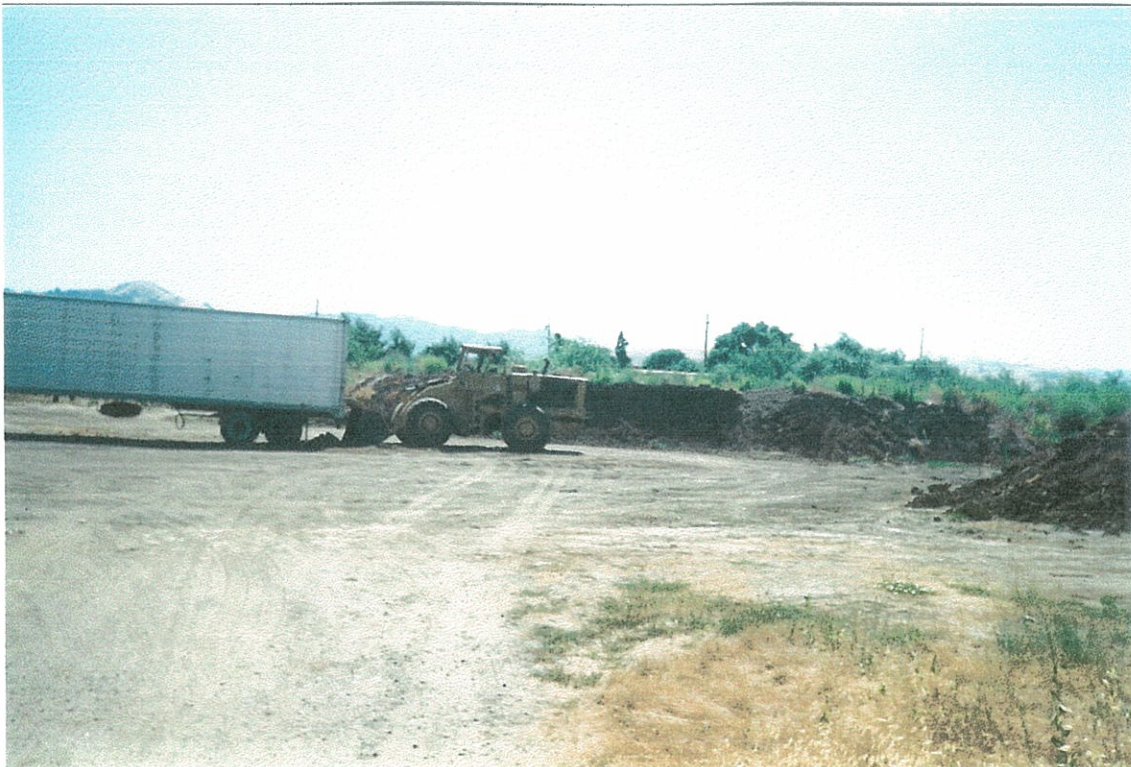
Photo #16: 12405 Murphy Avenue (APN 825-11-007), building materials storage yard by Llagas Creek.

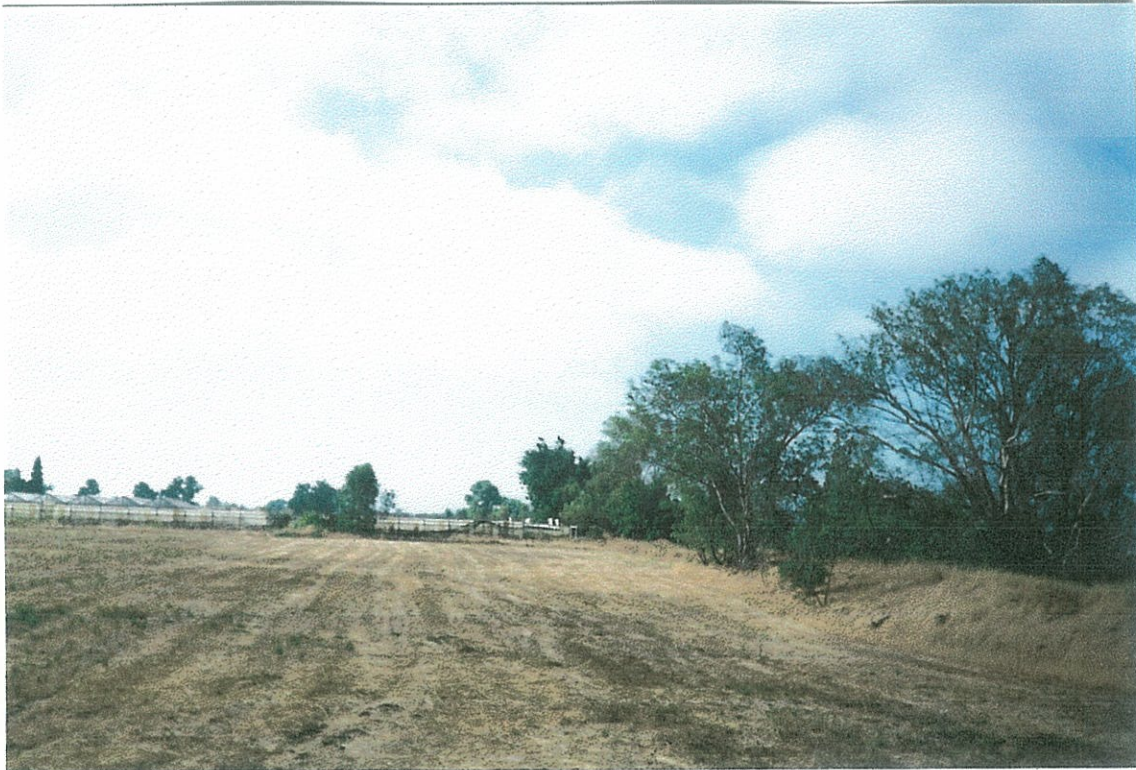
Photo #17: 11615 Murphy Ave. (APN 830-04-025), view south showing greenhouses near creek (on right).

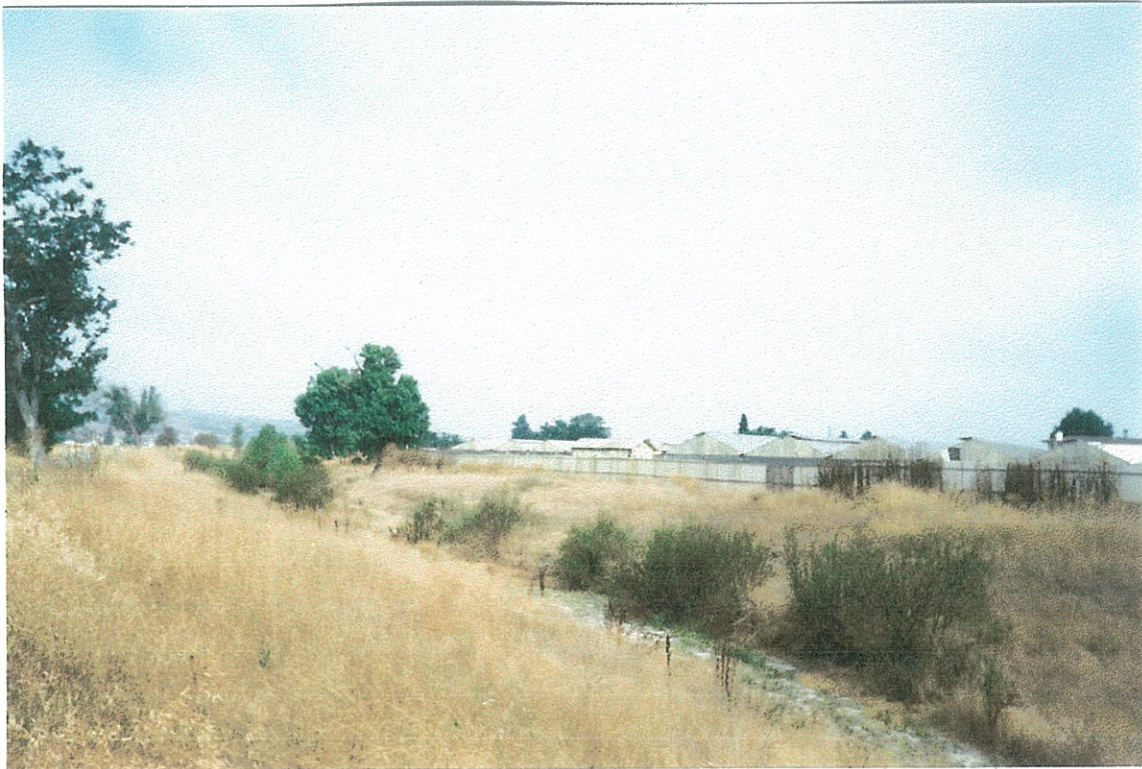
Photo #18: 11605 Murphy Ave. (APN 830-04-037), view north showing greenhouses near creek.

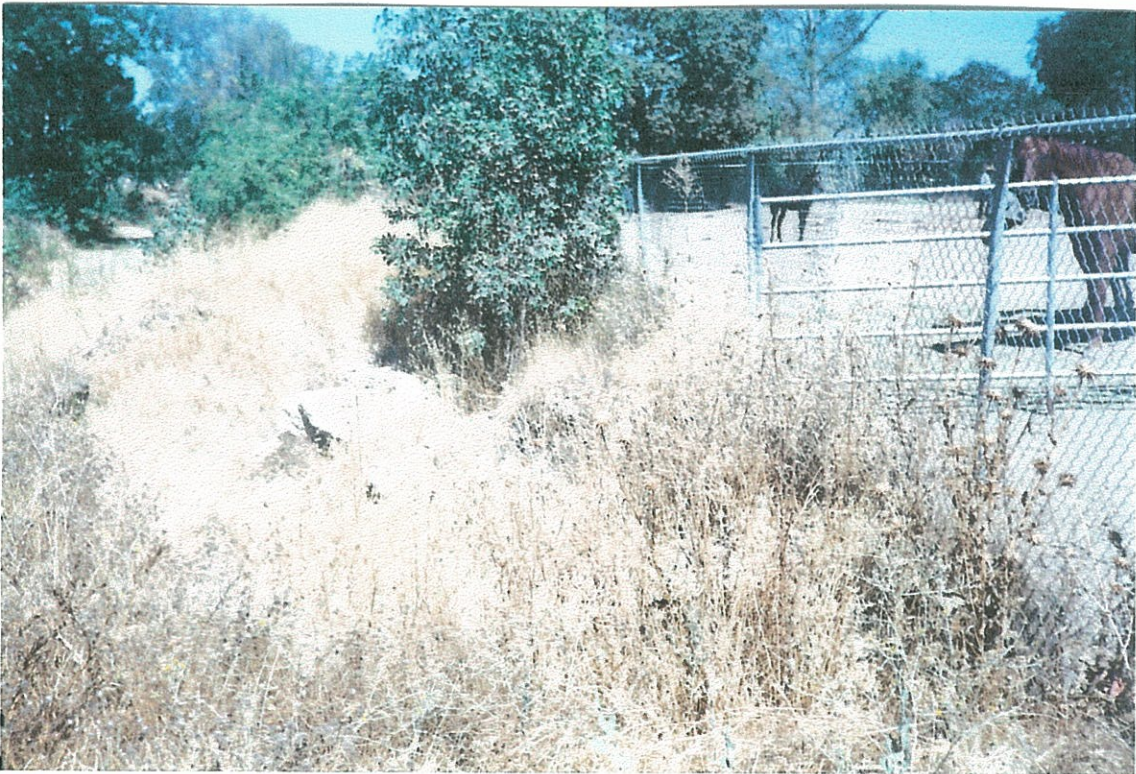
At three sites (APN 825-09-024, 12880 Llagas Avenue, and 1290 Masten Avenue), there is a risk of discharge of horse manure (nitrates and biohazard) to Llagas Creek because horses are penned or kept adjacent to the creek. At these parcels, PIERS recommends that construction workers use gloves so as not to make direct contact with manure during work activities. Also, the parcel owners should be encouraged to maintain a buffer zone between the horse areas and Llagas Creek, and to route drainage from the horse areas away from Llagas Creek.

Photo #25: 1290 Masten Ave. (APN 830-19-004), view north along creek showing adjacent horse corrals.
