To: All Plan Holders
From: Design Workshop
Date: 6/17/25
Project Name: Kellam Wyatt Park
Project: 6335
Subject: Addendum #1

DAM INSPECTION REPORT

EMILY BABCOCK LAKE DAM

DAM INSPECTION CHECKLIST AND REPORT

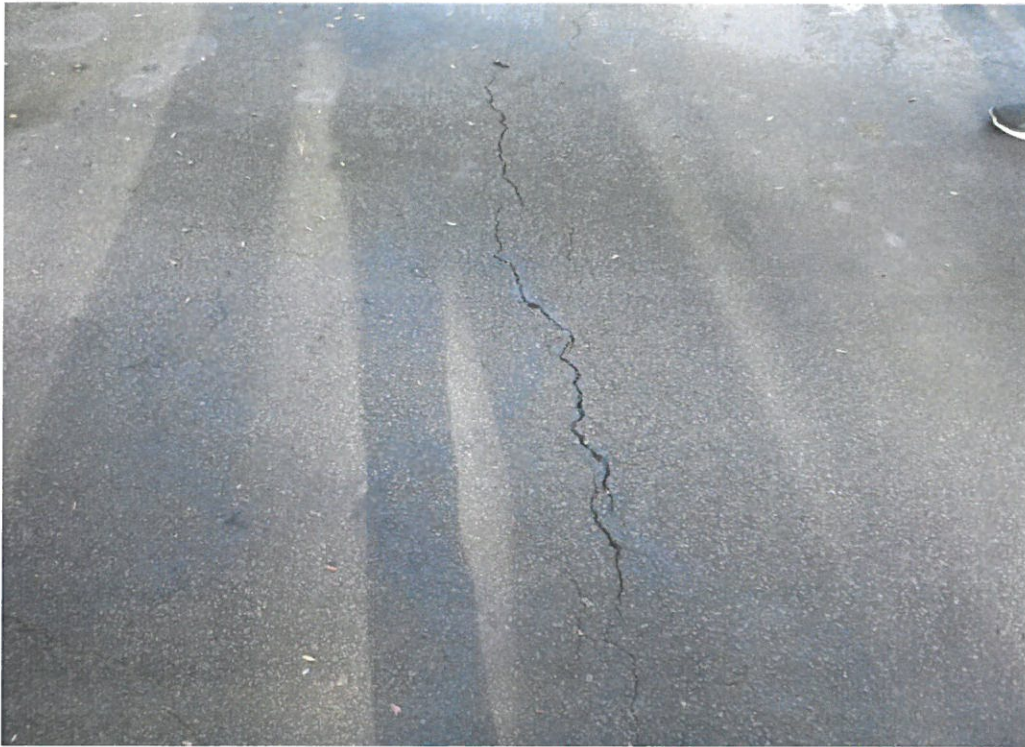
FULL WIDTH TRANSVERSE CRACK UP TO 1/4".

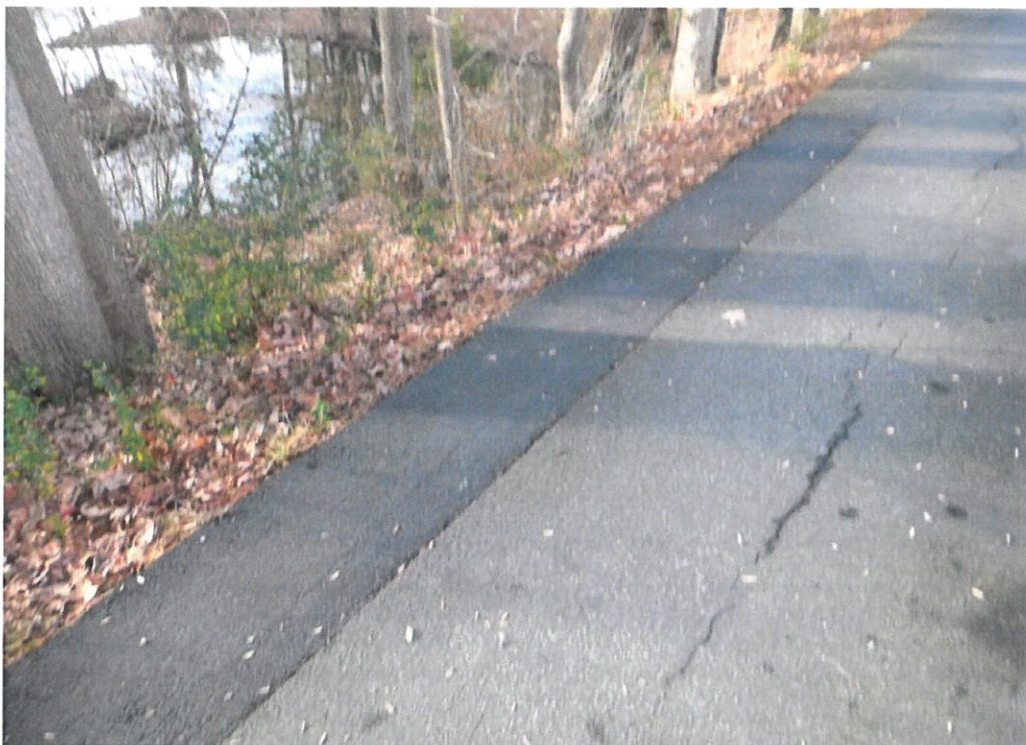
15' x 20" PATCH IN ASPHALT WEARING SURFACE ALONG SOUTH EDGE.

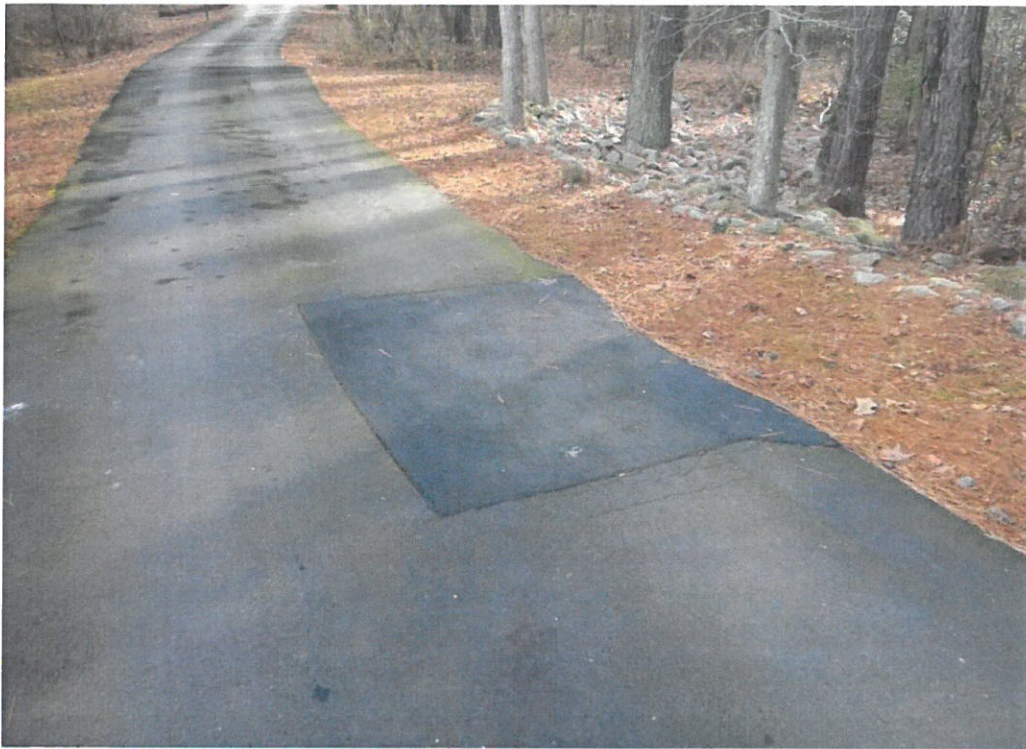
6' x 8' PATCH IN ASPHALT WEARING SURFACE INSIDE THE EMERGENCY SPILLWAY.

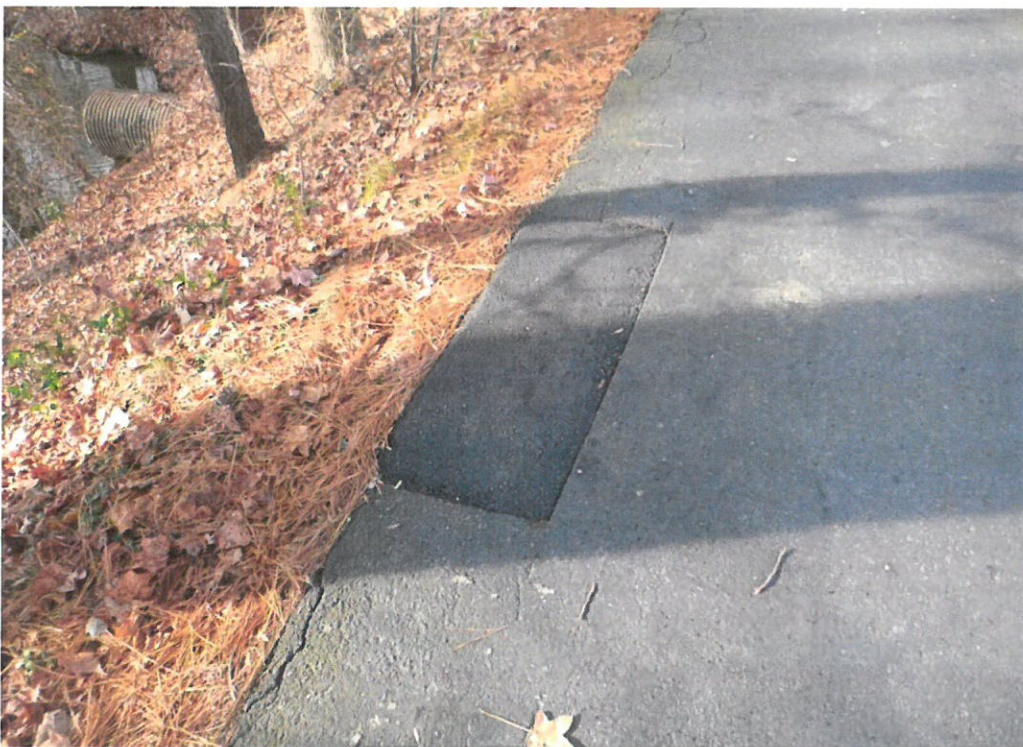
42" x 16" PATCH IN ASPHALT WEARING SURFACE ALONG SOUTH EDGE.

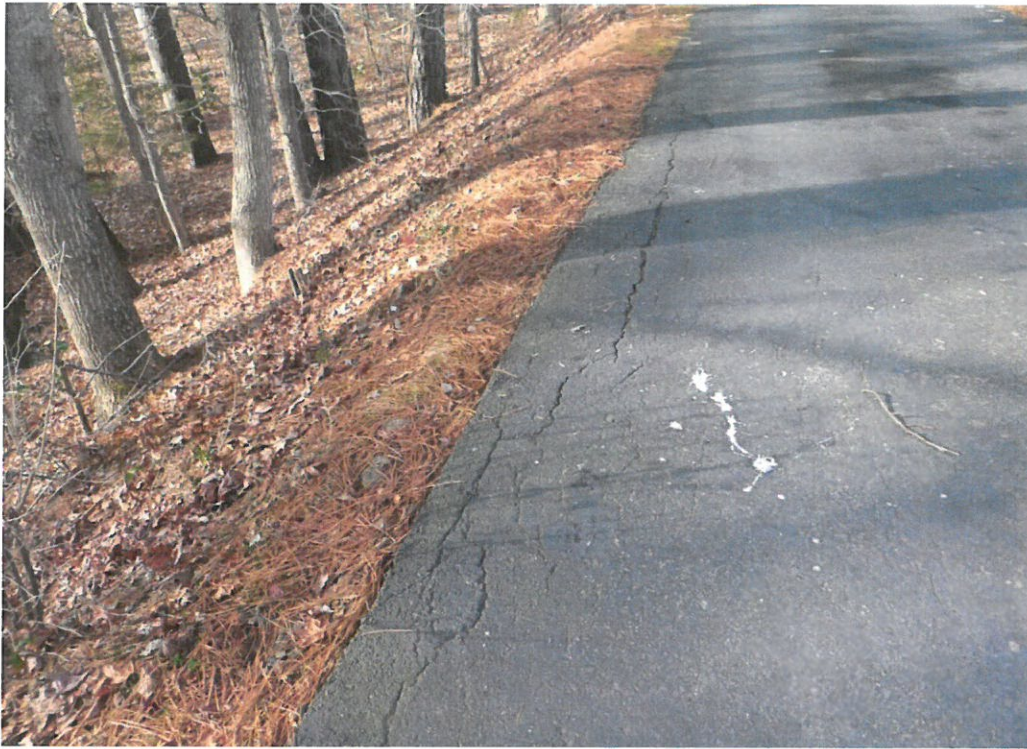
20' x 2' AREA OF SETTLEMENT AND MAP CRACKS IN ASPHALT WEARING SURFACE ALONG SOUTH EDGE.

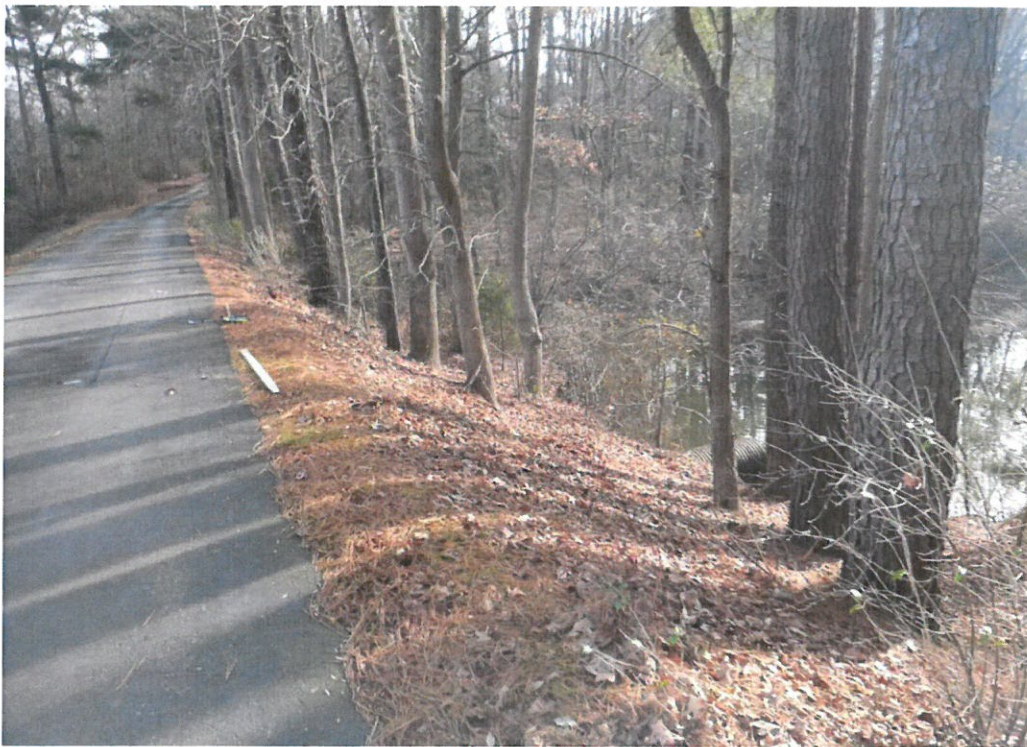
c. Is water level changed from normal?		X			
c. Development around reservoir?		X			
2. Embankment					
a. Is vegetative cover inadequate?	X		Upstream		
b. Are trees growing on either slope?	X		Large trees on downstream side	X

LARGE TREES ON DOWNSTREAM SIDE OF EMBANKMENT.

The trees along the downstream slope should be removed. Additional select trees on the west upstream end and below the emergency spillway could be removed at the same time. Once the trees are removed, the root system will begin to decay and seepage will eventually begin piping through the dam. At the time of tree removal, the widening (up to 14 ft. at top) of the downstream side of the dam is recommended to seal the dam and prevent seepage. The widening would address any erosion issues currently on the slopes and flatten the slope. The tree removal and dam widening would have to take place within a couple of years and cost in the range of \$50,000 for construction. With the recommended widening of the dam, the scour pool would also be addressed, and outlet pipe extended.

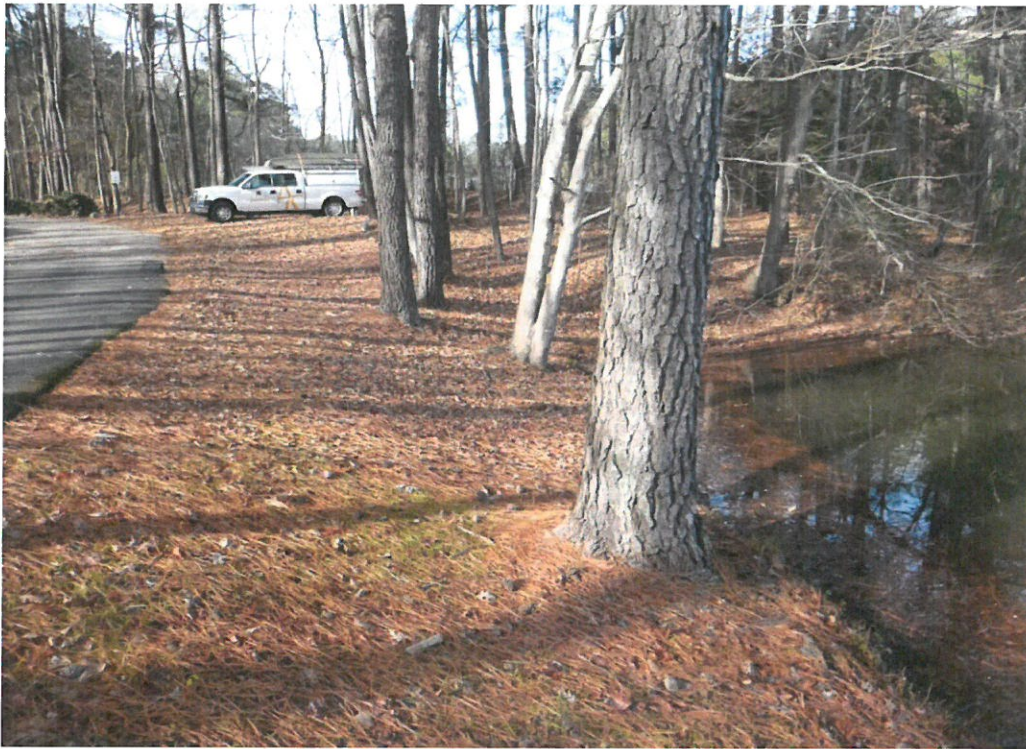
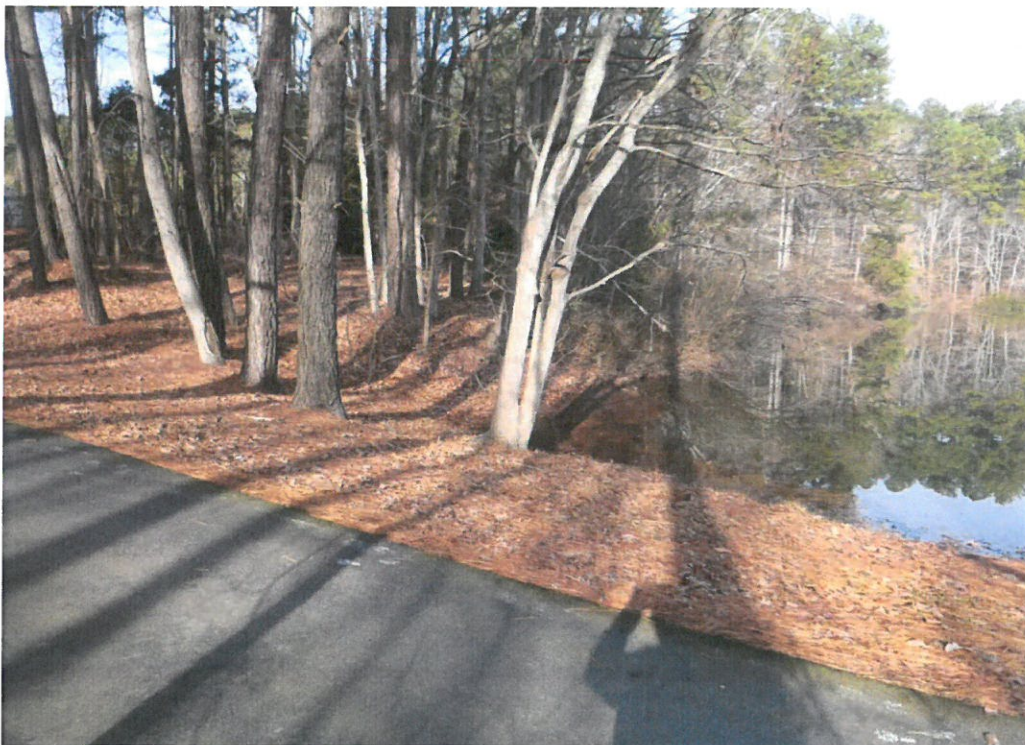
c. Is brush/weed control needed?		X	Maintain mowing		
d. Are trees growing at waterline?	X		6 Large trees at west end		
e. Is drift debris present?		X

6 LARGE TREES AT WEST END, UPSTREAM EMBANKMENT.

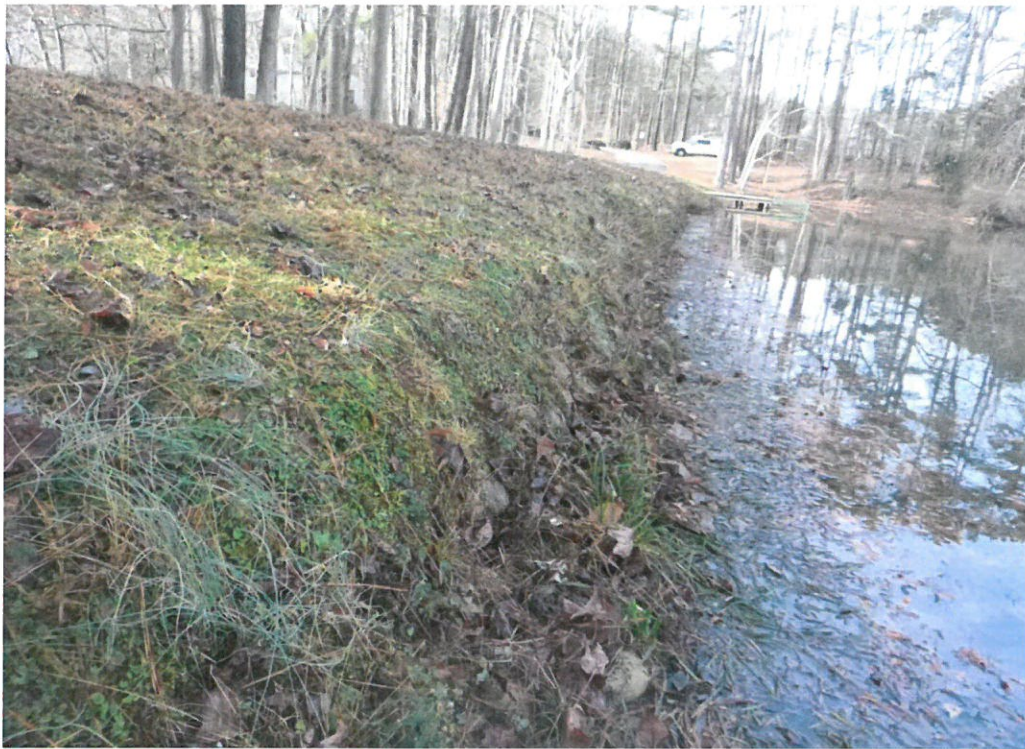
h. Are animal burrows present?		X			
i. Are cattle trails or beaver trails present?		X			
3. Upstream Slope Protection					
a. Any wave damage observed?	X		28" near vertical face on upstream side		X

28" NEAR VERTICAL FACE ON UPSTREAM SLOPE.

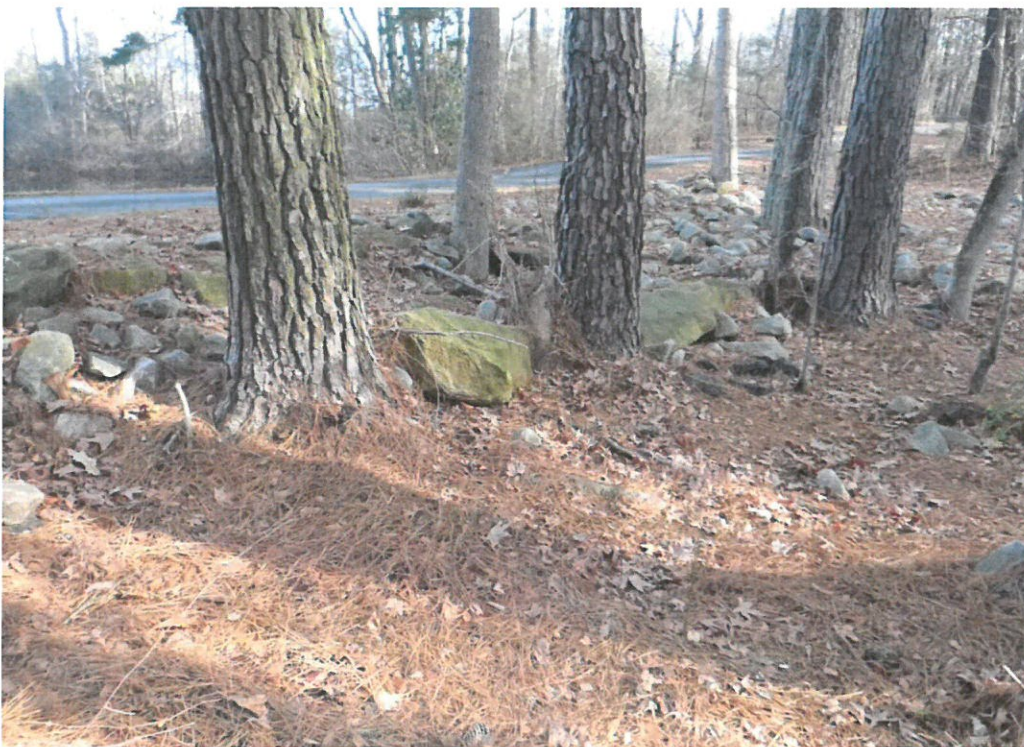
a. Is vegetative cover inadequate?		X			
b. Any animal trails observed?	X		Deer trails, burrows		
c. Any vehicular trails observed?		X			
d. Is flow area obstructed by trees, debris, trash, fence	X		Trees, rip rap

TREES AND RIP RAP, DOWNSTREAM SIDE OF EMERGENCY SPILLWAY.

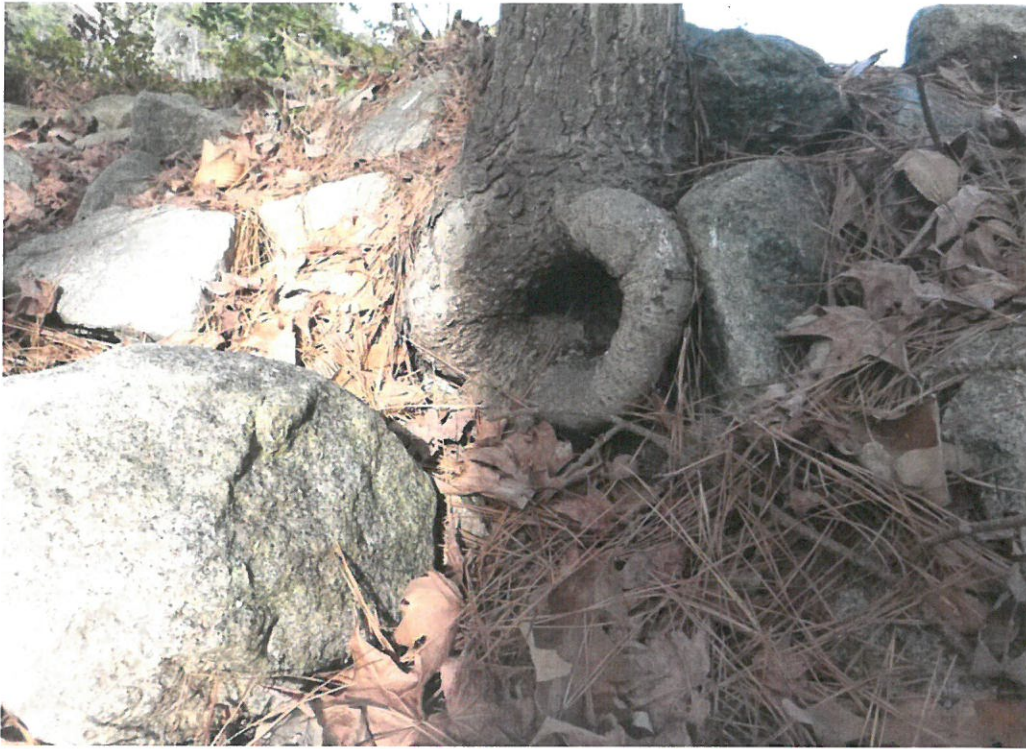
ANIMAL BURROW ALONG DOWNSTREAM SLOPE.

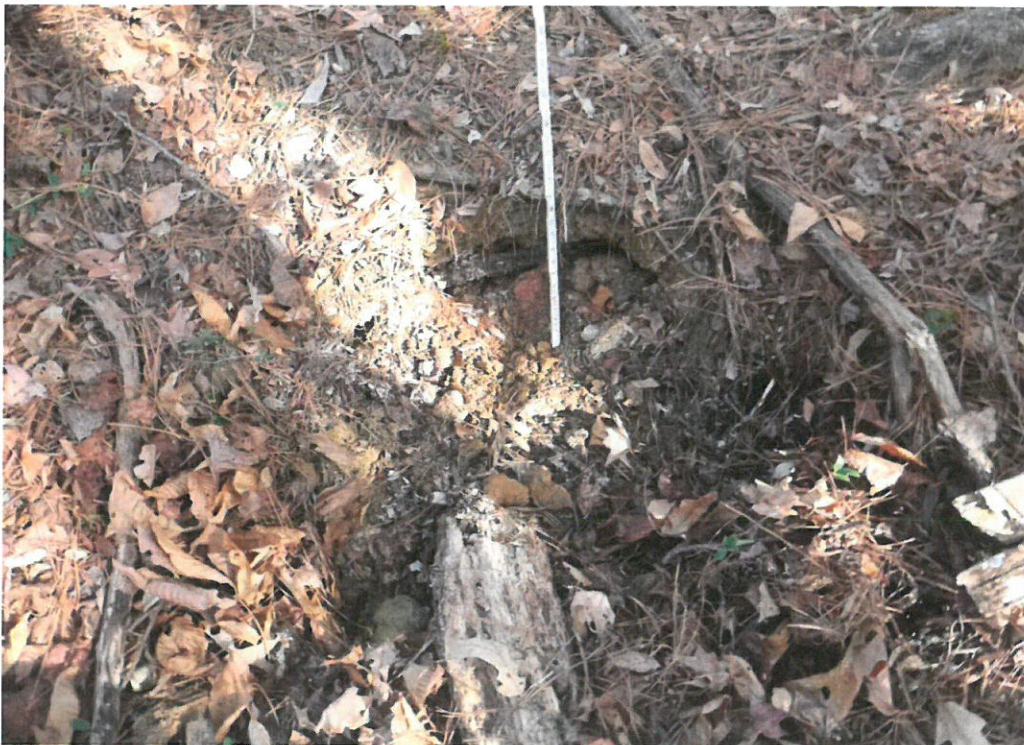
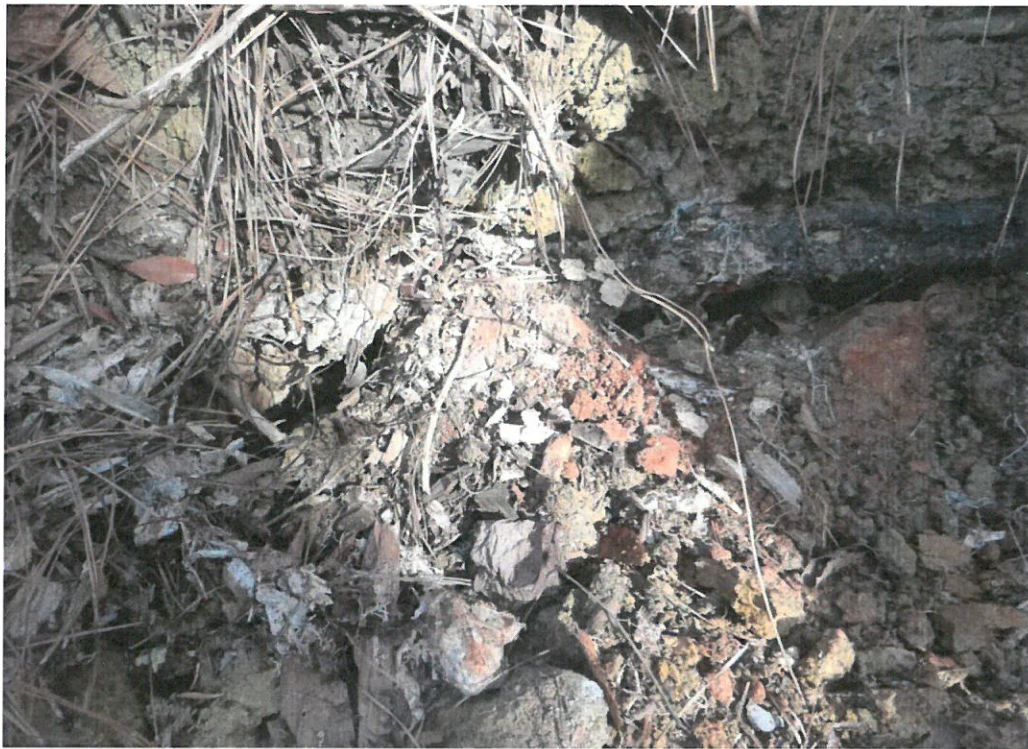
f. Are cracks, settlement, or bulges present?	X		3' Diam. X 16" deep seep on downstream side	X	
g. Is erosion damage present?	X		30 ft. Section of slope < 2:1	X

3' DIAM. X 16" DEEP SEEP ON DOWNSTREAM SLOPE.

1. Remove overburden and backfill seep on downstream side. (Low) 2. Apply bituminous coating to bottom of outlet pipe. (Low)						
ADDITIONAL NOTES FROM CHECKLIST ABOVE:						
1a. Random longitudinal cracks in asphalt wearing surface up to 1/8" wide. 1a. 6' x 8' patch in asphalt wearing surface inside the emergency spillway. 1a. Approx. 40' of asphalt wearing surface is raveling along south edge. 1a. 15' x 16" wide area of settlement and cracking up to 1/4" in asphalt wearing surface along south edge, 40 ft. west of emergency spillway. 1a. Full width transverse crack up to 1/4" wide in asphalt wearing surface near mid point of the dam. 1a. 15' x 20" patch in asphalt wearing surface along south edge with adjacent 1/4" wide longitudinal crack 2' inside of patch. 1a. 42" x 16" patch in asphalt wearing surface along south edge near culvert crossing. 1a. Approx. 20' x 2' area of settlement and map cracks in asphalt wearing surface along south edge over culvert crossing. 2b. 4' diam. area by 12" deep settlement at decayed stump location just west of culvert in downstream slope.

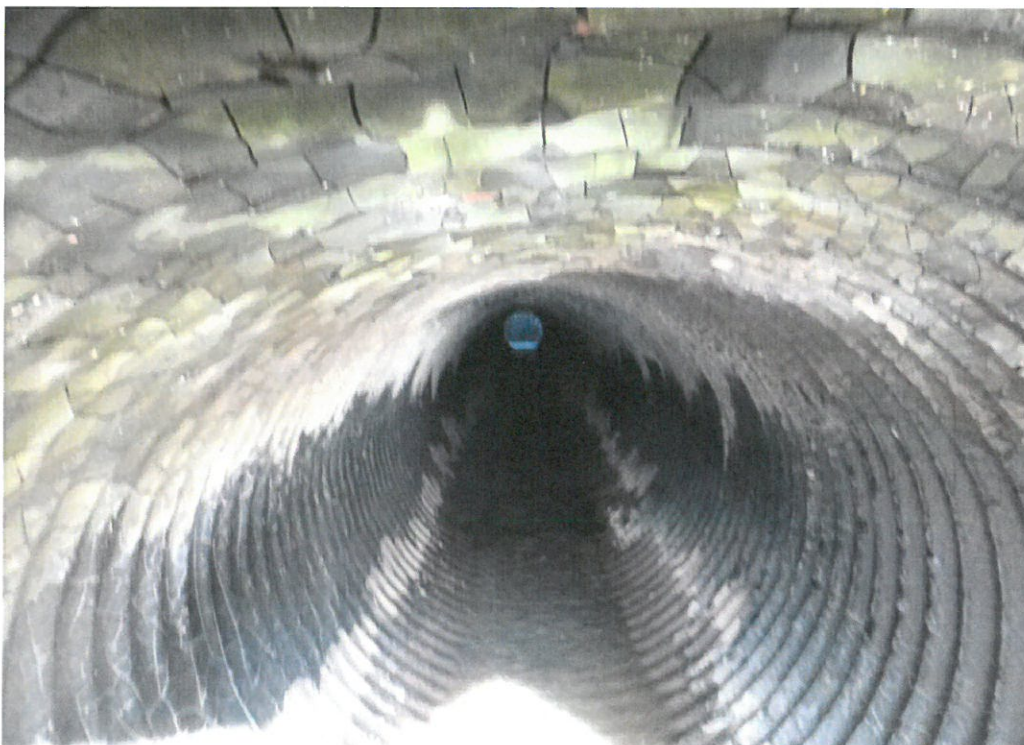
a. Does outlet exhibit deterioration?	X		Bottom 2' of coating needs replacement inside outlet pipe		X
b. Is concrete reinforcement exposed?		X			
c. Any corrosion of metal appurtenances?	X		Surface rust where coating is missing along bottom		X

BOTTOM 2' OF COATING NEEDS REPLACEMENT INSIDE OUTLET PIPE.

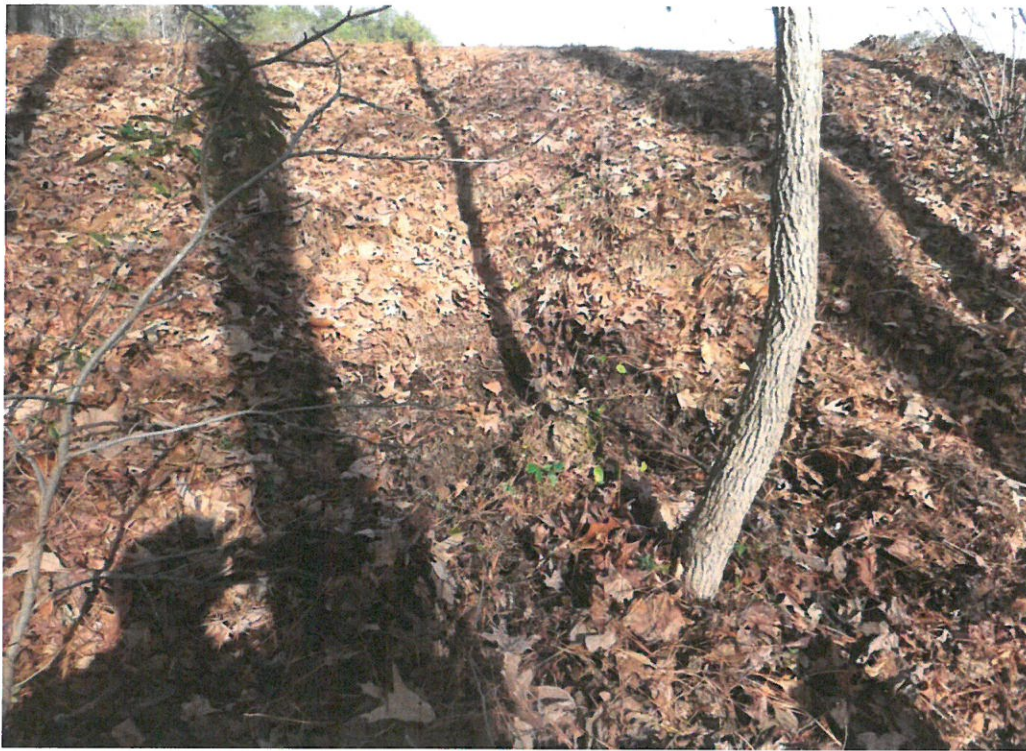
4' DIAM. AREA BY 12" DEEP SETTLEMENT AT DECAYED STUMP.

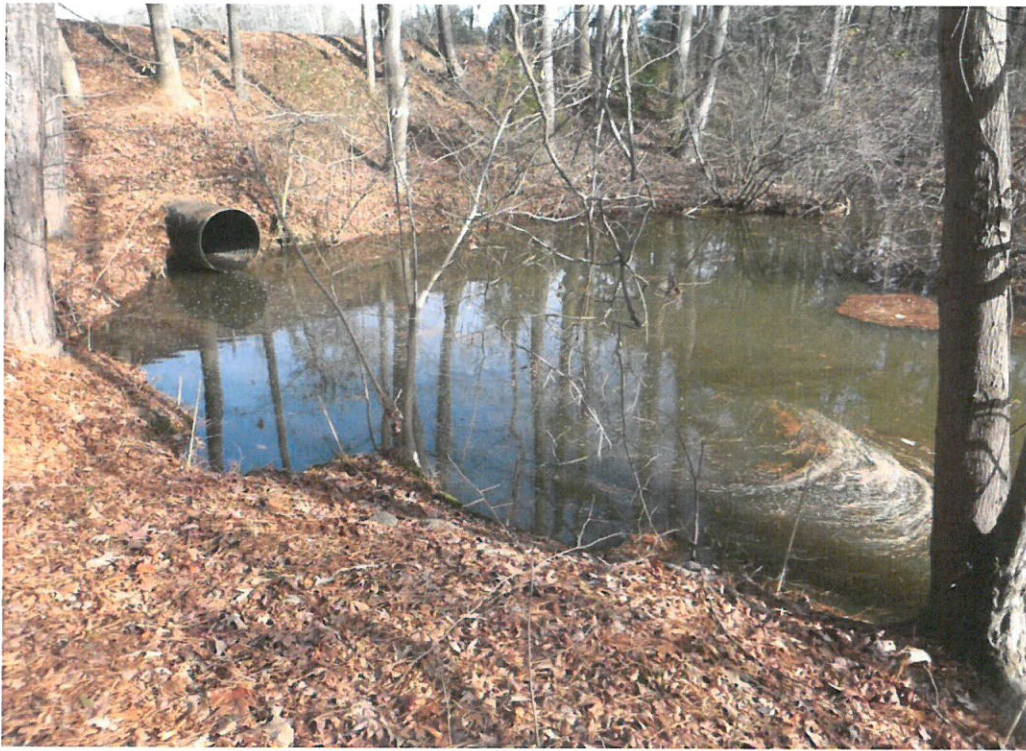
SCOUR POOL

c. Is foundation drain rodent guard missing?						
d. Observation of sediment laden flow?						
10. Principal Spillway Outlet Channel						
a. Is there a scour hole? Does it appear unstable?	X		Scour hole up against downstream embankment			X
